Certificate of Completion of the First-tier Tribunal for Scotland (Housing and Property Chamber) under section 60(5) of the Housing (Scotland) Act 2006

Chamber REF:PRHP/RP/15/0256

Re 7 Muirpark Drive, Bishopbriggs, G64 1RB being the subjects registered in the Land Register of Scotland under Title Number GLA190885 ('the House')

Re-inspection report

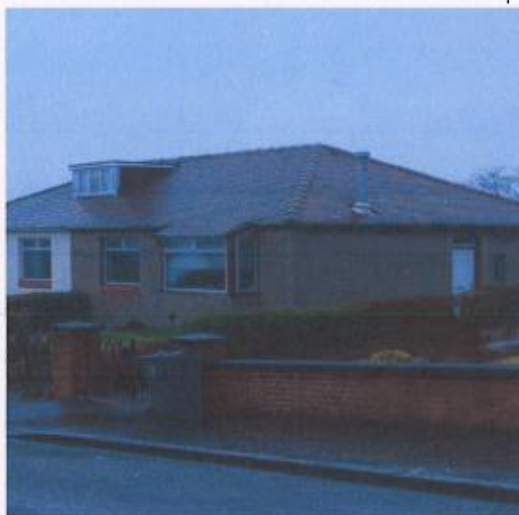
Front and side elevations – 19 December 2016

The landlord has paid for piecemeal repairs to the roof. Some re-pointing of tiles – notably ridge and hipped end tiles - has been carried out and the defective guttering has been repaired, although the tenant now contends that this is leaking again. This was not apparent on my inspection. However, there remain some areas of the roof where there still appear to be missing tiles – for example, on the side pitch above the door and near the apex and on the front pitch, above the guttering.
