Certificate of Completion of the First-tier Tribunal for Scotland (Housing and Property Chamber) under section 60(5) of the Housing (Scotland) Act 2006

112 Queen Street, Dumfries, DG1 2JT ('The Property')

Property Re-inspection Report

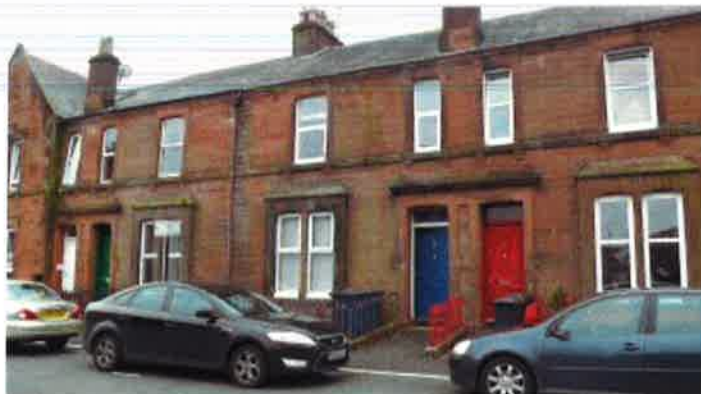
- The Contractor advised that excavation works along the rear elevation had been undertaken by the landlord, the window assembly sealed, the drain hole in the floor, previously used to drain the waste water from the washing machine, also sealed. It was observed that the door steps into the external kitchen door have been reset to ensure that rainwater flows away from the house and basement area. It was also noted that the window sill had been cleared although it was not evident to the Surveyor Member, or the Contractor, where the rainwater would eventually drain away to.

- Improved dampness readings were obtained along the lower sections of the rear elevation using a dual function dampness meter capable of determining levels of moisture below the surface, and deeper within building materials. The readings recorded would suggest that the measures outlined above have been successful.

- Meter readings were also obtained once again from the internal wall running perpendicular to the right of the window opening. These readings were higher than the ones obtained from the rear elevation and fell within the 22-40% range. They were also concentrated at a height of 4-5ft above the floor level in one small isolated section, and not in the vicinity of any timber. There was no obvious cause for this isolated section of dampness at this location suggesting that this section of wall may still be drying out. Rising damp can also be ruled out.

- In terms of the front basement room, the Contractor advised that the following works had been carried out: -
 - Externally, the soil levels had been excavated to a sufficient depth to discover a break in the rainwater drainpipe, previously undetected below ground level. This would have been the most likely cause of the saturated stonework and vegetation growth noted externally during the initial inspection, and the cause of the original high damp readings taken internally under the switchgear cupboard, and on the front elevation. The broken section of downpipe has been replaced;

probable source of dampness noted at the initial inspection. The hole has been sealed and made watertight;

- The sodden earth in the front garden has been removed and replaced by stone chips;
- The Landlord and the Contractor have undertaken “tanking” work on the interior face of the front elevation and a section of the floor slab.
- Dampness readings were taken internally along the front elevation, and on the wall beneath the switchgear cupboard. Although the meter readings were below those recorded at the initial inspection, they were still higher than normal, falling into the 20-30% range. This would suggest that the counter-dampness measures have in-part worked. Acknowledging that the stonework has been subjected to penetrating dampness for a lengthy period of time and had obviously been saturated, there is now visual evidence that the stonework is beginning to slowly dry out naturally.

- **The front and rear basement walls were rechecked for dampness throughout, with the readings taken indicating that the basement has continued to dry out since the date of the previous re-inspection. The recorded readings did not give any cause for concern.**
- **When set in radio wave mode, the damp meter detected the presence of significant moisture below the level of the concrete floor slab in the front basement. However, there was no evidence of surface moisture, and the readings were taken at a section of the floor slab where sub-floor dampness would not be a threat to exposed timber.**

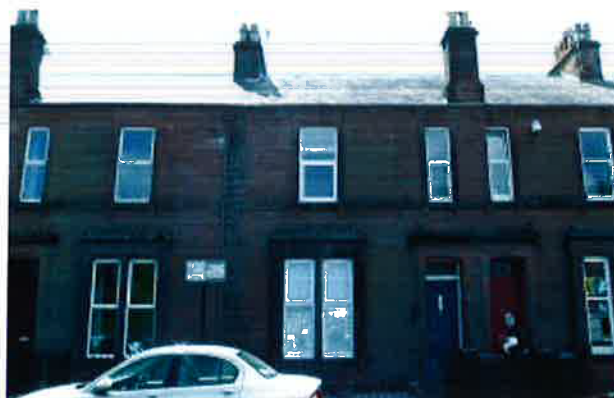
- Resolve the source of lateral damp penetration to the front and rear basement rooms and repair the dampness, rising damp and damp penetration to render the Property water tight.
