STATEMENT OF DECISION OF THE TRIBUNAL UNDER SECTION 24(1) OF THE
HOUSING (SCOTLAND) ACT 2006

Chamber Ref: FTS/HPC/RP/23/0558

Re: Flat 2/2, 190 Main Street, Cambuslang, Glasgow, G727EN, being the subjects
registered in the Land Register of Scotland under Title Number LAN21107 ("The Property")

Schedule of photographs taken during the inspection on 08/08/23

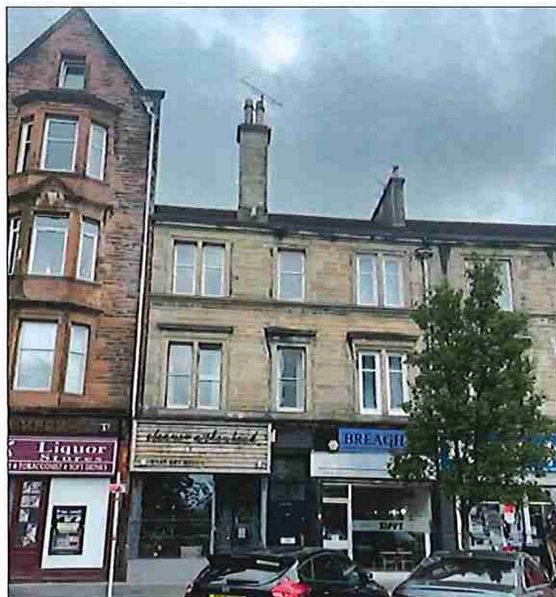
- b) The Landlord is the registered Landlord in the Scottish Landlords Register in relation to the Property.
- c) Water ingress has caused damage to the ceiling and the wall of the lounge of the Property. There were large areas of plasterwork missing from the wall.

- e) The ceiling and walls of the Lounge at the Property, being part of the structure of the Property, are not in a reasonable state of repair and accordingly the Property does not currently meet the Repairing Standard and in particular the Landlord has failed to comply with subsection (b) of Section 13(1) of the Act .

Large sections of plaster have been removed by contractors along the lounge wall and cracks are visible at the kitchen area.
Water staining and damage to the ceiling was visible.
High moisture readings were noted along the cornice and ceiling.

- (a) Carry out investigations to establish the cause of continuing high dampness readings at ceiling level in the lounge of the Property and to carry out any such works as may be necessary to ensure that there is no continuing water ingress at that area so that it is in a reasonable state of repair and in proper working order and

- (b) Repair the damaged plaster on the Lounge wall and ceiling so that it is in a reasonable state of repair and in proper working order
21. The Tribunal order that the works specified in the RSEO must be carried out and completed within the period of 6 weeks from the date of service of this Notice.
