### **Statement of Decision of the Housing and Property Chamber of the First-tier Tribunal for Scotland under Section 26 (1) of the Housing (Scotland) Act 2006**

**Property: 139 Burntscarthgreen, Locharbriggs, Dumfries DG1 1XW ("the Property"/ "the house")**

**Chamber Reference: FTS/HPC/RT/19/3253**

## **SCHEDULE OF PHOTOGRAPHS**

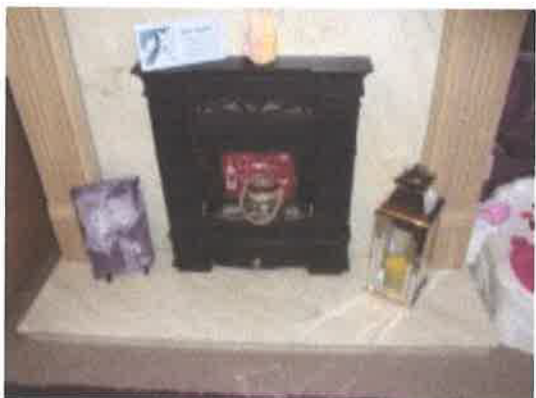
- The electric shower on the second floor has power but no water supply.
- The gas fire in the living room is not working. There is an electric radiator in the room..

**LIVING ROOM – GAS FIRE**

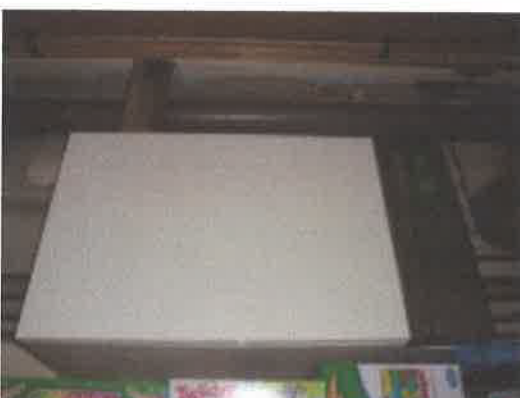
- The carbon monoxide monitor is inside the cupboard which houses the gas central heating boiler within one of the first-floor bedrooms. The carbon monoxide monitor in the living room is in the wrong location.

**REAR BED-GAS BOILER/CO MONITOR**

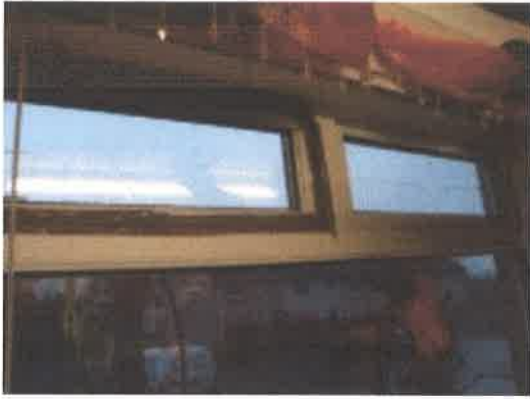
- The top opening kitchen window sashes both have faults. The right hand one (looking from inside the Property) is screwed shut and silicone sealed and cannot be opened, and the other one is loose from the frame when opened and is taped shut. Neither sashes have handles.

**KITCHEN – WINDOW**

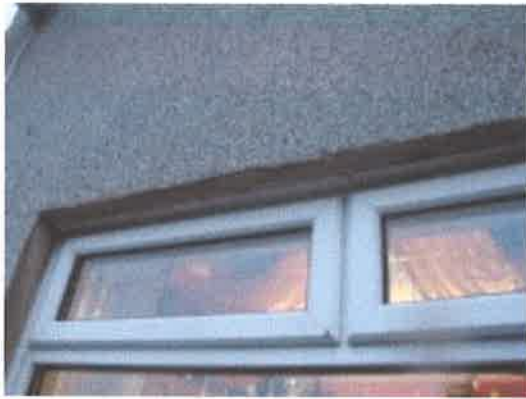
- There are cracks in the external render above the kitchen window and above the back door.
- The thermostatic control on the central heating boiler is broken and cannot regulate the temperature.

**KITCHEN – DEFECTIVE RENDER**

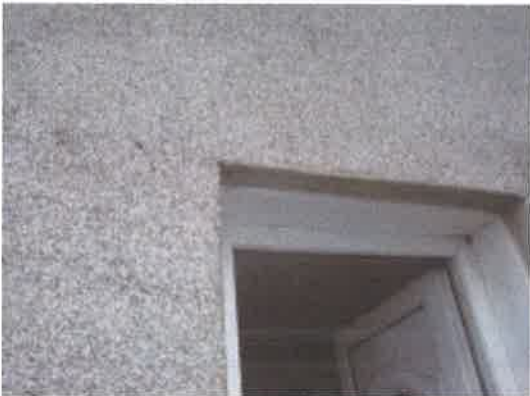
**REAR DOOR LINTOL-CRACKED RENDER**

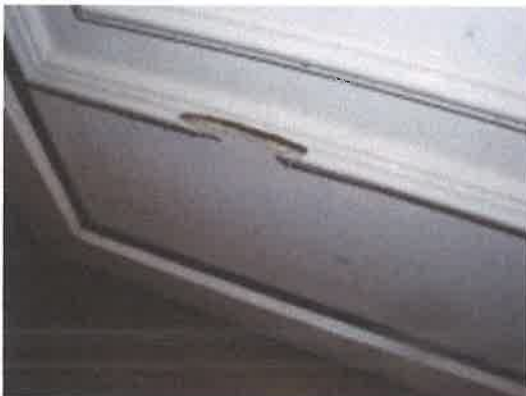
- There is evidence of a leak below the shower that has dripped into the kitchen below. The kitchen ceiling is bowed.
- There is a hole in the beading of the external surface of the back door.

**REAR DOOR-CRACKED**

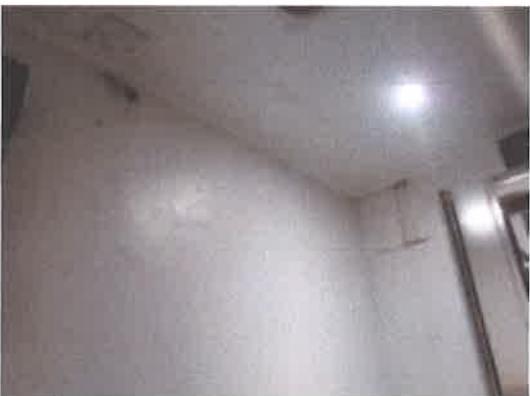
- There is evidence of water ingress on the ceiling of the first-floor bathroom. A hole in the ceiling has been boarded over, but the hole itself may still be there.

**SHOWER ROOM-DAMPNESS**

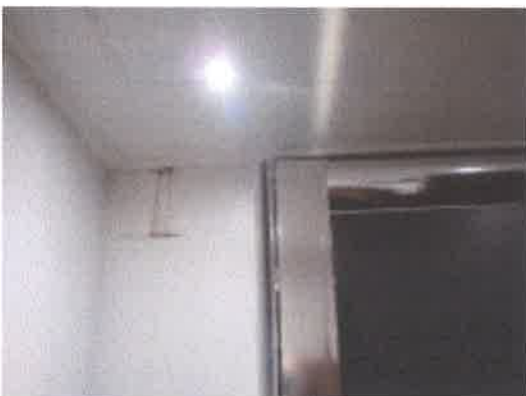
- The Tribunal has not seen a current Gas Safety Certificate for the Property.
- The electric shower on the first floor appears has a defective thermostat and the water temperature cannot be controlled. In addition, the shower screen is loose and insecure.

**SHOWER ROOM-LOOSE PANELS**

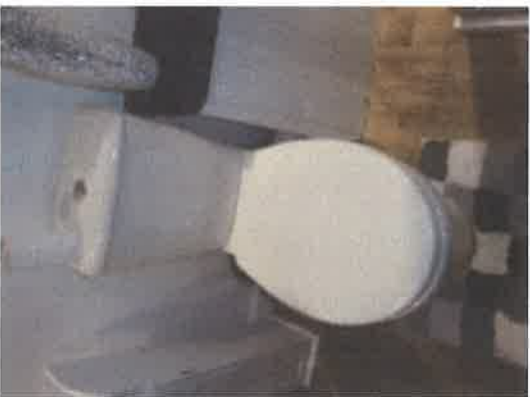
- The toilet in the first-floor bathroom is not properly secured to the floor beneath or to the wall behind.
- There are loose floorboards in the first-floor hallway.

**SHOWER ROOM – W.C.**

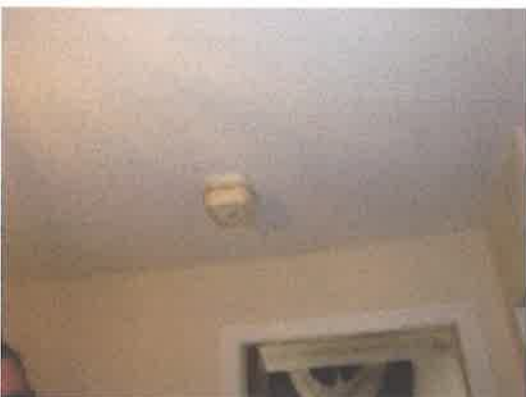
- There is no heat detector in the kitchen. There is a smoke detector on the first-floor landing, but there are no mains-wired and interlinked smoke detectors on the ground floor.

**1ST FLLOR LANDING – SMOKE DETECTOR**

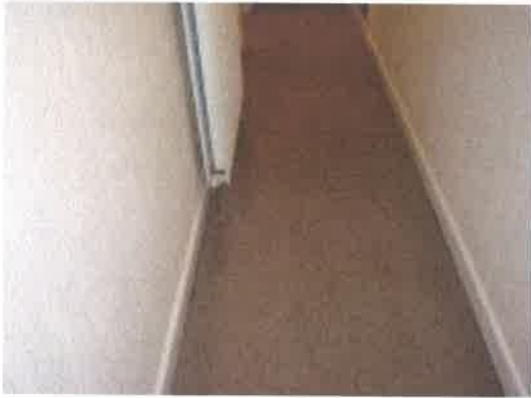
**1ST FL PASS – UNEVEN FLOOR**

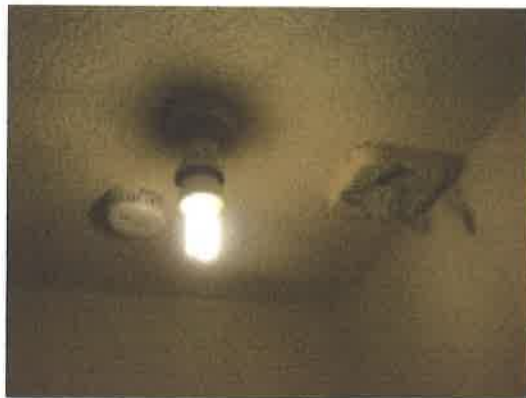
**ATTIC LANDING- BATTERY SMOKE ALARM**

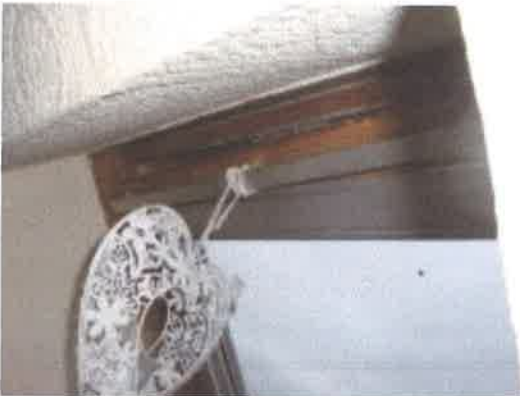
- The left hand (looking from the inside) Velux window in the attic bedroom has a broken ventilator mechanism and its timber frame is defective and heavily stained by the effects of condensation.

**ATTIC- VELUX –BROKEN VENT**

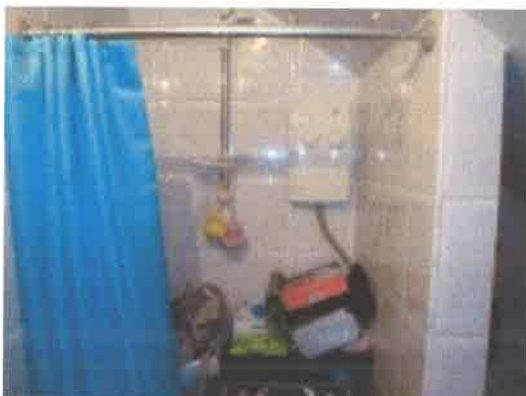
**ATTIC – SHOWER**

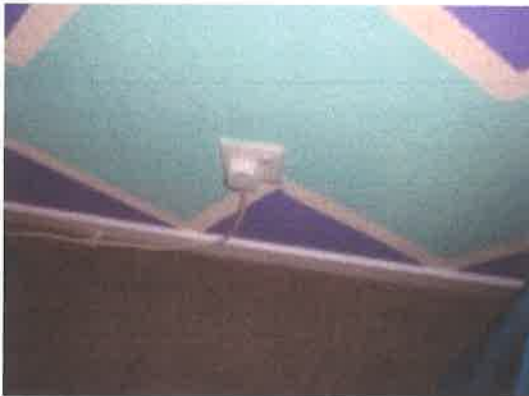
- There is a damaged power socket in the living room and a defective socket in the first-floor rear bedroom, which cannot be switched off.
- The Tribunal has not seen an Electrical Installation Condition Report in respect of the Property.

**REAR BED. – DEFECTIVE SOCKET**

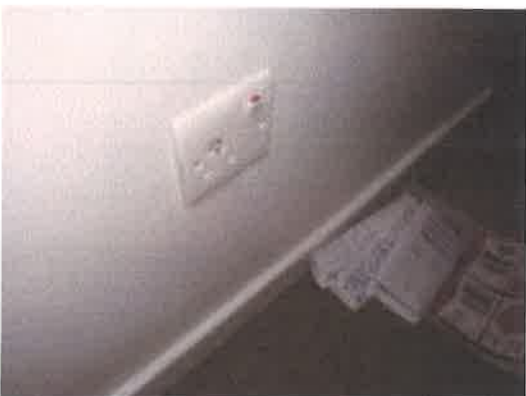
**LIVING ROOM – DEFECTIVE SOCKET**

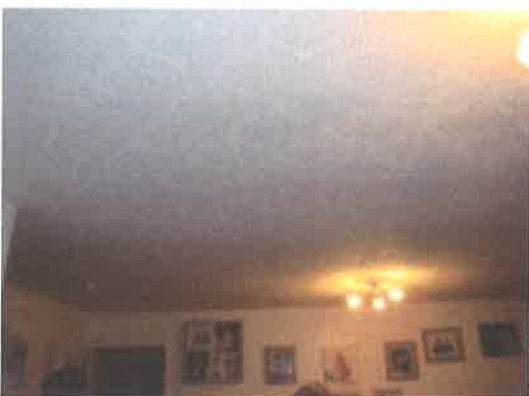
**LIVING ROOM CEILING –NO ALARM**

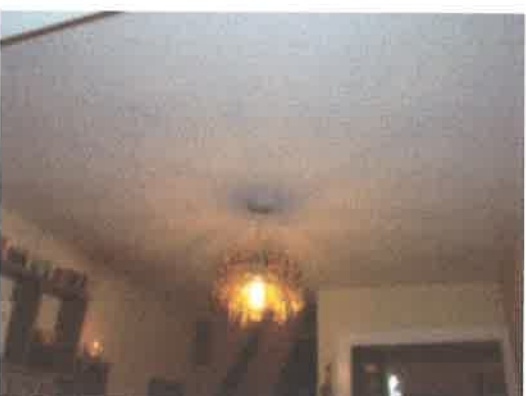
**HALL – NO ALARM**

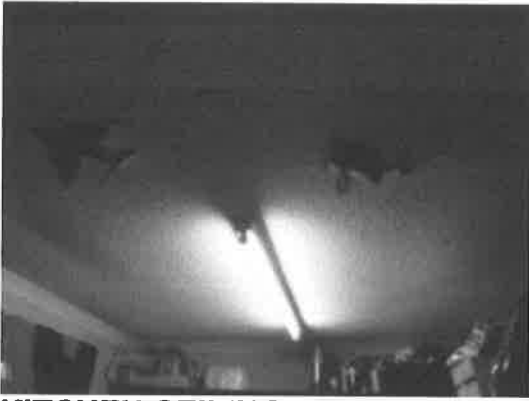
14. The Tribunal was particularly concerned about the risk of collapse of the kitchen ceiling and the absence of a compliant system for smoke and heat detection and the incorrect positioning of the carbon monoxide monitors. The inability to control the temperature of the shower on the first floor means that there is a real risk that a user might be scalded.

**KITCHEN CEILING – HOLED AND BOWED. NO ALARM.**
