**Decision and Statement of Reasons: Housing (Scotland) Act 2006
Section 24**

**Mains of Boquhan Farmhouse, Boquan Estates, Kippen, Stirlingshire
FK8 3JQ ("The House")**

Photographic Schedule – Mains of Boquhan Farmhouse, Boquhan Estates, Kippen FK8 3JQ

Date of Inspection: 20 April 2018

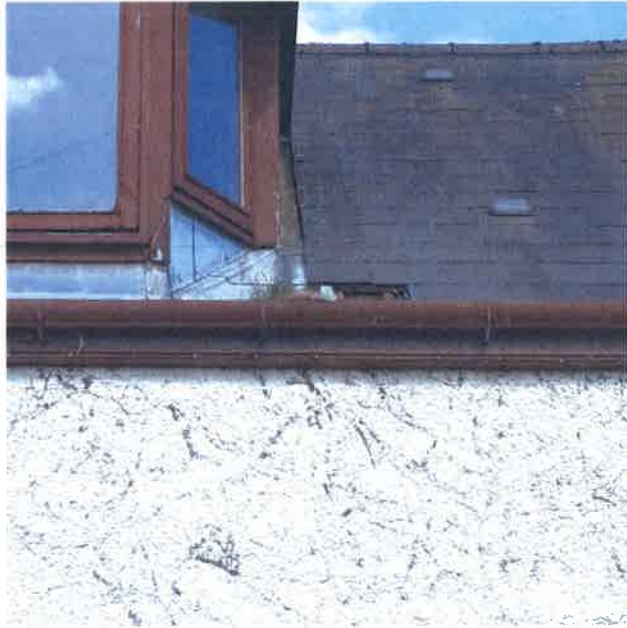
18. The gutters were inspected from the upper windows and outside. The gutters are choked with weeds and silt debris.
19. The roof was inspected from ground level without the use of a ladder. It could be seen that there was a tile missing at around eaves level to the front east of the roof and the mortar fillet at the sun lounge gable was displaced and part missing.

- 32. There was clear evidence that the external roof is in need of repair as there is a tile missing around eaves level to the front east of the roof and the mortar fillet at the sun lounge gable is displaced and part missing.

3 Missing tiling front elevation east

- (b) To ensure that all the plumbing within the House is operating satisfactorily in that it is working and there are no leaks within the system,
- (c) To repair and make good the missing tile and verge mortar fillet at the front of the house,

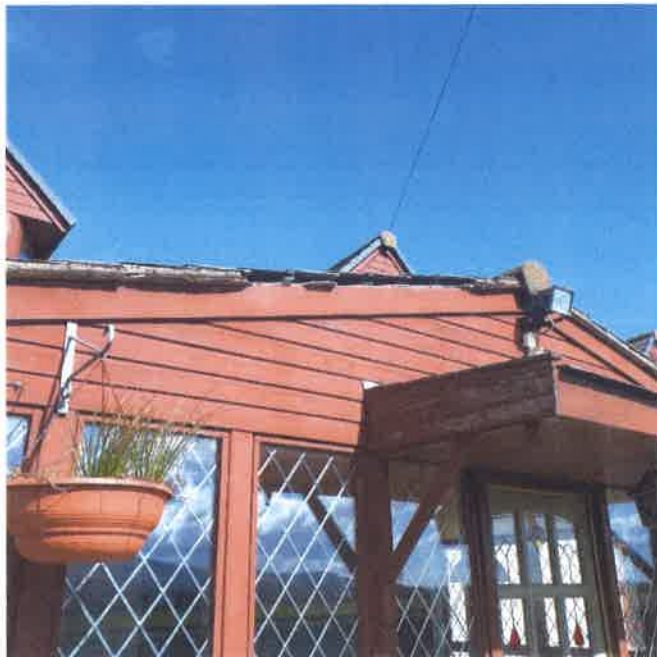
4 Missing/displaced mortar fillets at front elevation sun room porch

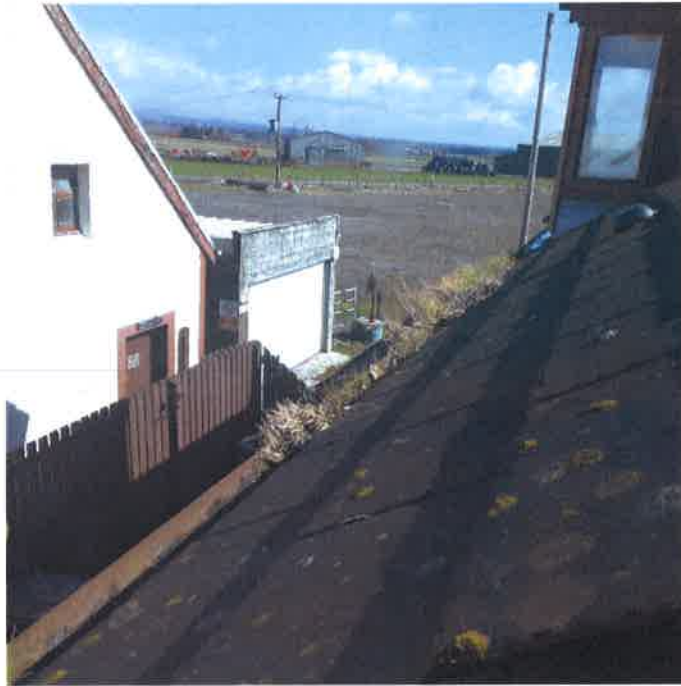
5 Example of weed build up in the gutters to the rear

- (g) To clean and repair the gutters to ensure that any water in the gutter is able to run freely and
- (h) To provide an Electrical Installation Condition Report (EICR) showing the electrical installation reaches a satisfactory standard with no C1 or C2 items reported and it to be dated after the date of the inspection by the Tribunal. The aforementioned EICR should be carried out by a suitably qualified and registered SELECT or NICEIC electrical contractor.

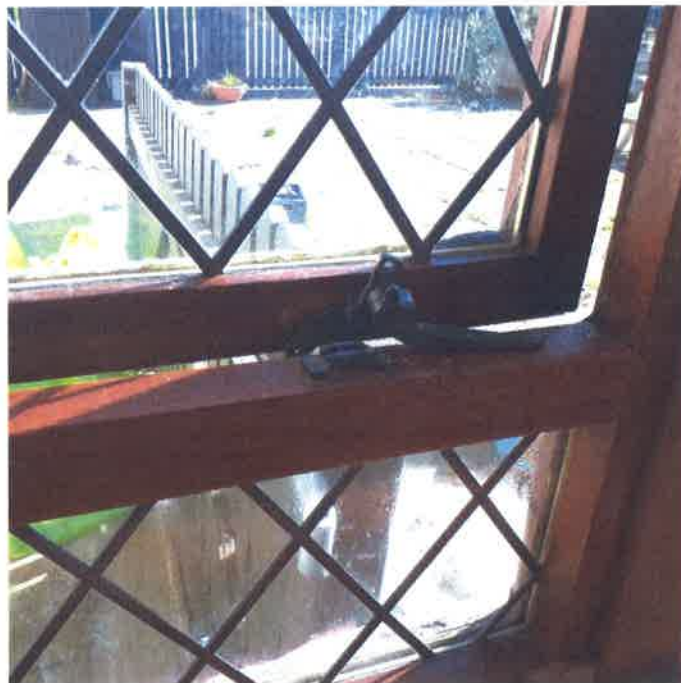
- 30. The Tribunal was in no doubt, from its inspection, that the property did not meet the Repairing Standard.
- 31. There was clear evidence the windows needed cleaned of the moss on the outside and repaired or replaced. Many of the windows could not be opened due to concerns about the poor condition of the windows and that opening them could cause further damage. There is a need for a complete overhaul of all of the windows to ensure that all are wind and watertight and are properly operable. There will likely be a need to replace some of the more badly affected units.

6 Example of defective window ironmongery

- (e) To repair and make good or replace the windows to ensure that all windows are properly operable,
- (f) To repair and make good or replace the internal doors to ensure that all doors are properly operable,

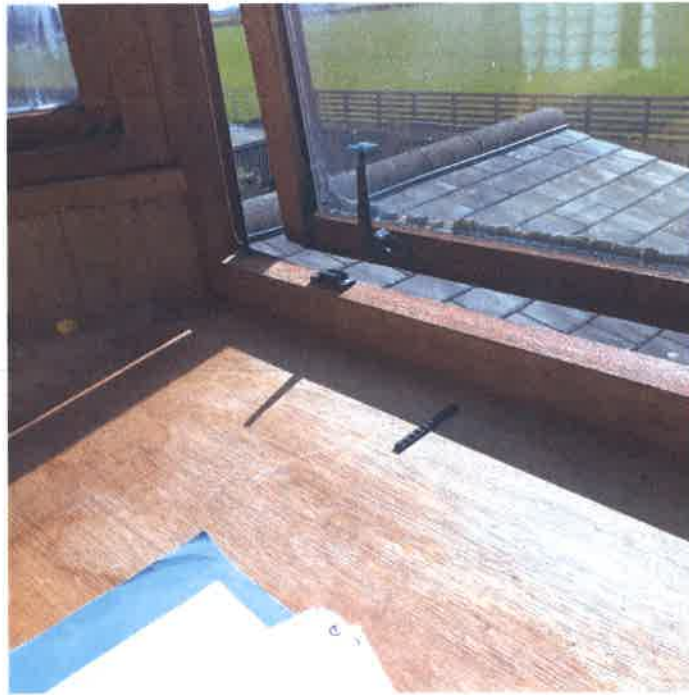
7 Example of moss build up on external window glazing (first floor front bedroom)

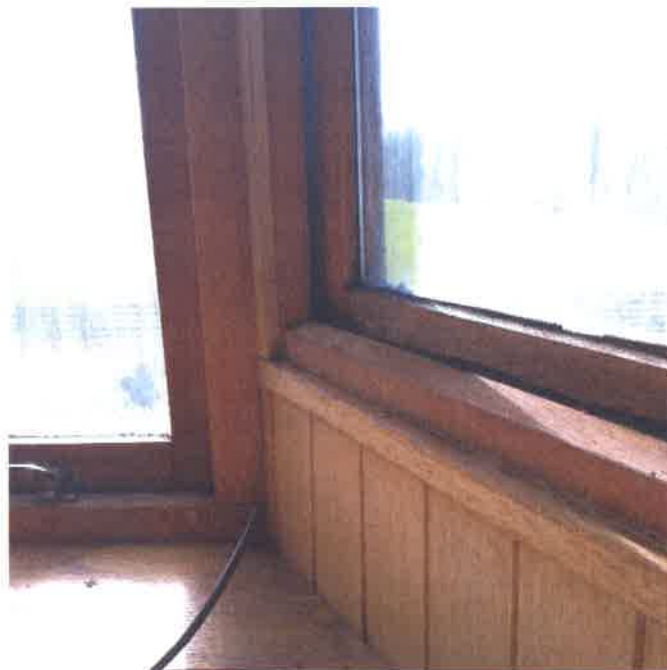
8 Example of ill-fitting window unit (first floor front bedroom)

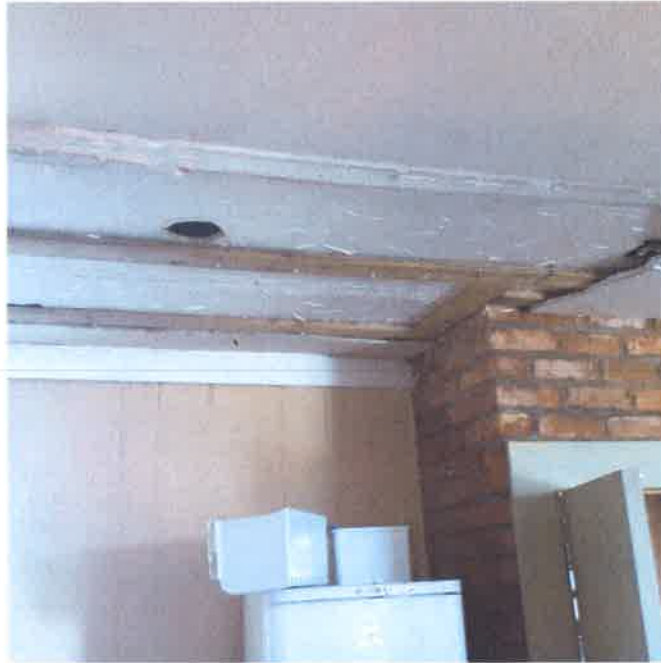
12. The kitchen was then inspected. The windows were generally in a poor and unmaintained condition. Some were unable to be opened for health and safety reasons. Water penetration, likely from defective pipework above in the first floor bathroom, had resulted in the part-collapse of the ceiling plasterboard. There was evidence of water staining down the north wall. The doors were ill-fitting and difficult to open and close.

- 33. The plaster board ceiling in the ground floor kitchen is part collapsed which is likely as a result of defective drainage likely from the bathroom above.

9 Part collapsed ground floor kitchen ceiling; water staining noted on wall

- (d) To repair and make good the plaster board to the kitchen ceiling including repairing any damage caused to the ceiling structure and make good any decoration,

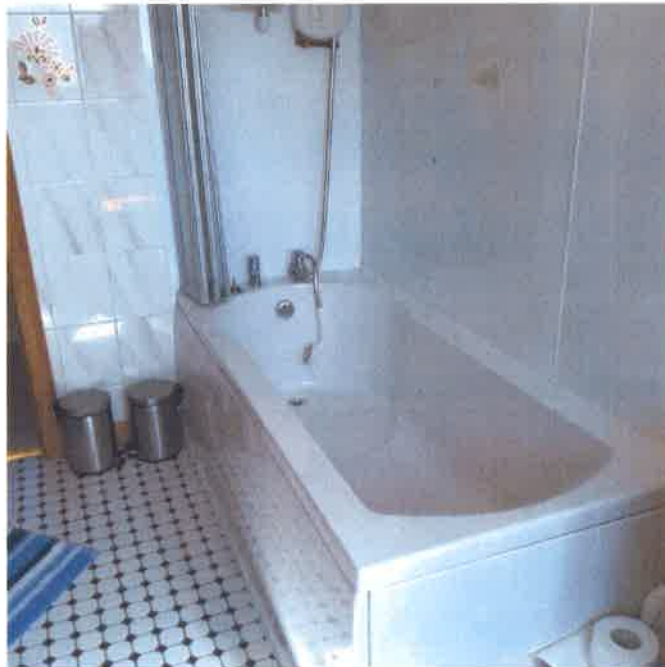
17. The first floor bathroom was then inspected. The wash basin and bath briefly ran water; likely to be residual in the pipework, as the water ceased running and there was a strong drain smell shortly thereafter. The same issues with the windows as detailed above were noted.

10 First floor bath; suspected source of kitchen leak below.

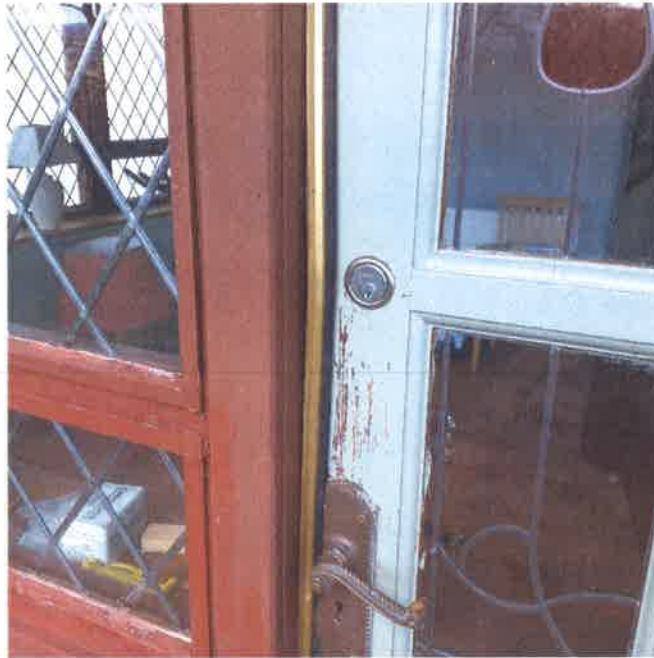
14. The sun lounge was then inspected. The same issues arose with the windows as detailed above. The door was boarded over and was unable to be opened.

11 Secured sun room external door (boarded over internally for security)

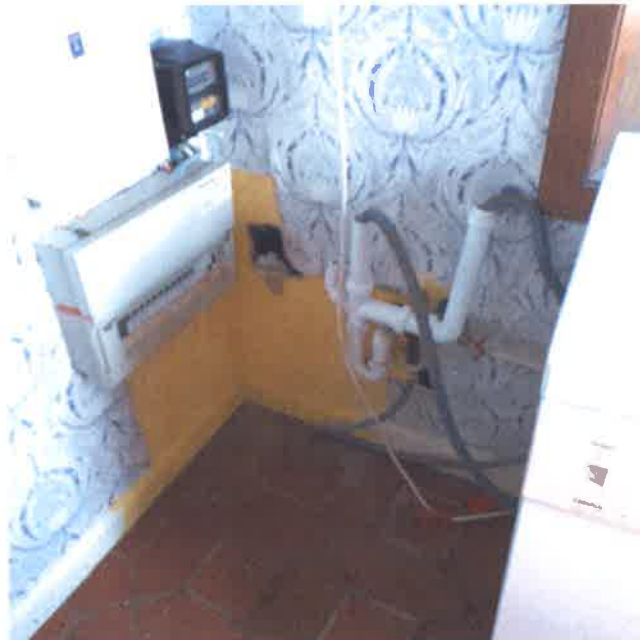
9. The House was not occupied. Some furnishings remained in it and there were floor coverings in place. The heating system was not able to be turned on. The electricity and water supplies were turned off. The electricity was not able to be tested. The electrical switchgear was noted as being in the utility room.

12 Electrical switchgear and ad-hoc washing machine plumbing in ground floor utility room

37. As electricity was turned off it was not possible to confirm if it was working or not. This would be resolved by providing an Electrical Installation Condition Report (EICR) showing the electrical installation reaches a satisfactory standard with no C1 or C2 items reported and it to be dated after the date of the inspection by the Tribunal. The aforementioned EICR should be carried out by a suitably qualified and registered SELECT or NICEIC electrical contractor.

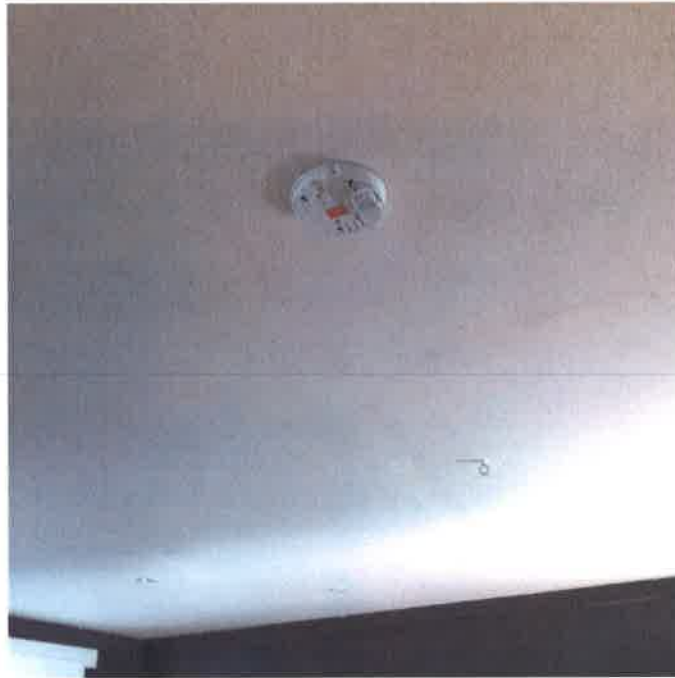
13 Defective ceiling mounted smoke detector in ground floor kitchen

42. The Tribunal would wish to point out that the work needs to be done to ensure that all smoke and heat detectors are in working order and are inter-linked from the mains supply. A heat detector should be provided in the kitchen and smoke detectors provided in the sitting room and in the first-floor hallway. A Carbon dioxide detector should be provided in the Livingroom.

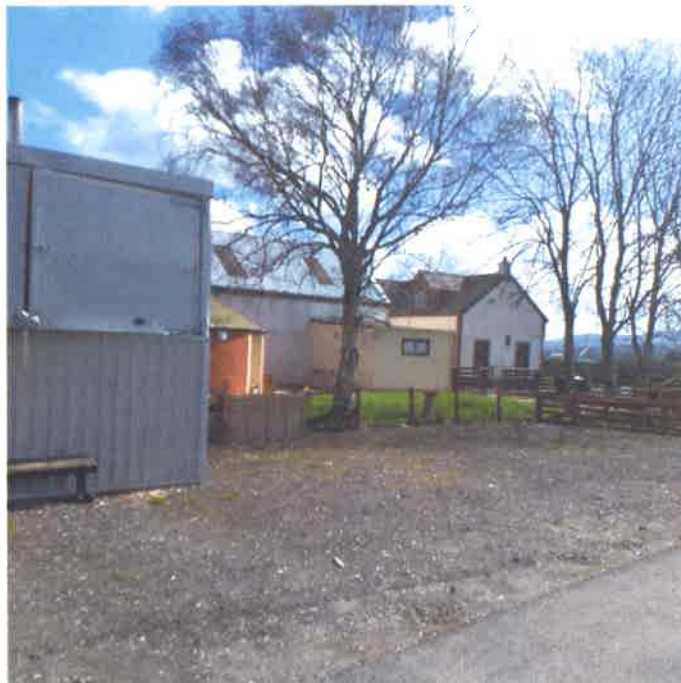
20. The bio mass boiler was inspected. This was housed in a separate building in close proximity to the House. We understand that the installation serves a number of buildings on the estate, including the House under inspection. The system was not operational at the time of our visit and therefore there was no space heating or hot water supply to the House on the day of inspection.

- 34. That the internal doors are ill fitting and do not close properly.
- 35. There was no evidence brought forward that the biomass boiler was in operational order. The biomass boiler was switched off and this is the reason that there is no operational space heating or hot water in the House. In any event, the space heating and hot water supply should be

14 View of bio-mass boiler metal container housing (LHS) with dwelling to the rear (RHS)

- (a) To carry out sufficient works to the bio-mass boiler to allow space heating and hot water system to be operable within the House or the installation of an alternative heating system to allow heating of the House and hot water in the House and to ensure that all the appropriate safety certificates are in place for the above.

reinstated to ensure adequate heating/hot water throughout. This will include a full check on all of the radiators and pipework, where aged leakage stains could be seen on some of the pipework surfaces.
