**Housing and Property Chamber
First-tier Tribunal for Scotland**

STATEMENT OF DECISION FOR REPAIRING STANDARD ENFORCEMENT ORDER (“RSEO”) UNDER SECTION 24 HOUSING (SCOTLAND) ACT 2006 (“the Act”).

27 Everard Drive Glasgow G21 1XG

Schedule of photographs taken during the inspection of:
27 Everard Drive, Glasgow, G21 1XG

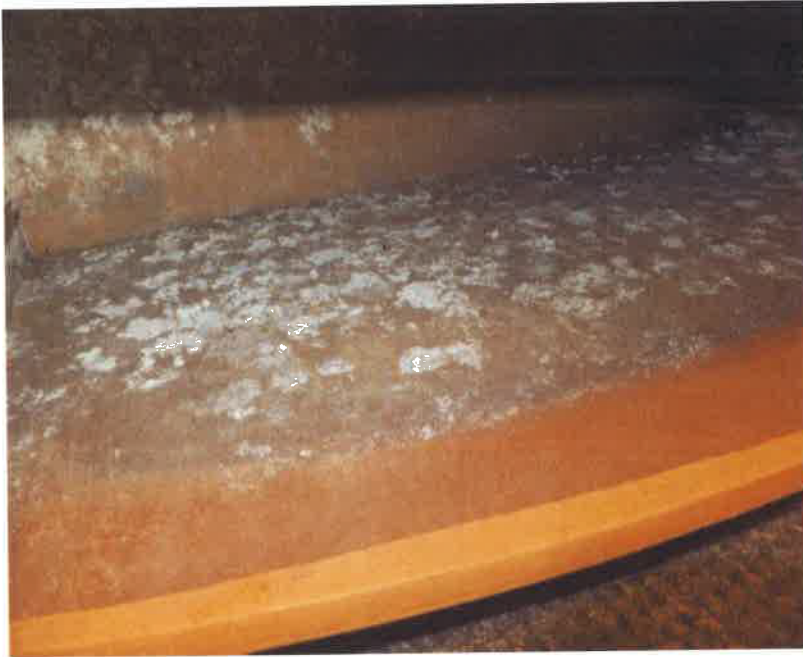
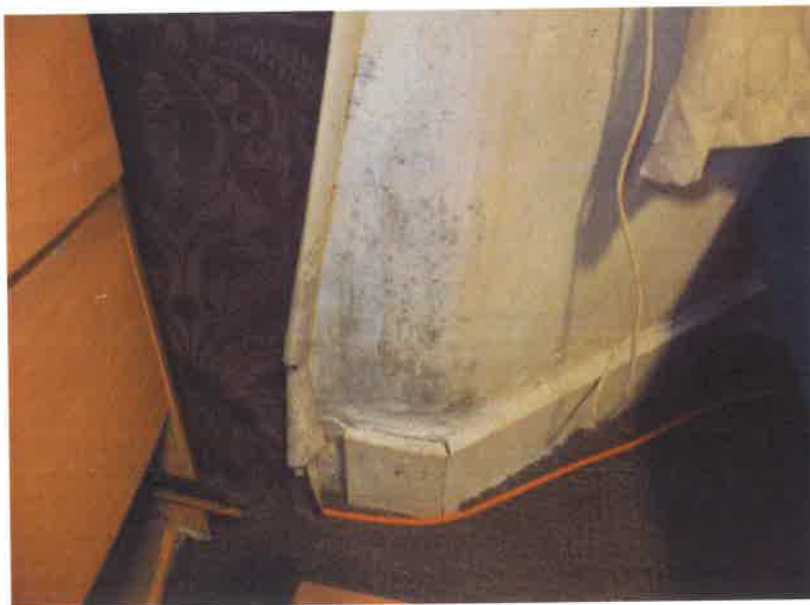
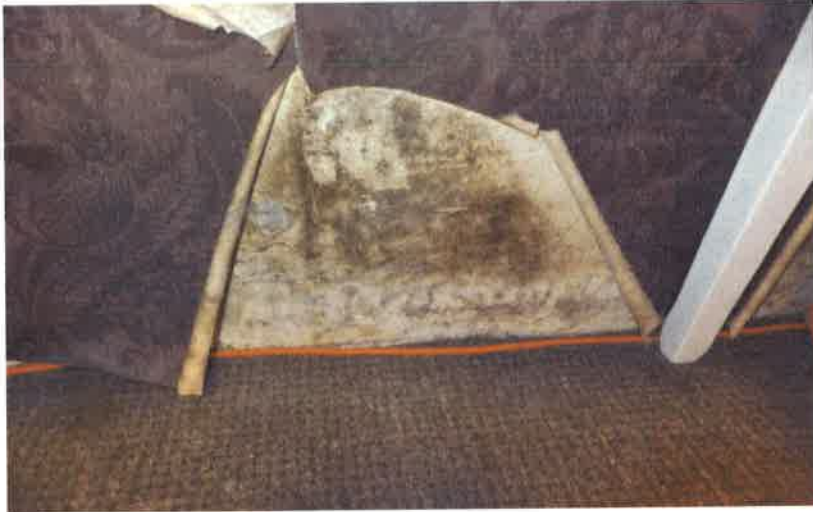
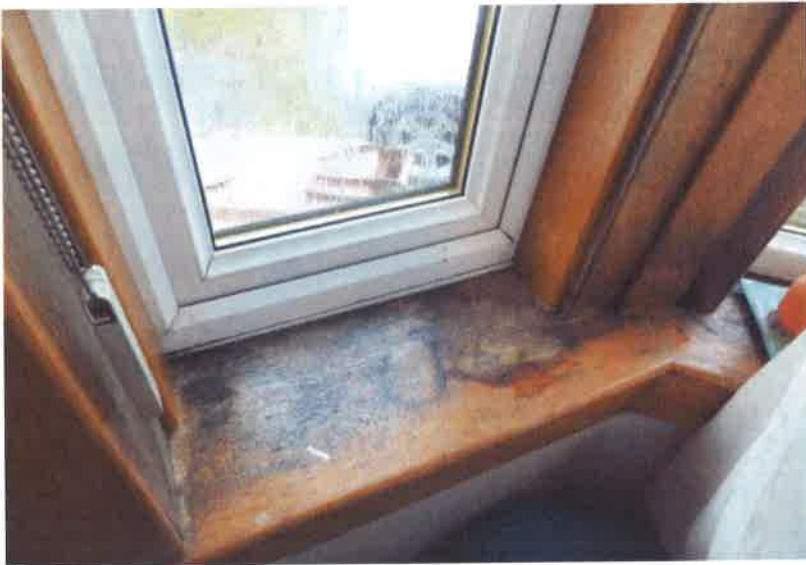
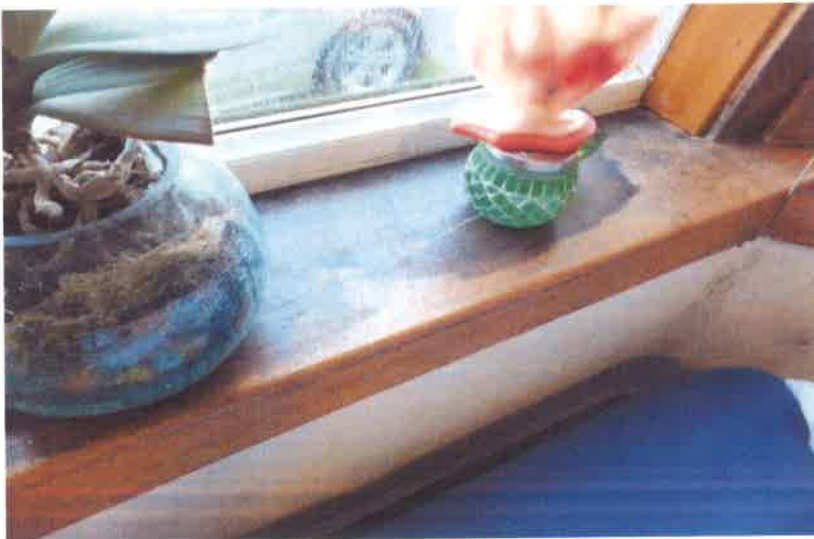
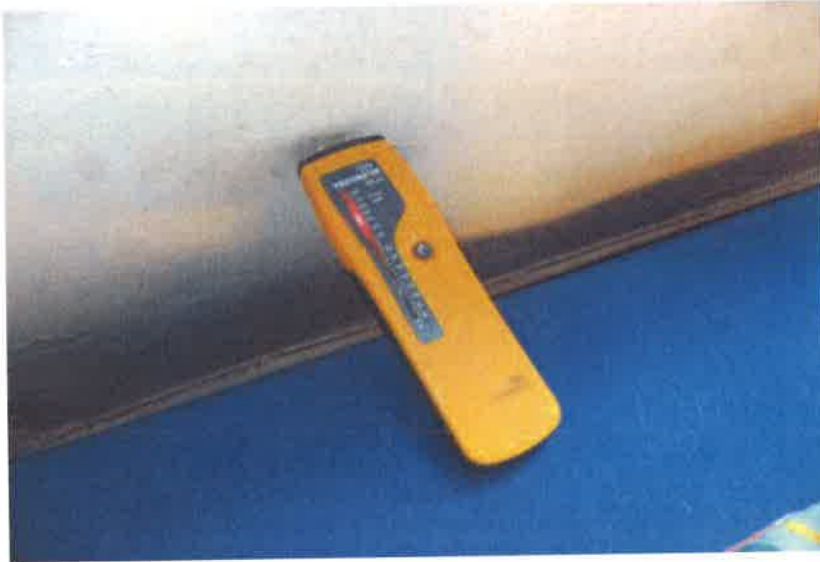
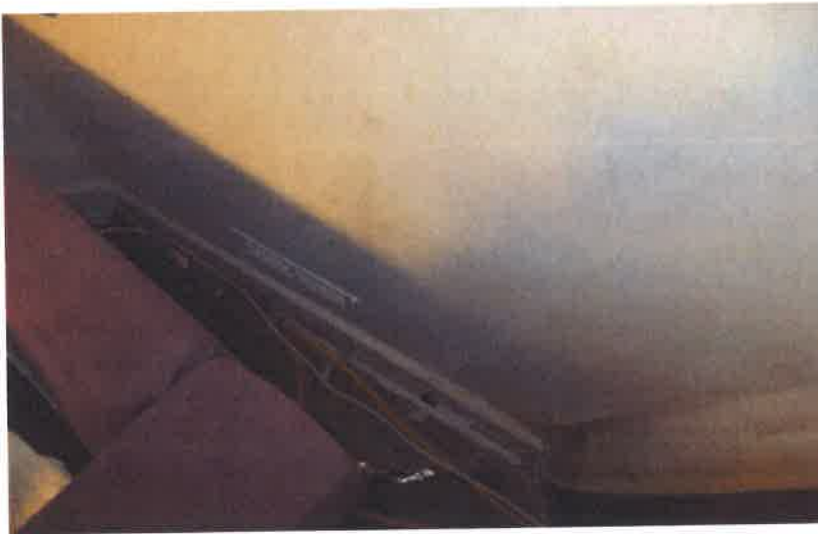
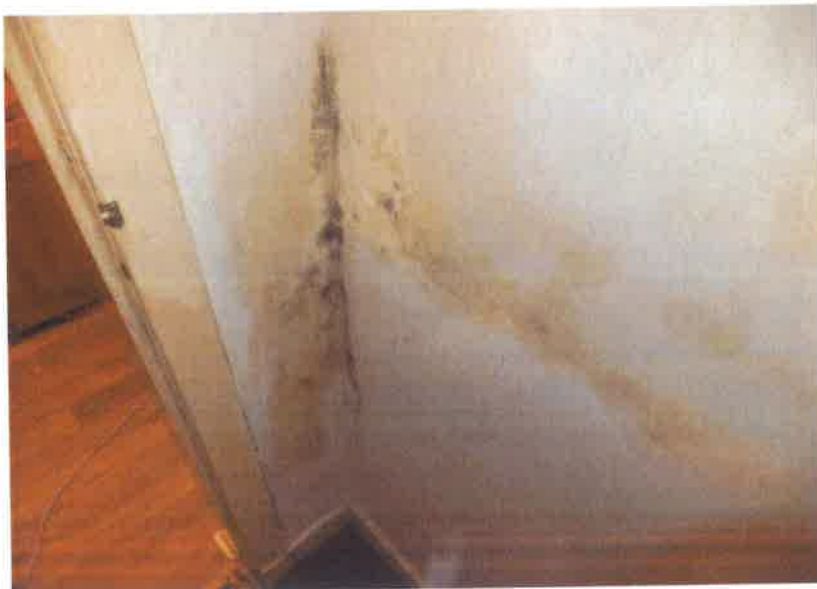
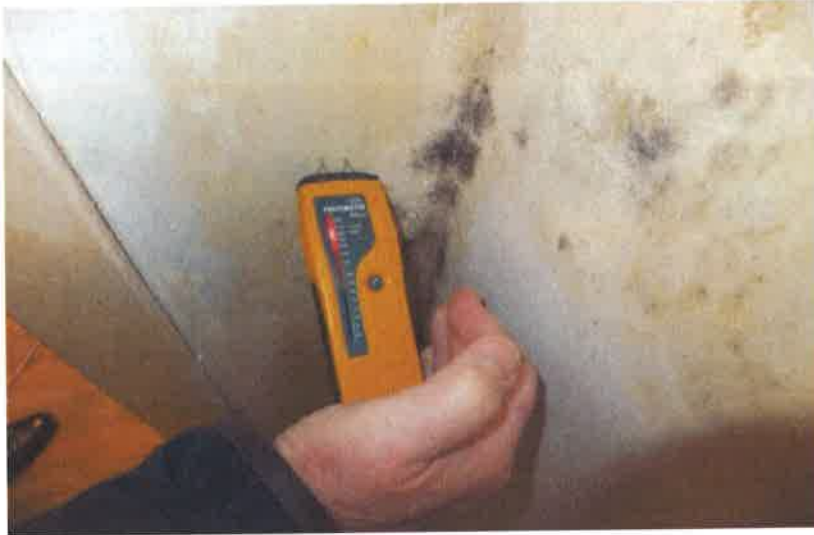
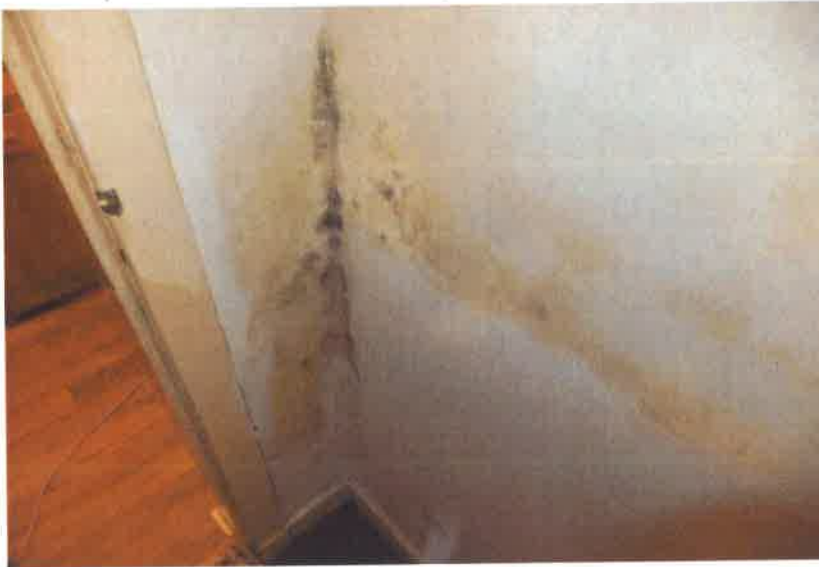
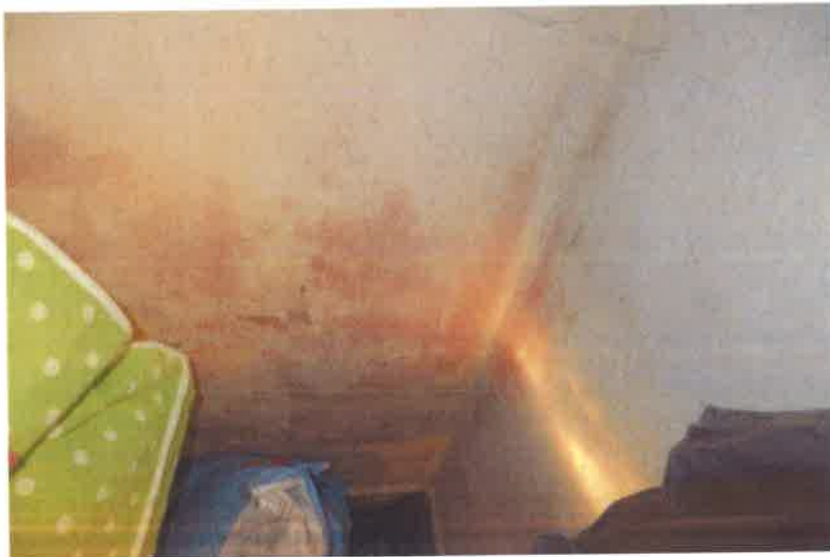
Front ground floor bedroom: (Photographs 1 - 11)

There were extensive signs of damp mould on walls, particularly beneath the bay window. A drawer unit was seen to be infested with damp mould. The windows were affected by condensation to the extent that the window sills were discoloured. Excessive damp readings were found on the walls including the chimney breast wall.

Mould was present on an internal wall adjacent to the door (Photograph**) which was seen to emanate from the hall cupboard (see below).

- 2. To obtain from a suitably qualified timber and damp specialist a detailed report relative to the property throughout with particular reference to the damp and water ingress with full inspections of the sub-site and void and the ventilation arrangements throughout the property.**

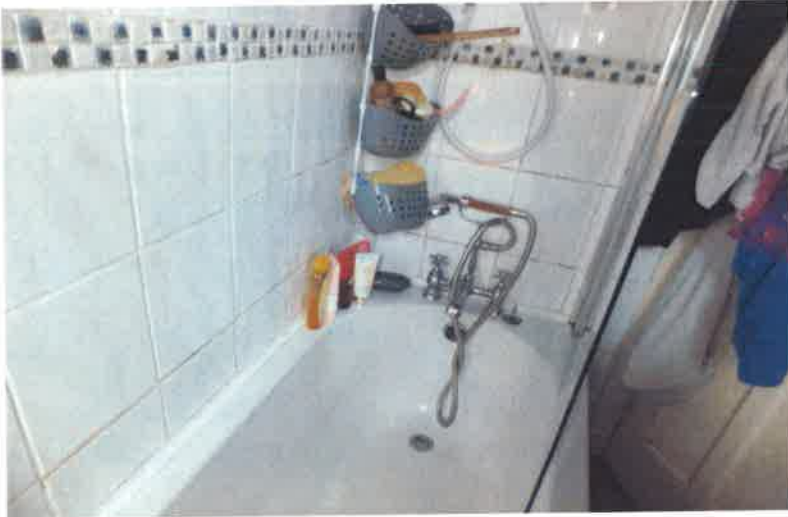
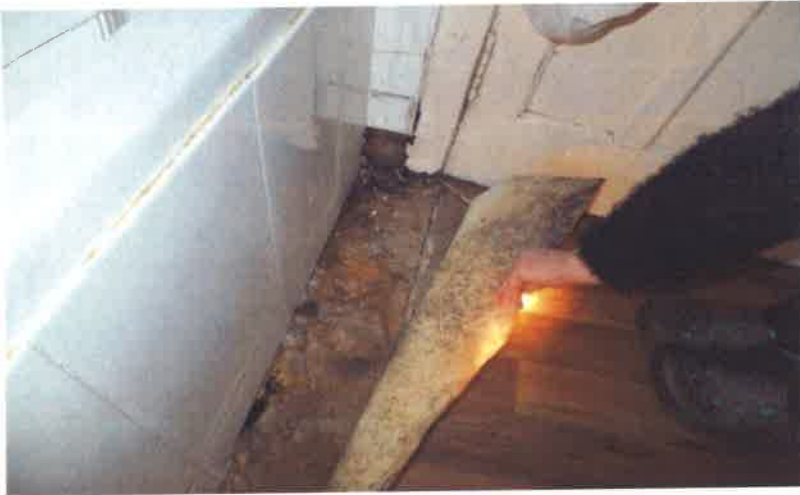
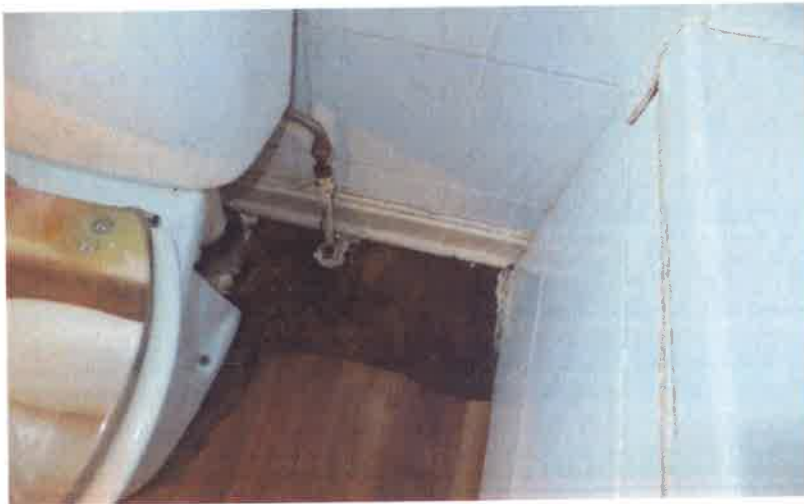
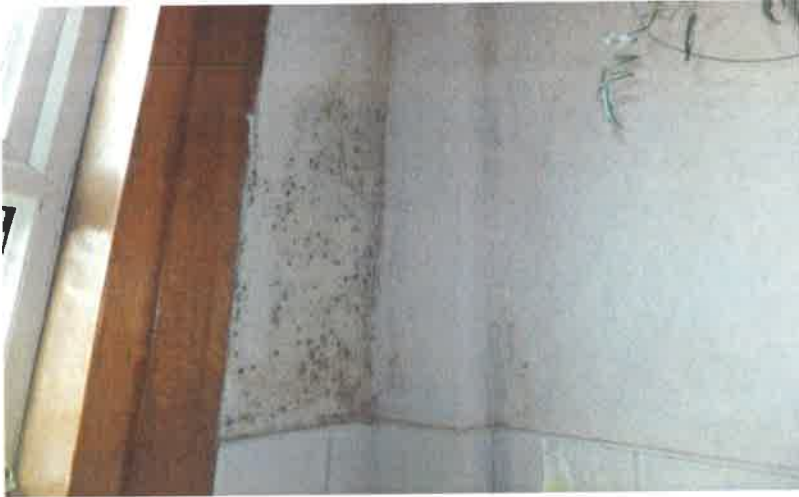
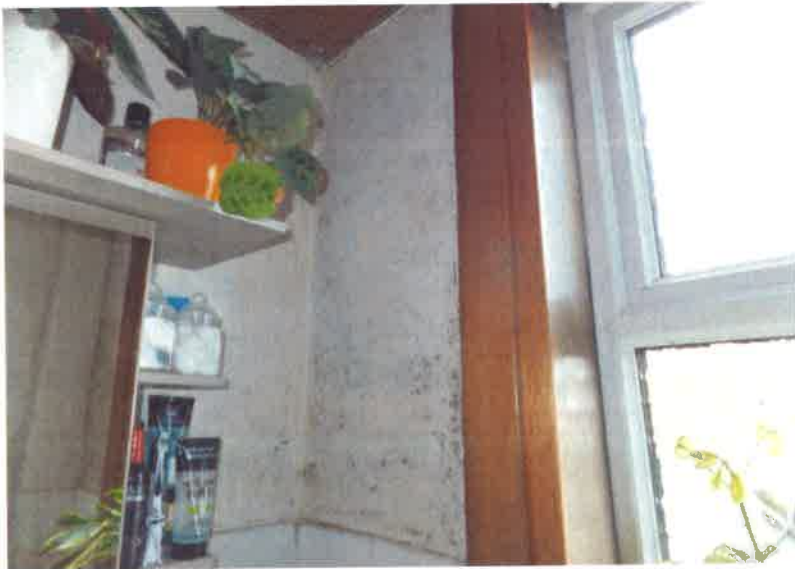
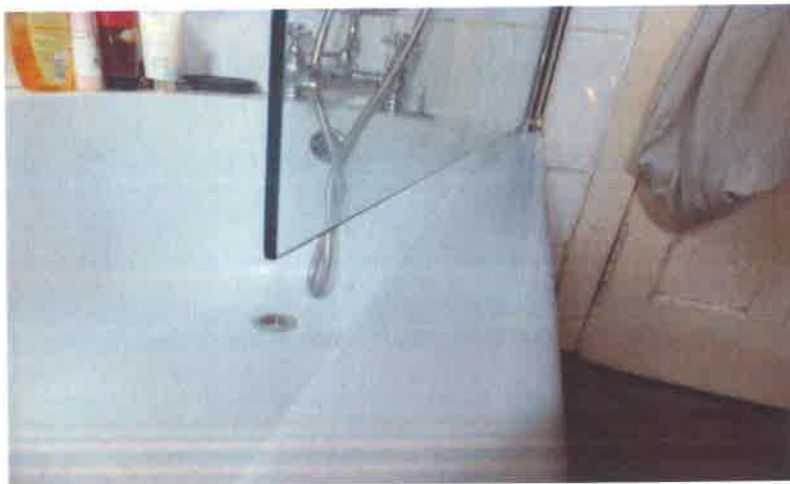
Bathroom: (Photographs 12 - 17)

The flooring adjacent to the bath was seen to be badly affected by water spillage, with holes in the floor as a result. The bath seal appeared to be in poor condition which has contributed to the water damage. The electric shower over the bath was reported by the tenant to be inoperable as she had disconnected the water and electric supplies in approximately 2013 due to the leaks.

- 4. To instruct a suitably qualified plumber and electrician to carry out the necessary repairs to the bath and electric shower unit in the bathroom on the ground floor and to the shower tray and WC in the showroom on the upper floor.**

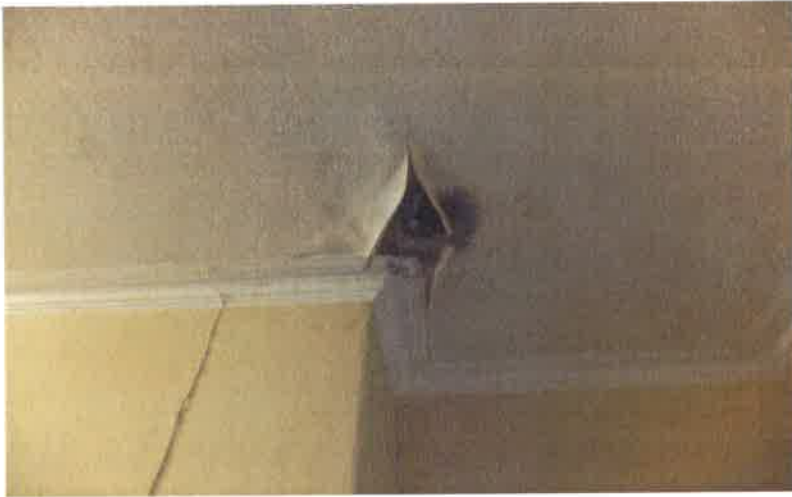
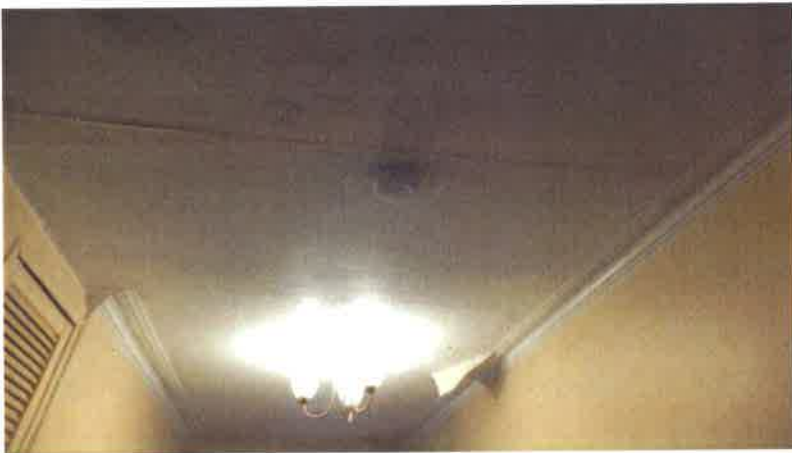
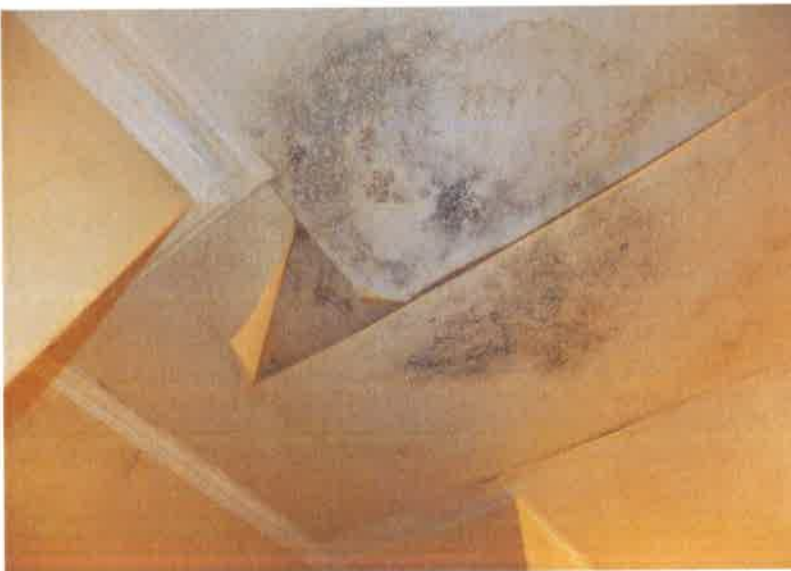
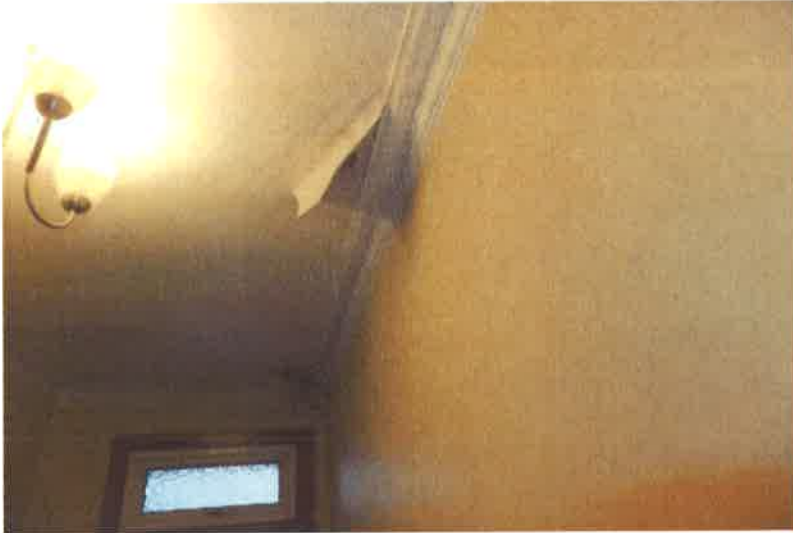
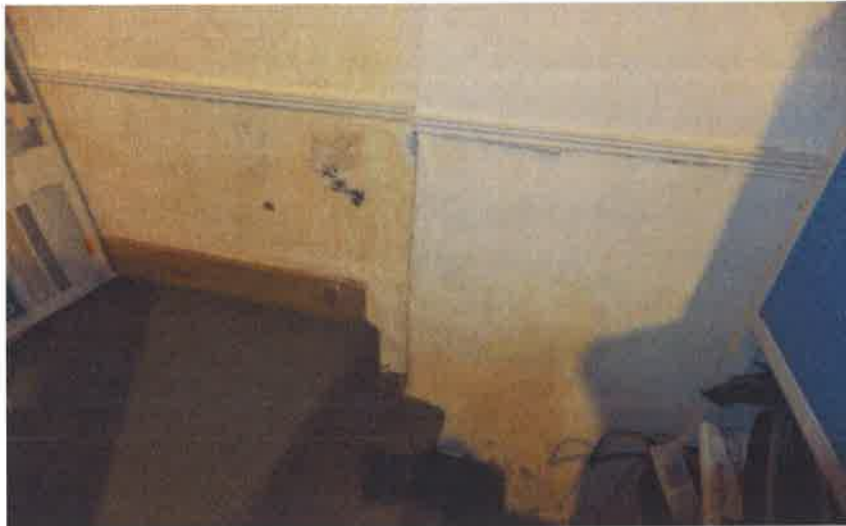
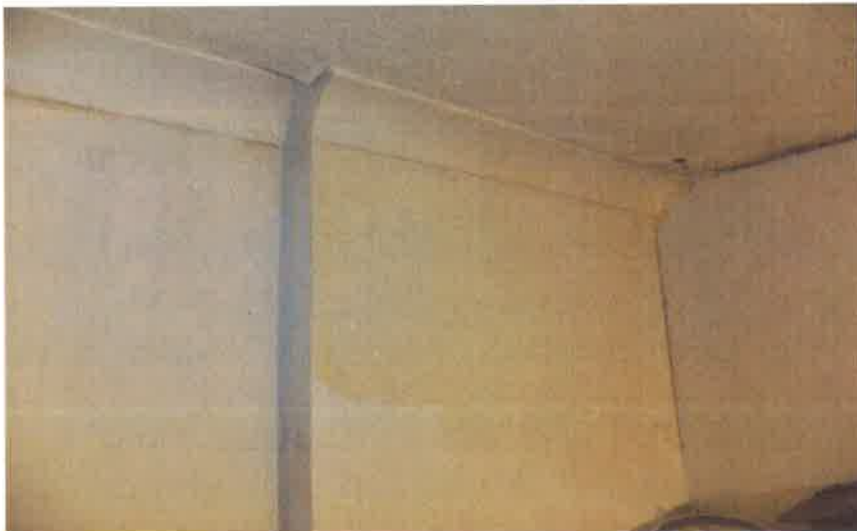
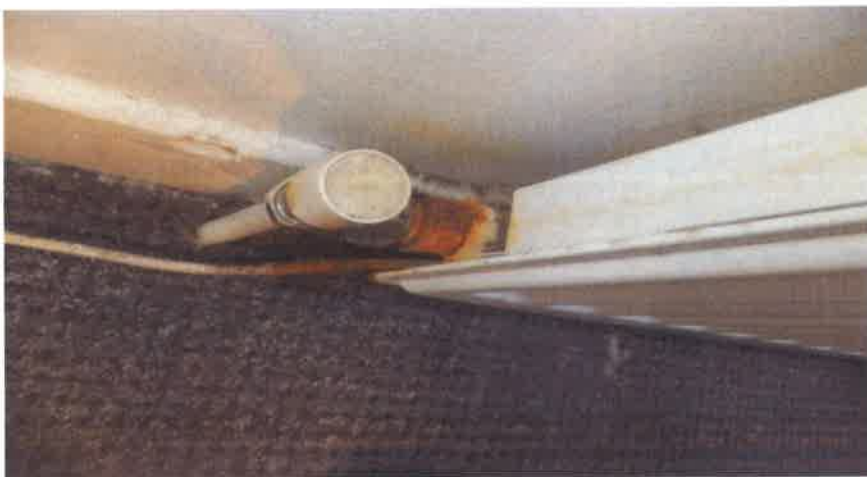
Hall Cupboard and Hall: (Photographs 18 – 21 and 39 - 41)

The hall cupboard adjacent to the bathroom wall with the electric shower and the bath was seen to be affected by damp. Meter readings confirmed excessive damp.

A battery-operated smoke detector was fitted in the hall. The tenant advised that she had fitted same.

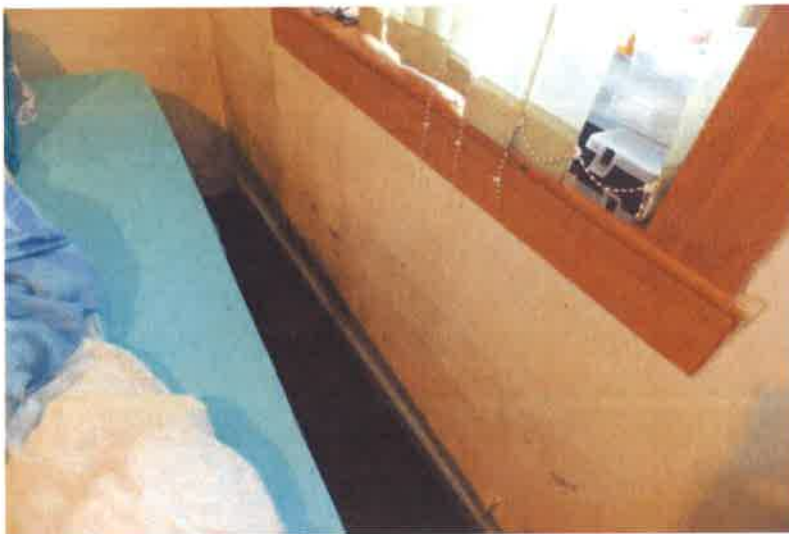
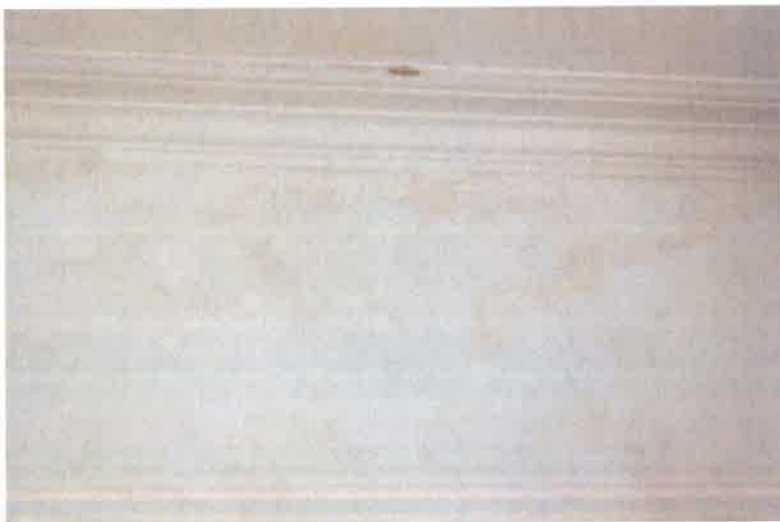
Rear Ground Floor Bedroom (Right): (Photographs 22-23)

The wall beneath the window and the chimney breast wall were affected by damp mould, as confirmed by excessive moisture readings.

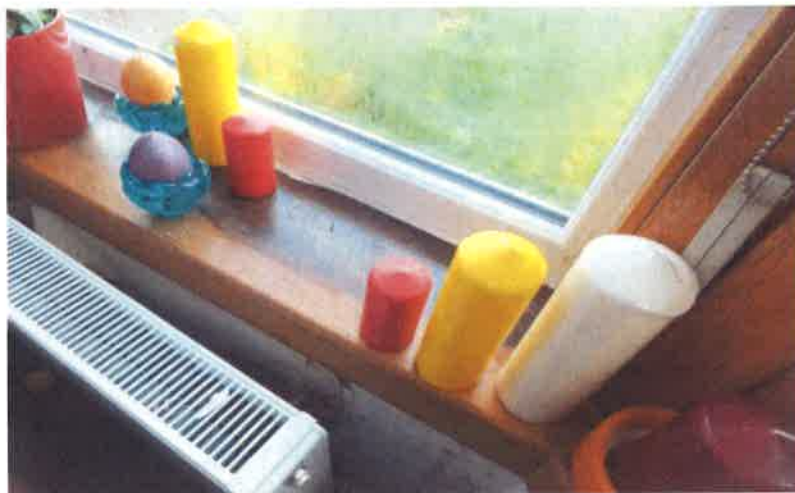
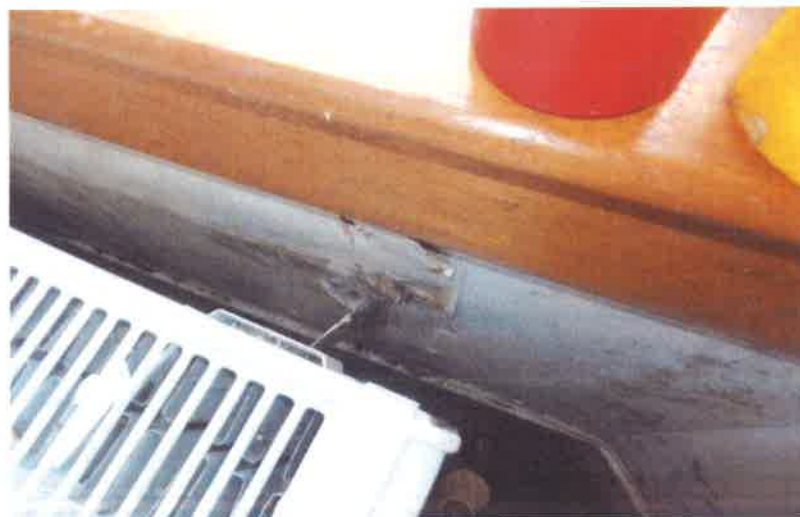
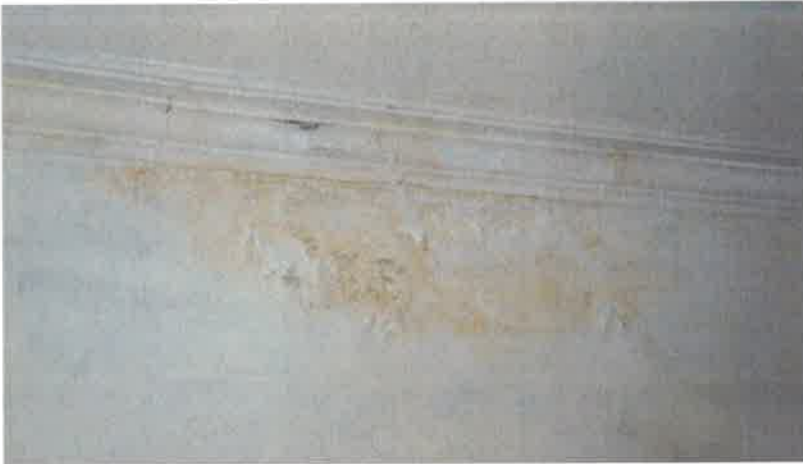
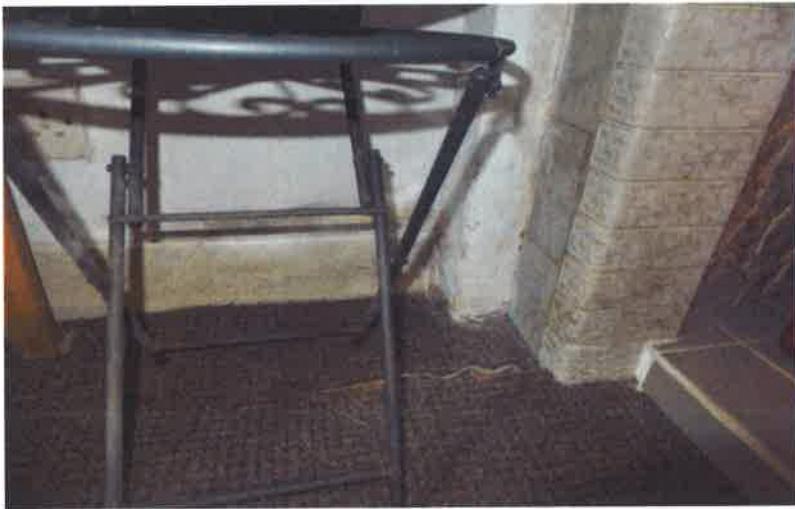
Lounge / Living Room: (Photographs 25 - 28)

Damp staining was evident: around the base of the front window frame and on the timber window sill, on the chimney breast and adjacent wall. Moisture readings were taken at both areas which proved positive with moisture contents of between 30% and 60% at the areas tested. The windows were affected by condensation.

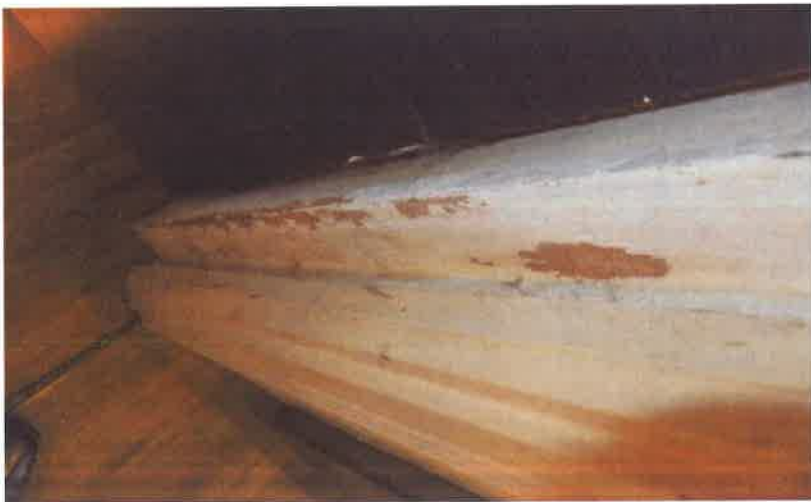
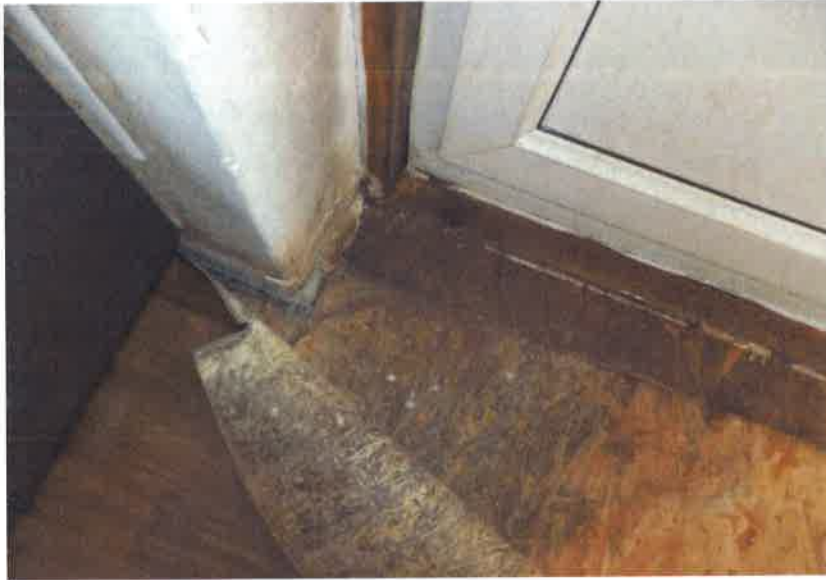
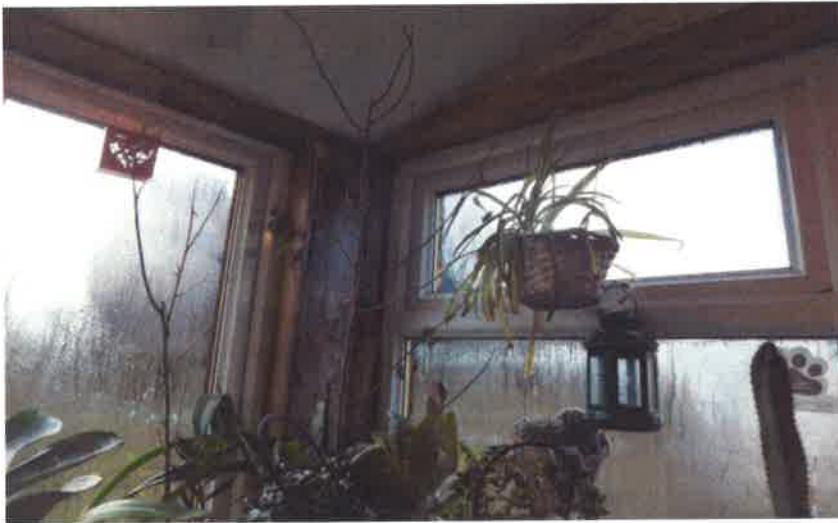
Kitchen / Utility area: (Photographs 29 - 31)

Areas of mould were seen affecting the walls and kitchen units as well as in the utility area. We did not detect any areas of asbestos as complained of but we are not qualified to make such a finding.

There was no heat detector in the kitchen.

- 7. To obtain from a suitably qualified and accredited asbestos management surveyor report on the presence of any asbestos material within the property.**

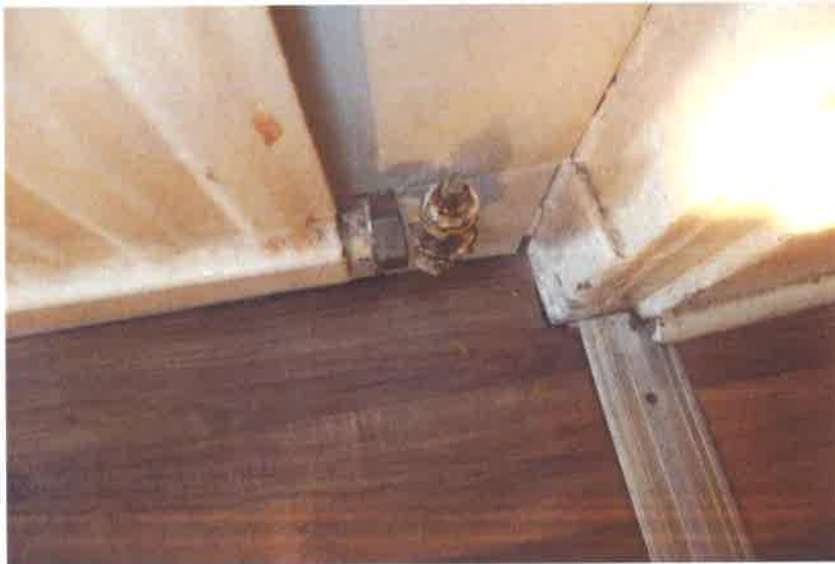
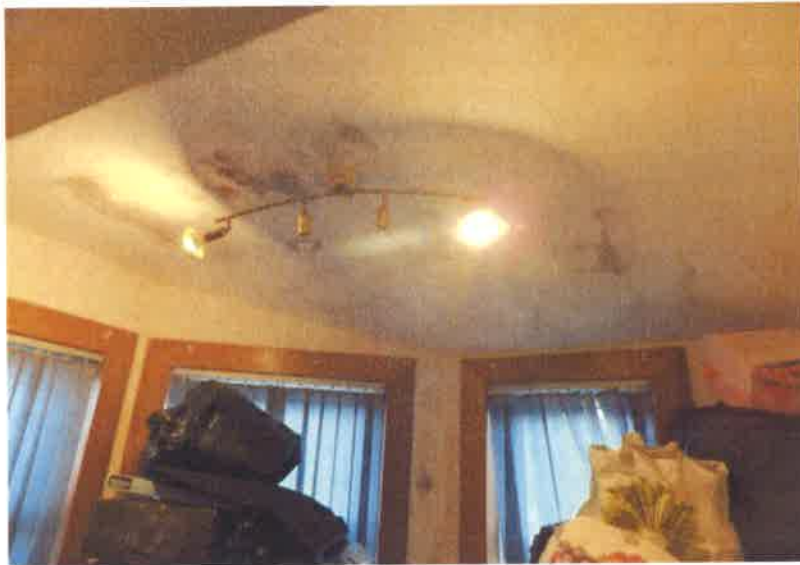
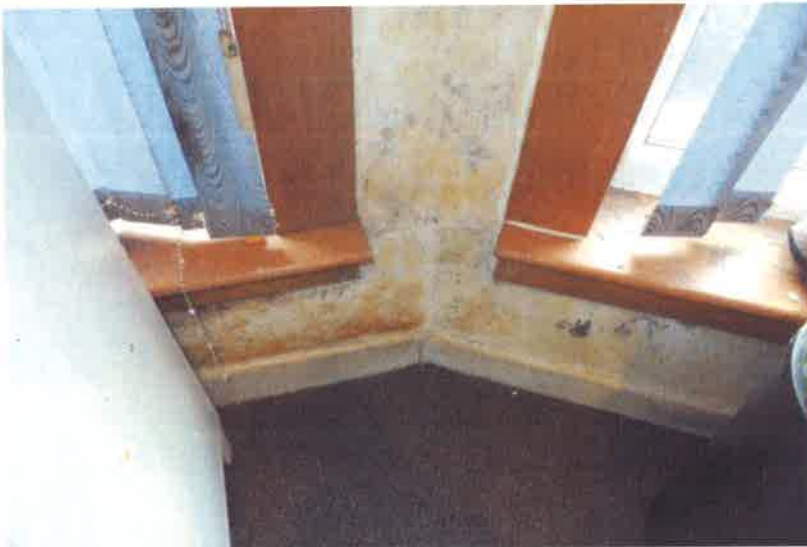
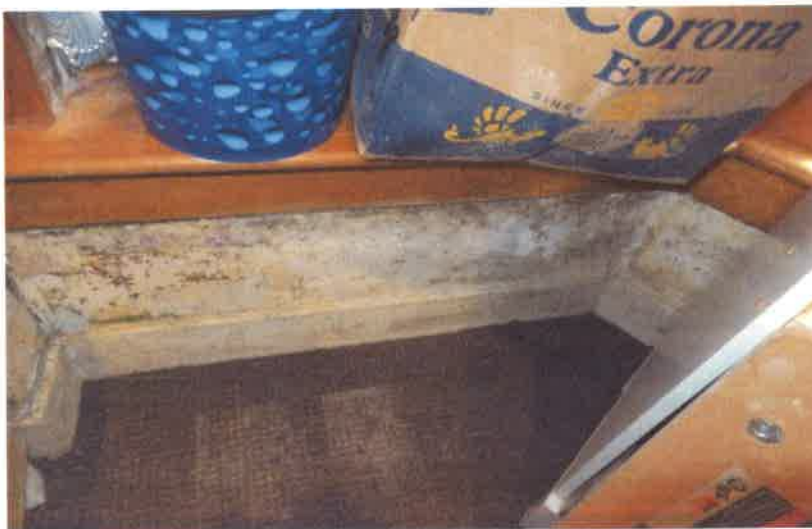
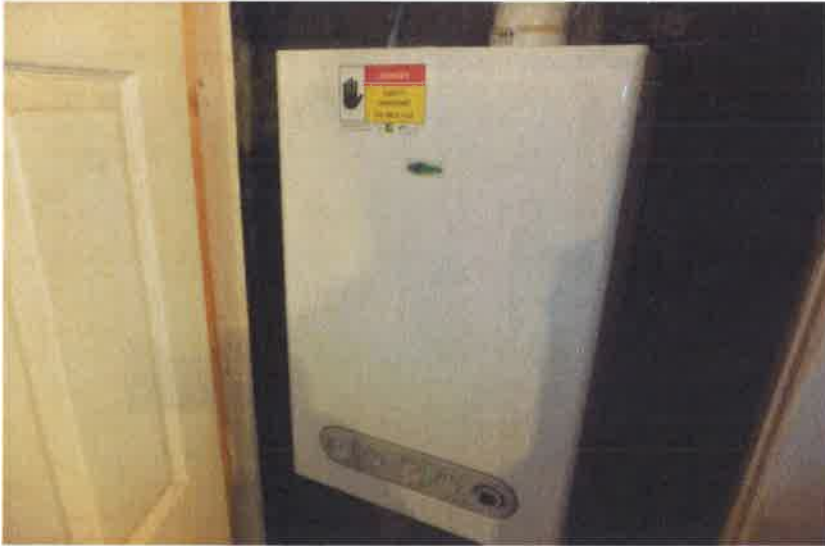
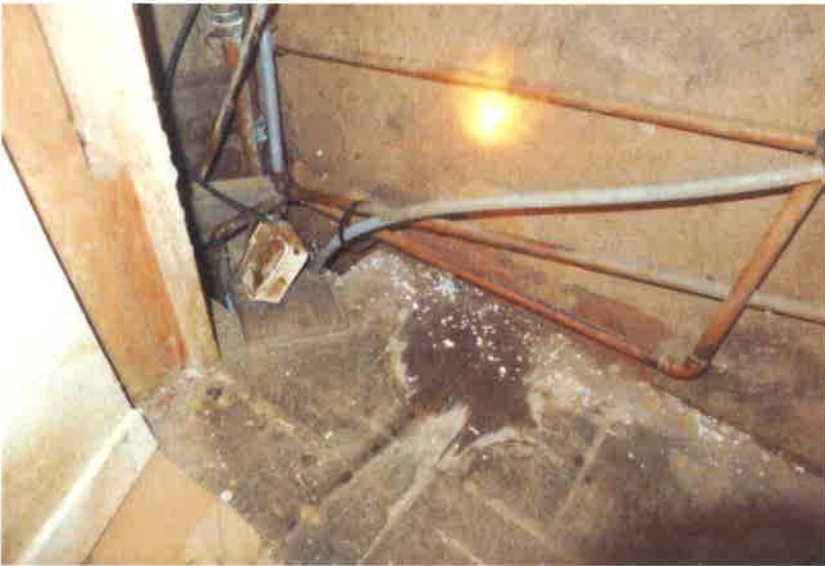
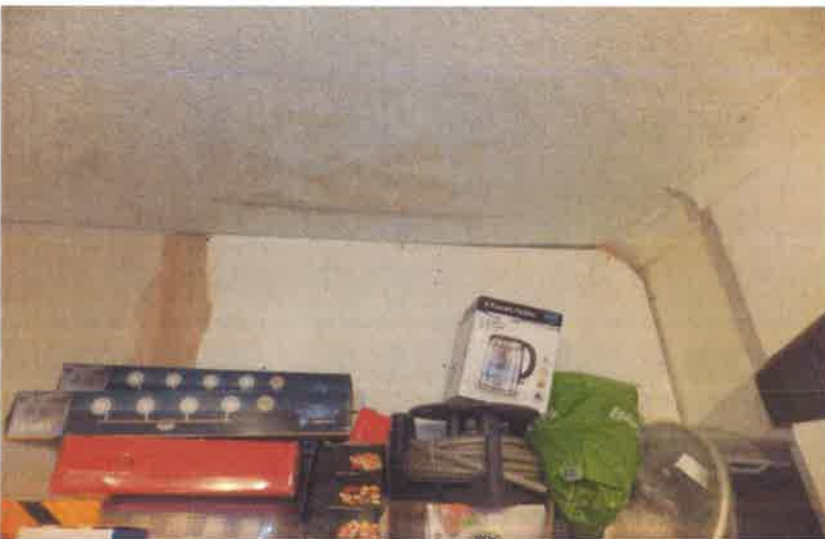
Rear Room (Left) – (presently used as a store): (Photographs 32 – 38)

The external walls were seen to be affected by excessive moisture readings and mould.

This room housed the central heating boiler in a cupboard. The boiler had a clear sign warning of danger – 'DO NOT USE'. The tenant advised that she did continue to use the boiler and said that she had signed a disclaimer letter in respect of such use. She had no other means of heating or hot water. There was evidence of leaking water around the boiler.

There was no carbon monoxide detector in the room housing the boiler cupboard.

The central heating radiators throughout the house were seen to be in poor condition. Some radiators were leaking as were the pipes and valves on others. A number of the radiators were reported not to work at all and others were reported to be very slow to heat.

- 6. To obtain from a suitably qualified and accredited gas heating engineer a full report on the central heating system throughout the property including the boiler, paperwork, radiators and valves and carry out all necessary work to repair and all replace all defective parts thereafter to produce to the tribunal are satisfactory and contemporary Gas Safe Report.**

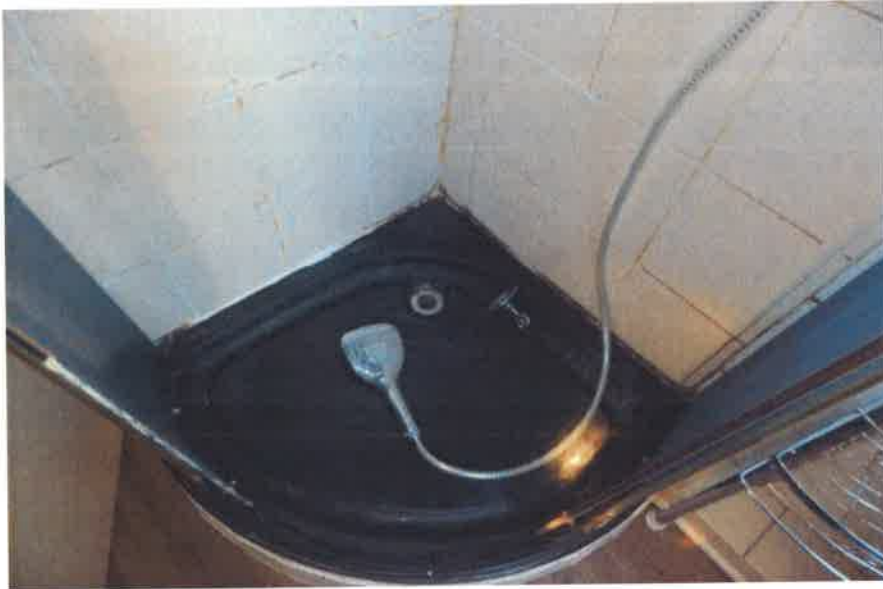
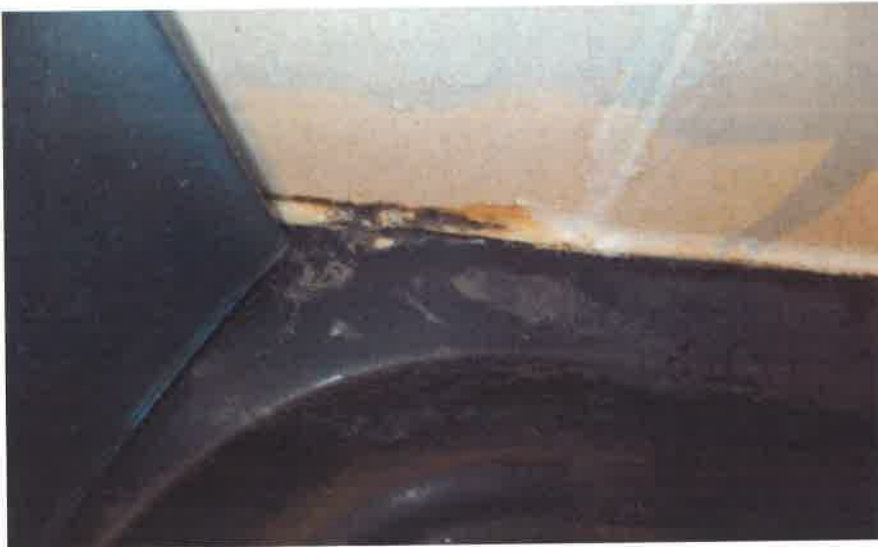
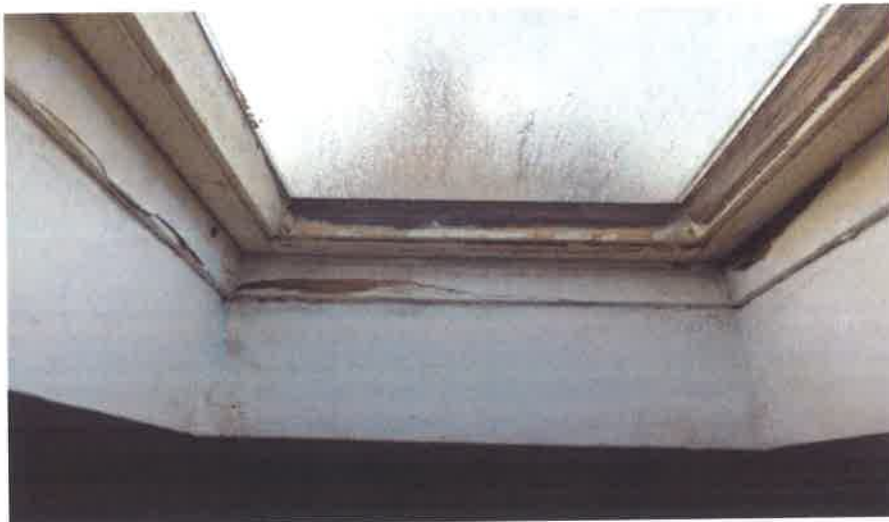
Upstairs Shower Room: (Photographs 42 - 44)

The shower unit was seen to be in poor condition. the tenant reported that the shower could not be used as the grout and seals leaked water into the hall and cupboard below.

The WC was also reported to be inoperable as the cistern overflowed when flushed.

The tenant reported that a workman had attempted in the past to resolve a damp problem beneath the skylight window by use of a plastic bag which had been plastered over.

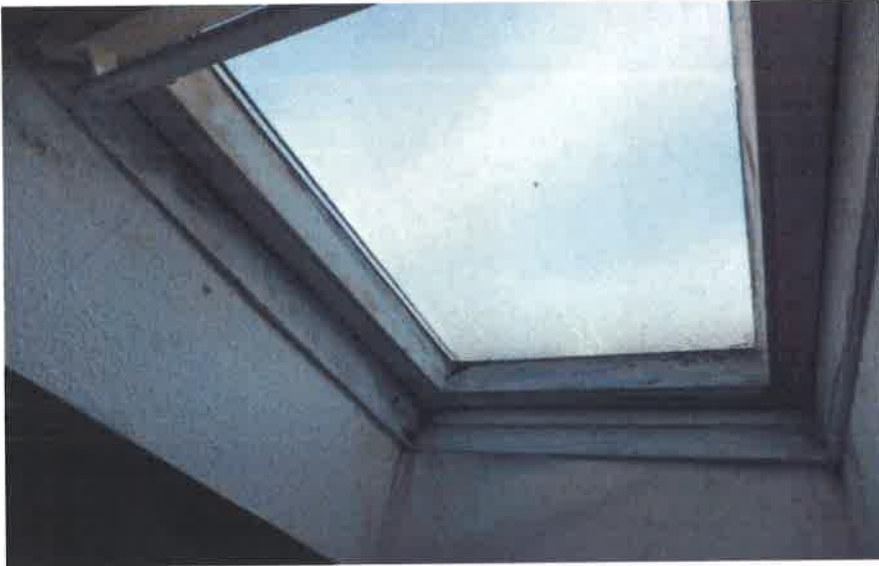
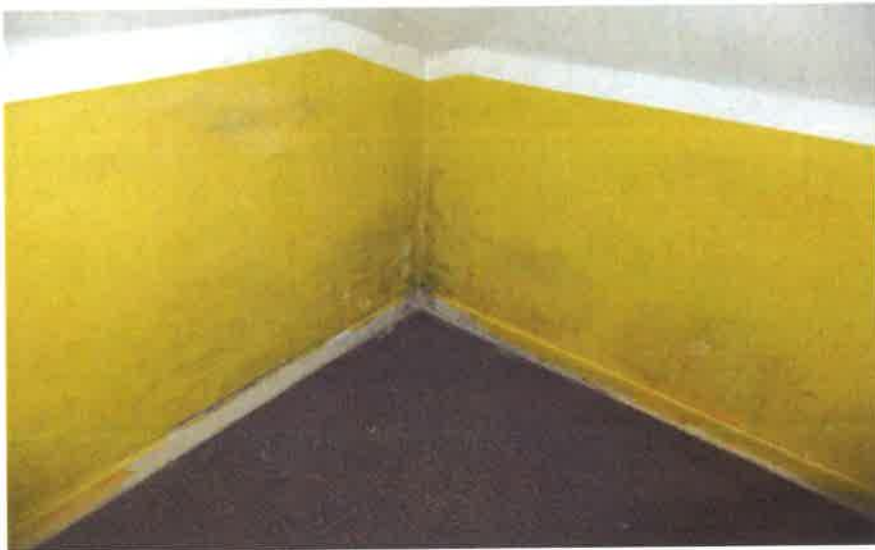
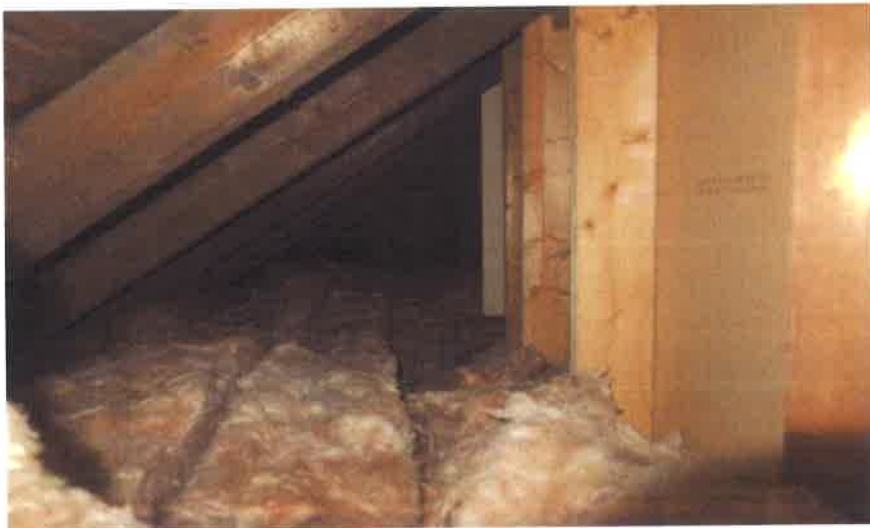
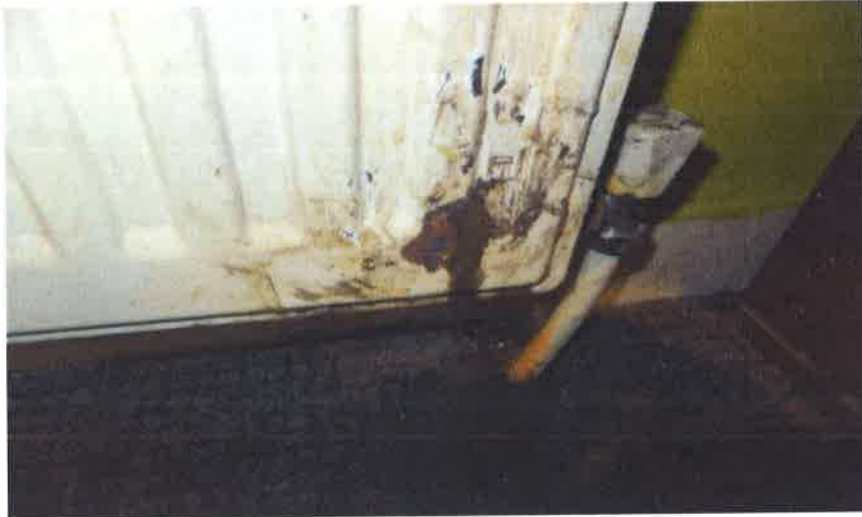
Bedrooms: (Photographs 45 - 48)

The walls below the velux windows in both front bedrooms as well as the external wall in the left-hand room were affected by damp mould.

The velux window in the left-hand room was insecure and in a dangerous condition.

An inspection of the eaves area in the front right upper floor bedroom disclosed insulation was present but the roof void lacked ventilation. Excessive damp and staining to sarking noted.

- 1. To obtain from a suitably qualified roofing contractor a full report to cover, without prejudice to that generality: the condition of the existing roof cladding and future life expectancy thereof; the condition of the down-pipes gutters and water drainage and disposal facilities.**

- 3. To carry out such repairs as are identified in the reports as necessary to the roof, gutters downpipes and water drainage and disposal to eliminate the ingress of water to the roof-space and the property.**
