**Housing and Property Chamber
First-tier Tribunal for Scotland**

STATEMENT OF DECISION FOR REPAIRING STANDARD ENFORCEMENT ORDER (“RSEO”) UNDER SECTION 24 HOUSING (SCOTLAND) ACT 2006 (“the Act”).

27 Everard Drive Glasgow G21 1XG

Schedule of photographs taken during the inspection of:
27 Everard Drive, Glasgow, G21 1XG

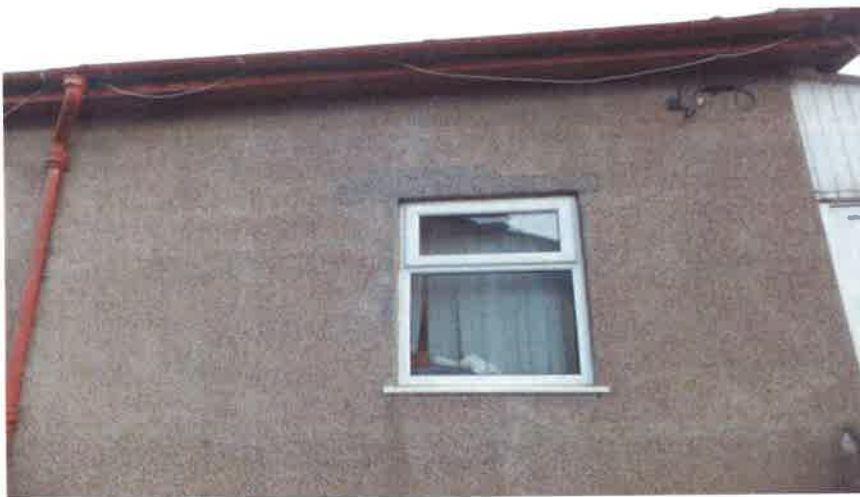
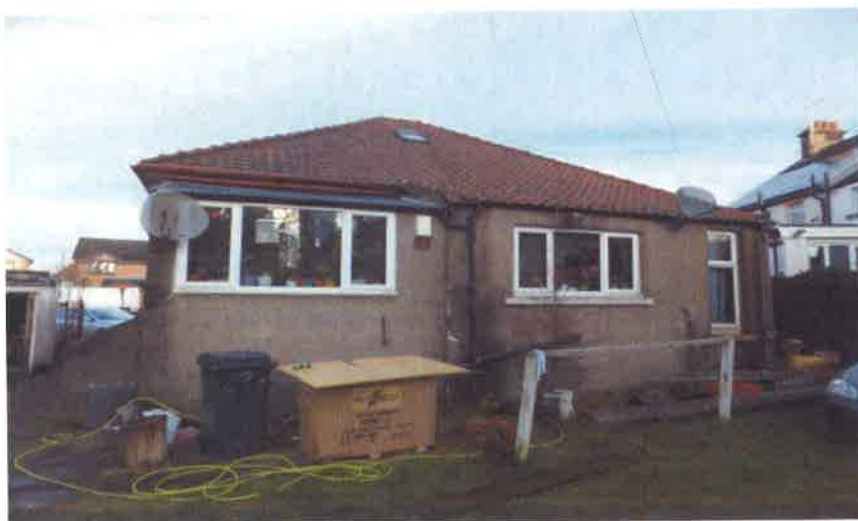
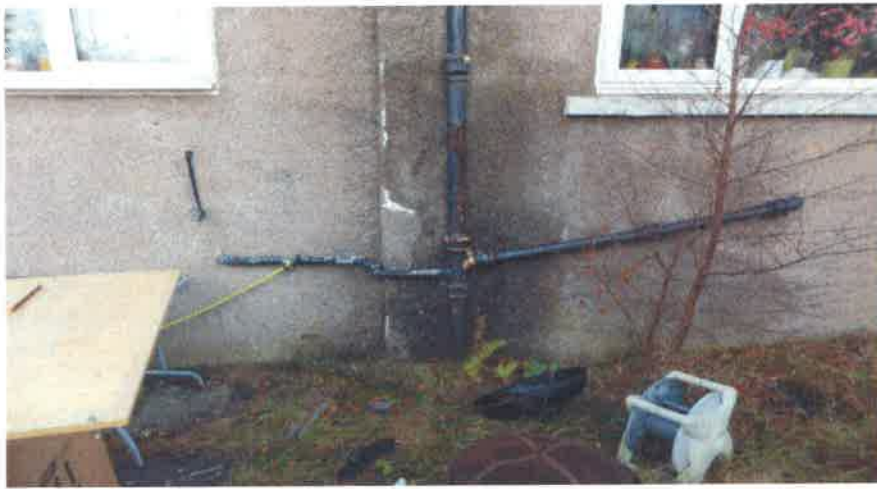
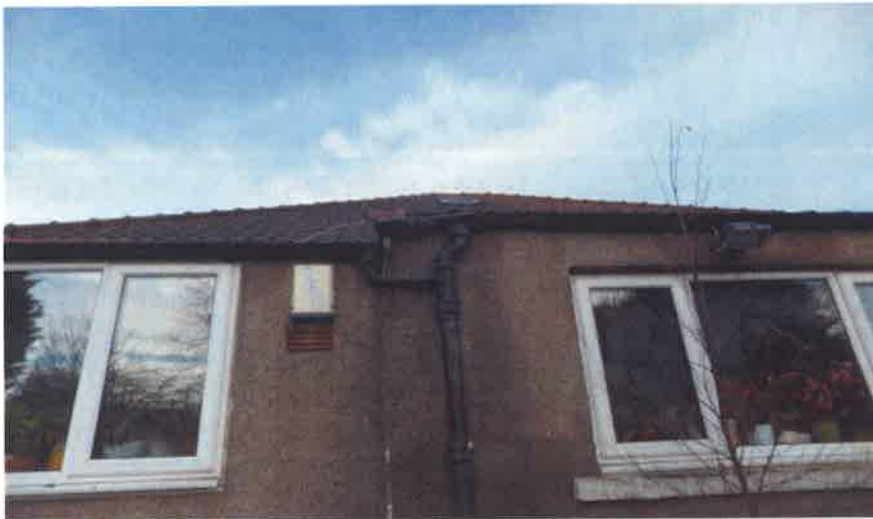
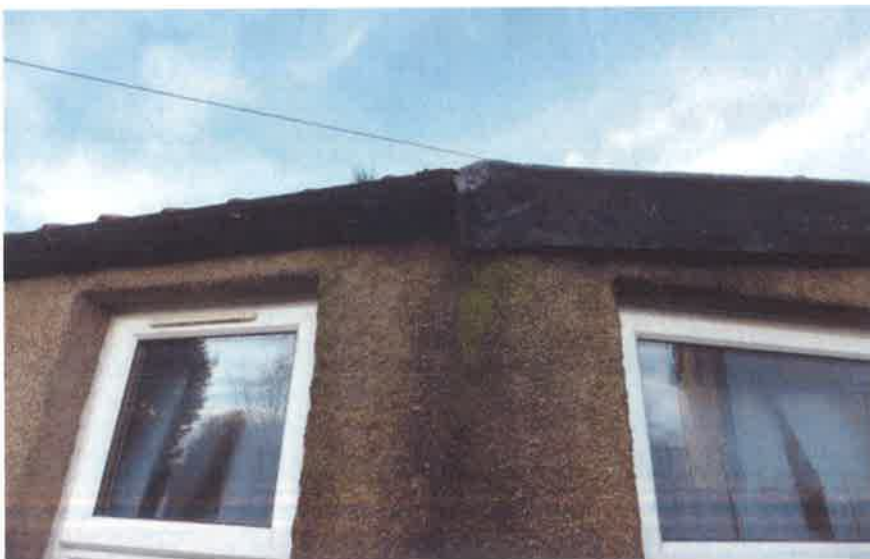
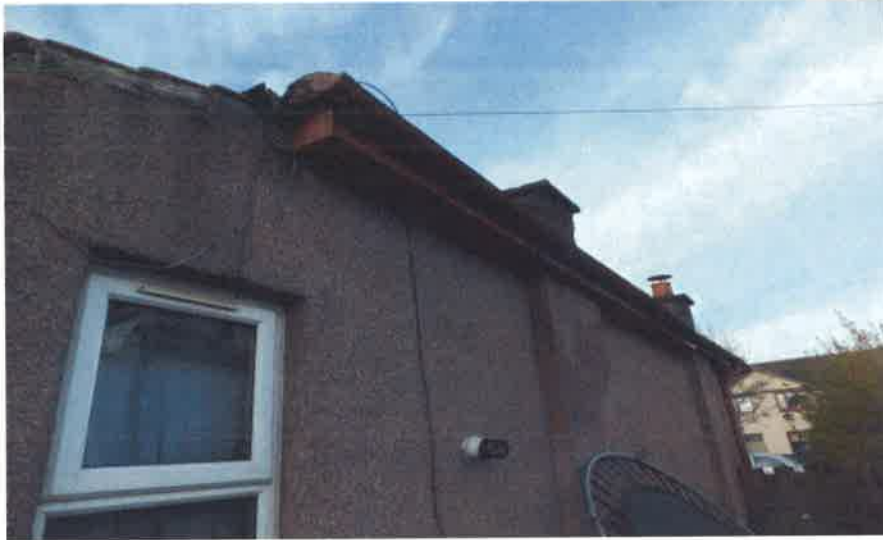
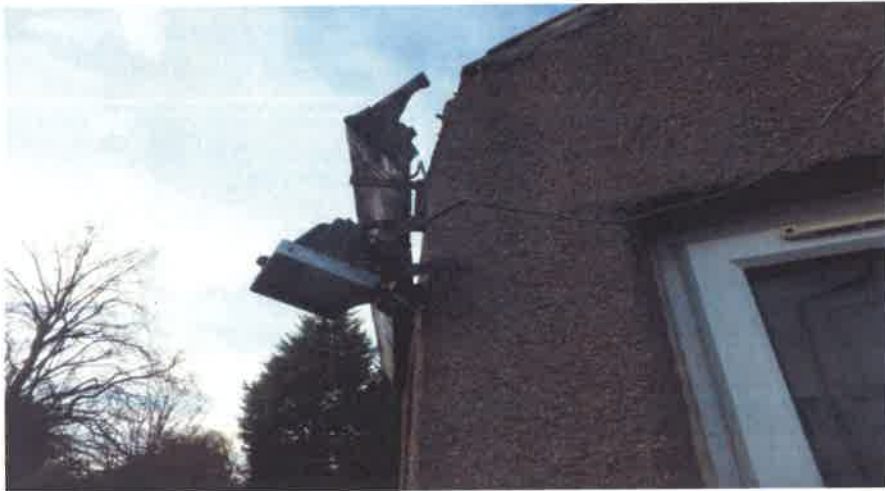
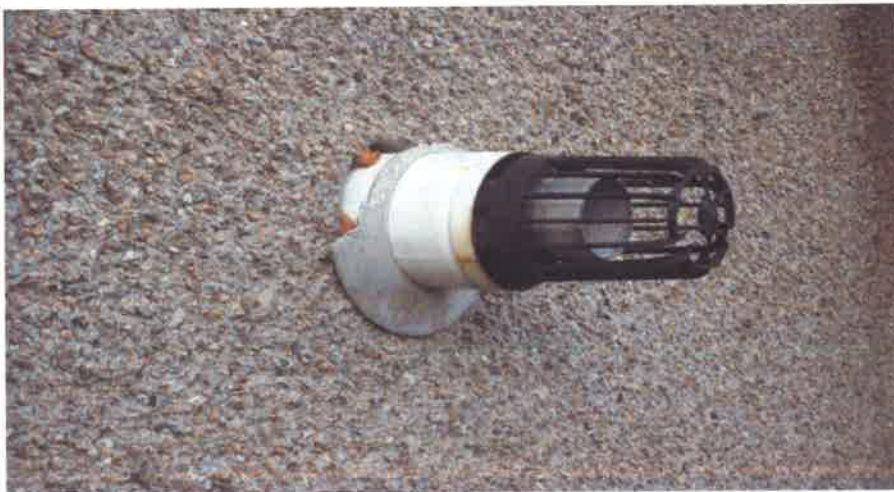
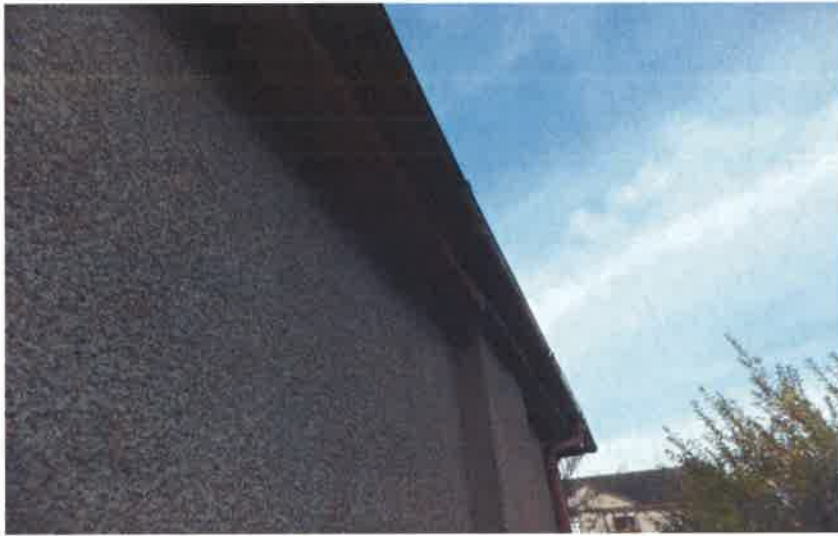
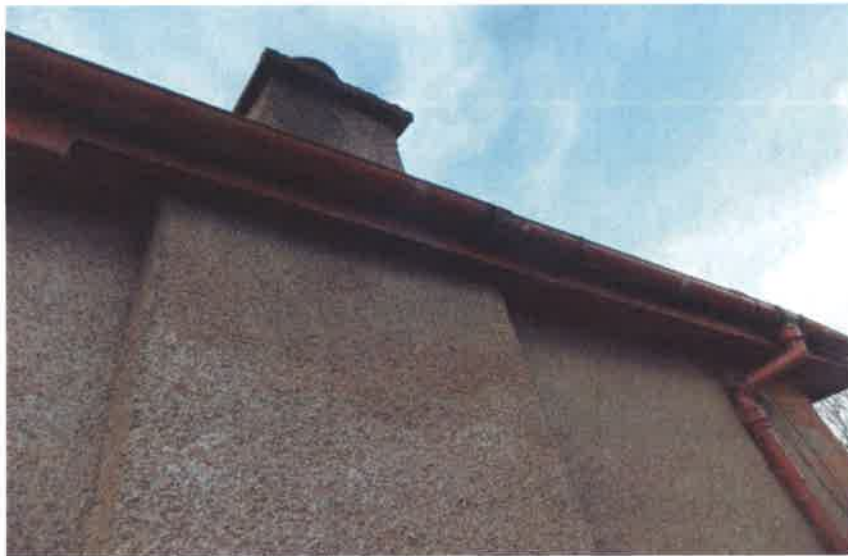
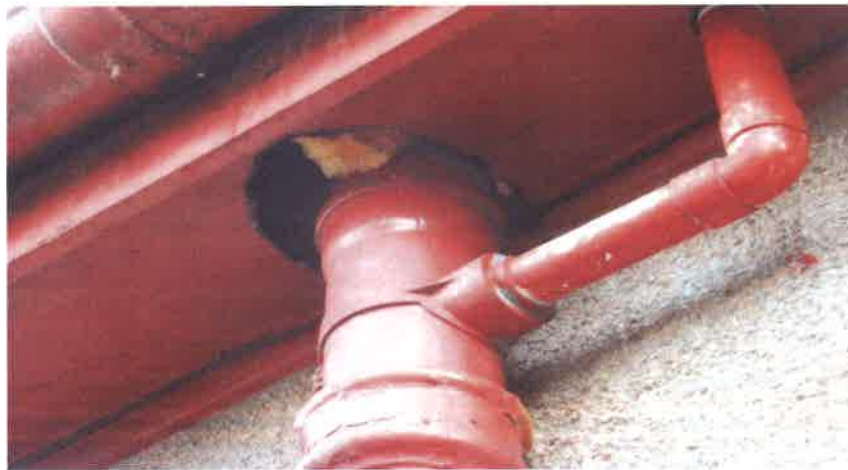
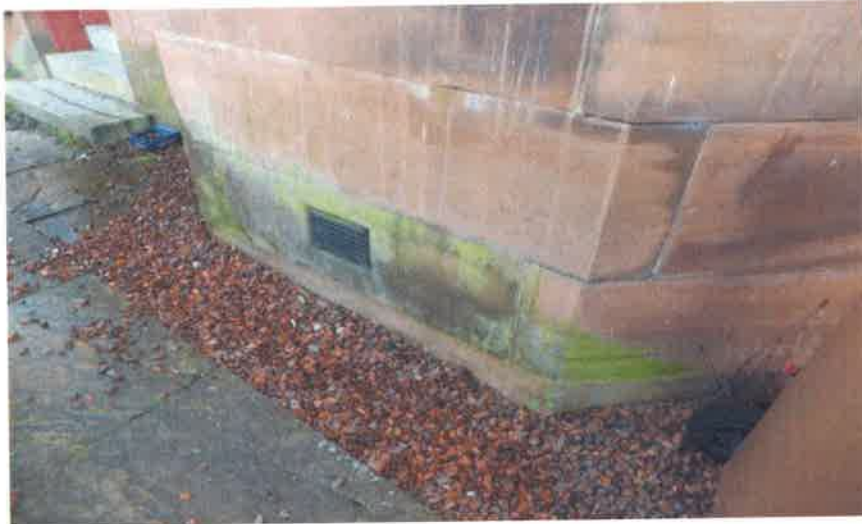
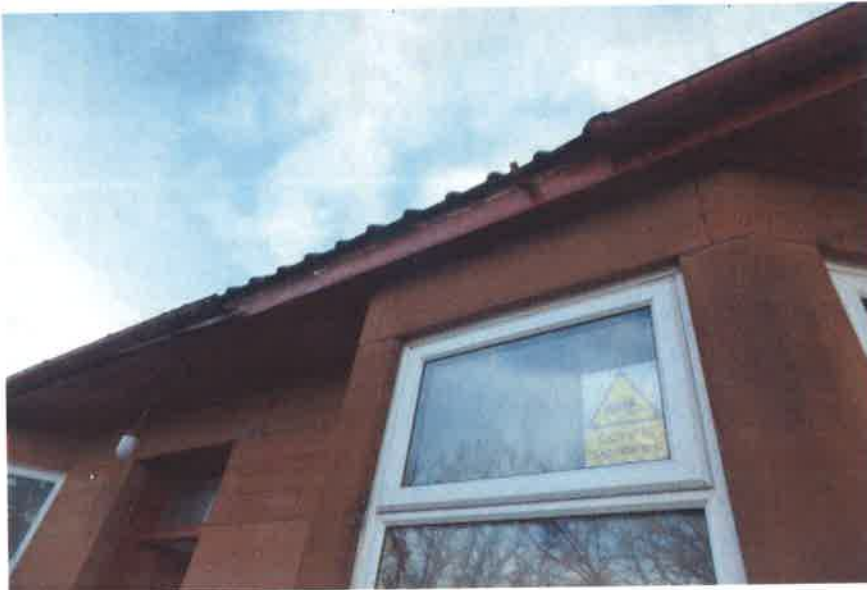
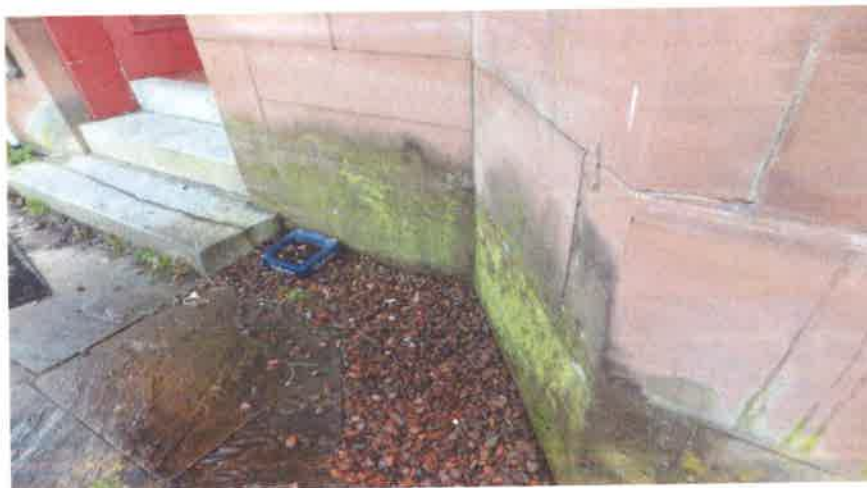
External: (Photographs 49 - 62)

The roofing tiles appeared to be of some considerable age. There were slipped and missing tiles. The gutters were in serious need of repair and replacement. There were areas of missing gutters. The downpipes were in poor condition with splits and leaks.

- 1. To obtain from a suitably qualified roofing contractor a full report to cover, without prejudice to that generality: the condition of the existing roof cladding and future life expectancy thereof; the condition of the down-pipes gutters and water drainage and disposal facilities.**

- 3. To carry out such repairs as are identified in the reports as necessary to the roof, gutters downpipes and water drainage and disposal to eliminate the ingress of water to the roof-space and the property.**

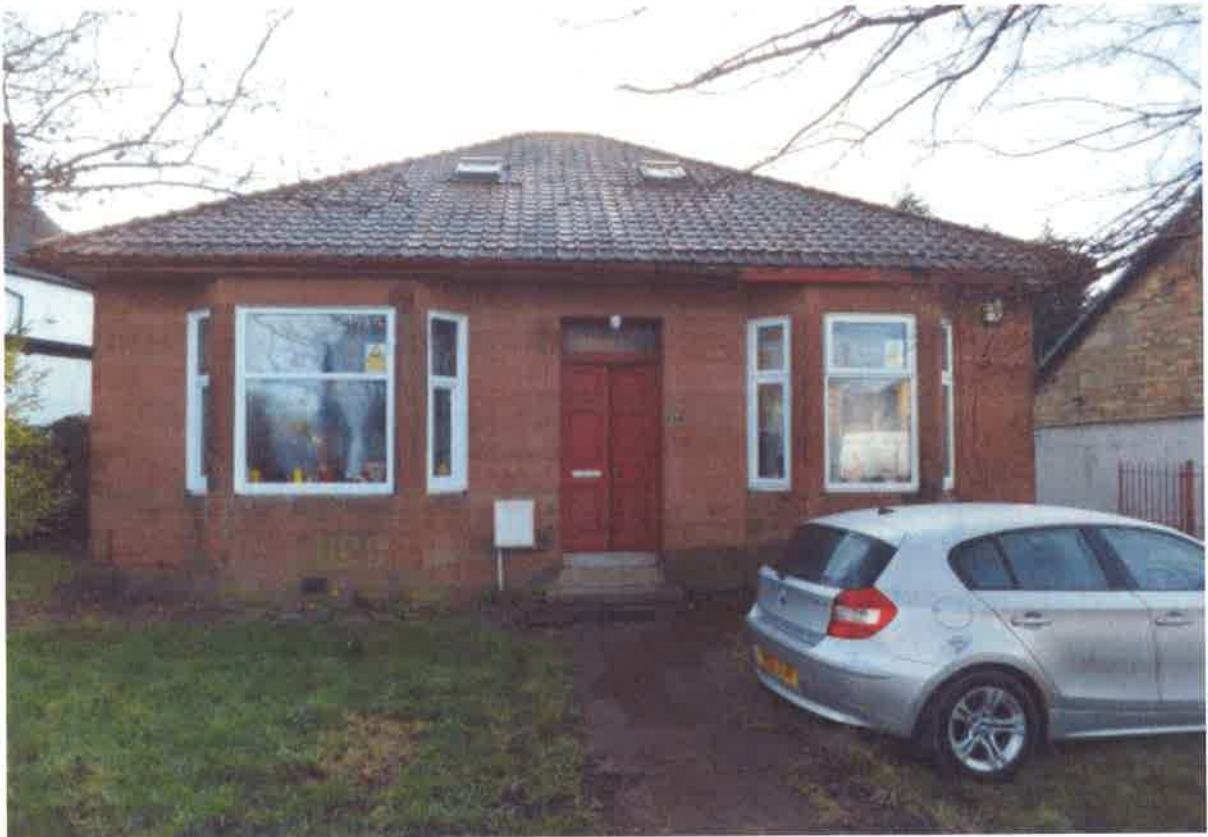
Picture 64

6. The tribunal inspected the property on the morning of 27 November 2018. The tenant and Ms Malloy were in attendance throughout the inspection. The landlord did not attend the inspection.
7. The photographs, taken at the time of the inspection referred to below are contained in the Schedule attached hereto.
8. The property is a one and a half storey detached red sandstone house estimated to have been constructed around 90 years ago and located within a mixed commercial and residential area. There is garden ground surrounding the house and a garage adjacent to the west elevation. The front elevation is of pointed red sandstone construction with the other elevations rendered externally. The roof is pitched, clad externally with tiles. (Photograph 64 front elevation)
9. The accommodation, over two levels, may be described as comprising:
