**First-tier Tribunal for Scotland (Housing and Property Chamber) ("the tribunal")**

**STATEMENT OF DECISION: Housing (Scotland) Act 2006, Section 24(1)**

**Flat 3/1, 337 Wellshot Road, Glasgow, G32 7QW  
TITLE number GLA15179  
 (“The House”)**

**SCHEDULE OF PHOTOGRAPHS**  
**Flat 3/1, 337 Wellshot Road, Glasgow, G32 7QW**  
**FTS/HPC/RP/18/0898**  
**Inspection Date – 23rd July 2018**  
**Weather – Dry, overcast**

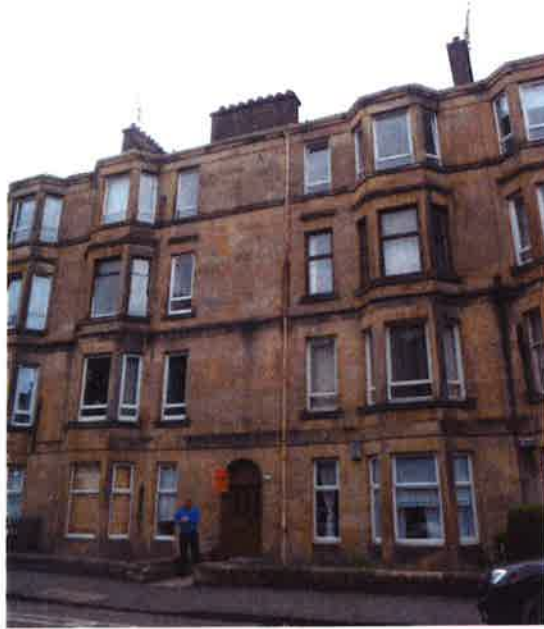
1. The property

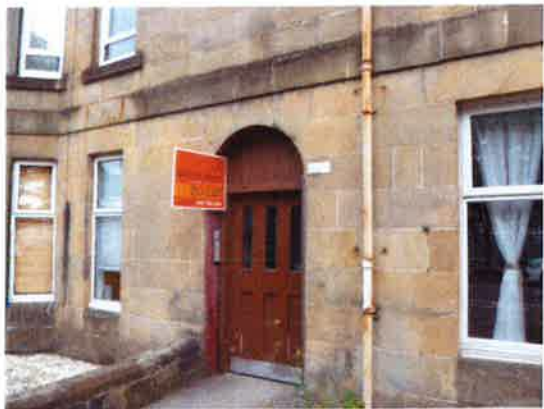
2. Close entrance

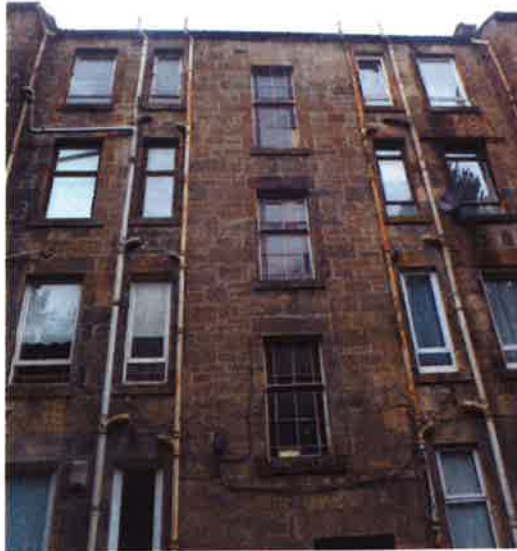
3. Rear elevation

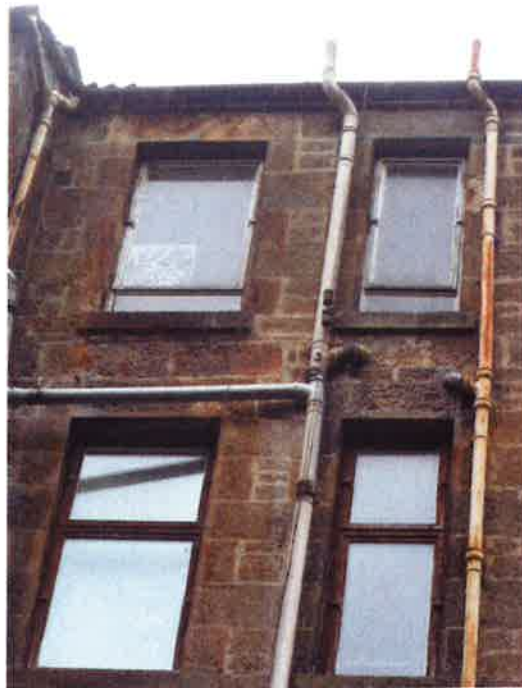
30.2.1. On inspection, the window in the rear bedroom was noted to have a timber frame with a single glazed pane. The glass pane was cracked and a sheet of clear taping had been affixed to hold it together. The window was difficult to open but it did open. The window itself was not a very good fit. There were gaps around it. Draught proofing strips had been affixed but were falling off and were ineffectual. It would be possible for water and wind to enter the House.

30.2.2. See **Schedule of Photographs, numbers 3 and 4** (external views), **5 and 6** (internal views).

4. Rear windows

1. To repair or replace the windows in the rear bedroom and bathroom so that they are capable of opening and closing and they are wind and watertight.
2. To repair or replace the broken double glazing unit to the right hand casement of the living room window.
3. To seal off the openings around the pipework in the ceilings in the hall cupboard and the front bedroom.

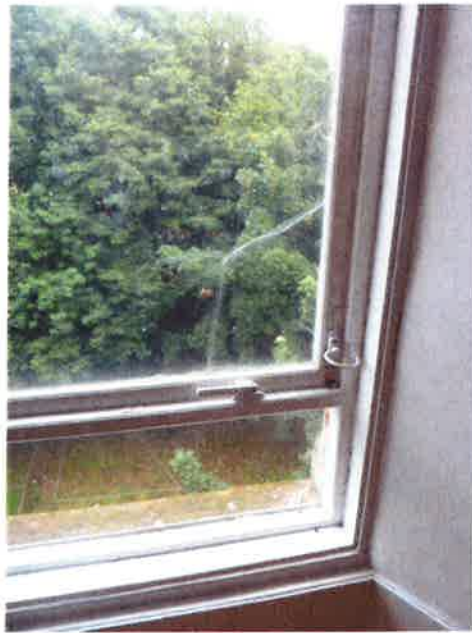
- e. There are no items in the kitchen which require to be removed.
- f. The window in the rear bedroom is not wind and watertight. It is in poor condition and has deficient draughtproofing. It is difficult to open and close. The pane of glass is cracked and held together with taping.

5. Back bedroom timber window

34.2.2. The Landlord advised the Landlord's Representative in the phone call that morning that he intends to instruct replacement of the rear bedroom window and the window in the bathroom with uPVC units.

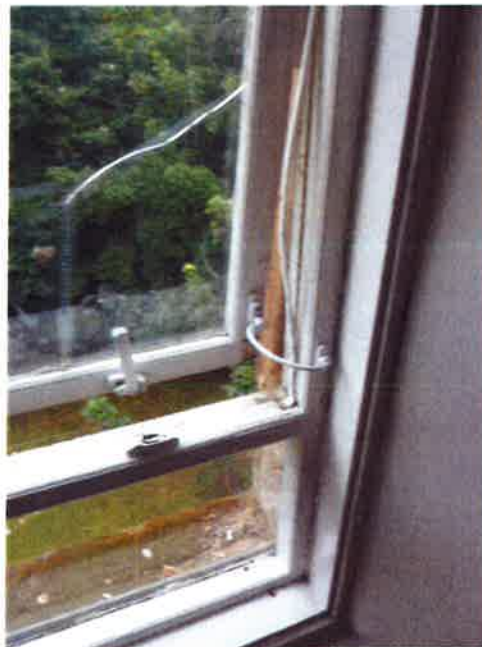
34.2.1. The Landlord's Representative advised that the Landlord had instructed a contractor to carry out a temporary repair by putting the film over the window. The draught excluders were also applied at that time. He accepted that at inspection they were seen to be falling off and were ineffectual.

6. Back bedroom window showing failed draught stripping

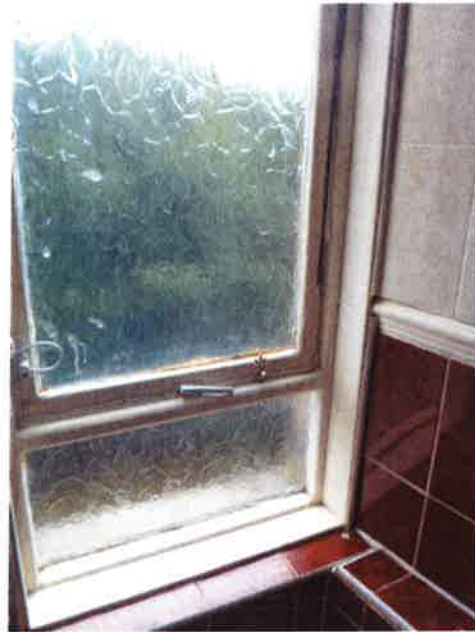
30.7.1. On inspection of the bathroom window (rear elevation) it was noted to have a timber frame. In a similar way to the rear bedroom window, draught proof stripping had been applied but was falling off and was ineffectual. It would be possible for water and wind to penetrate the House. See **Schedule of Photographs, number 7.**

- l. The bathroom window is not wind and watertight. It is in poor condition and has deficient draughtproofing.
- m. The hall cupboard is not wind and watertight. There is a hole in the hall cupboard ceiling around pipework serving a redundant boiler and the sky can be seen through the hole.

7. Bathroom window showing failed draught stripping

34.10.1. As already submitted, the Landlord has now stated that he intends to replace this window with a uPVC unit.

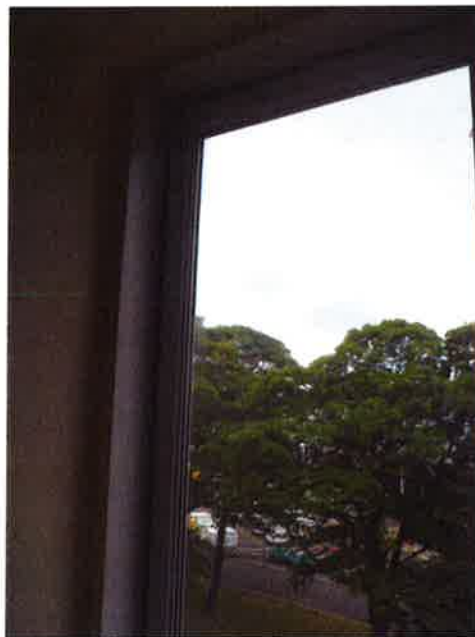
30.3.3. On inspection of the living room window, it was noted to be a uPVC framed in three sections, each section comprising an opening casement and a deadlight. On the right hand section the casement double glazing unit external pane was missing. There was a screw hole at the foot of the middle section of the frame but there was no screw present. The handle in middle window did not go all the way down and could possibly be improved with adjustment but the window was secure. The left hand window casement was secure and fitted well. See **Schedule of Photographs, number 8** of the left hand window section.

36.2.2. There is a pane of double glazing missing from the right hand living room window double glazing unit.

8. Living room window

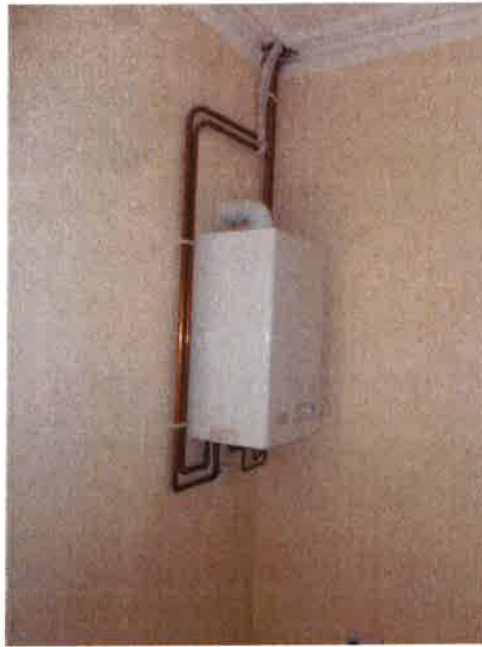
9. Central heating boiler in front bedroom

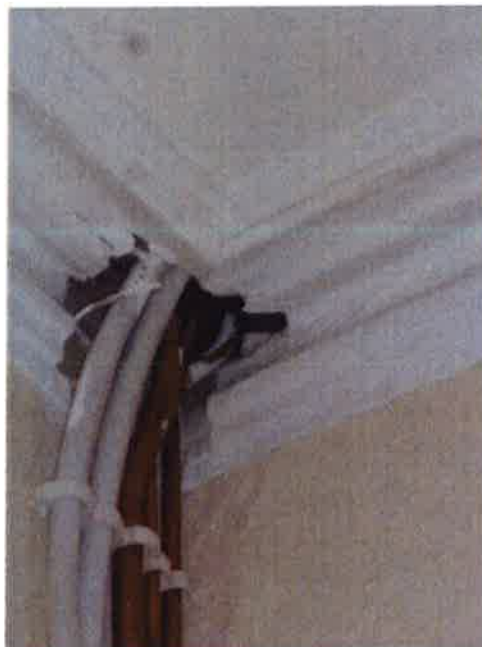
10. Hole in ceiling above boiler

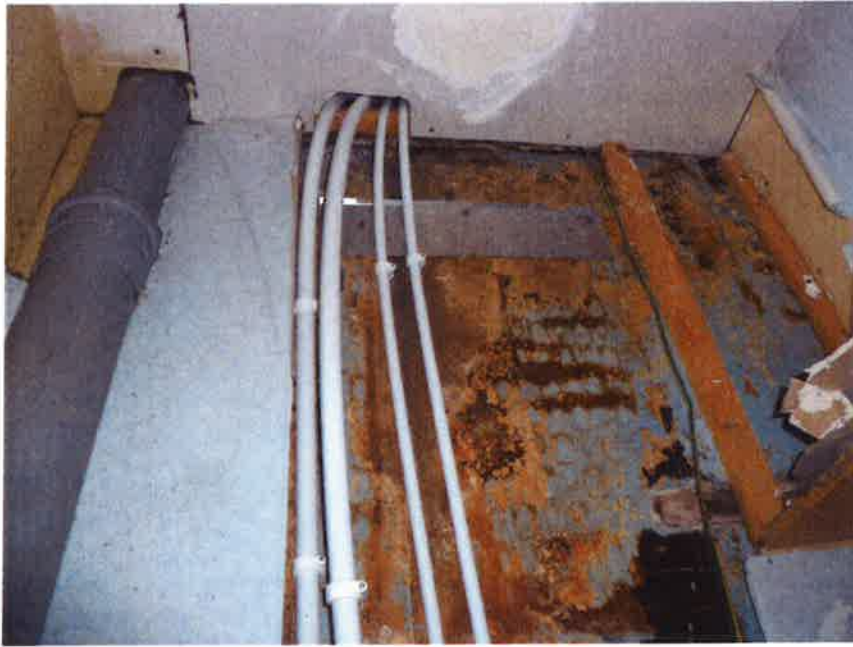
11. Hole in ceiling at heating pipes - hall cupboard

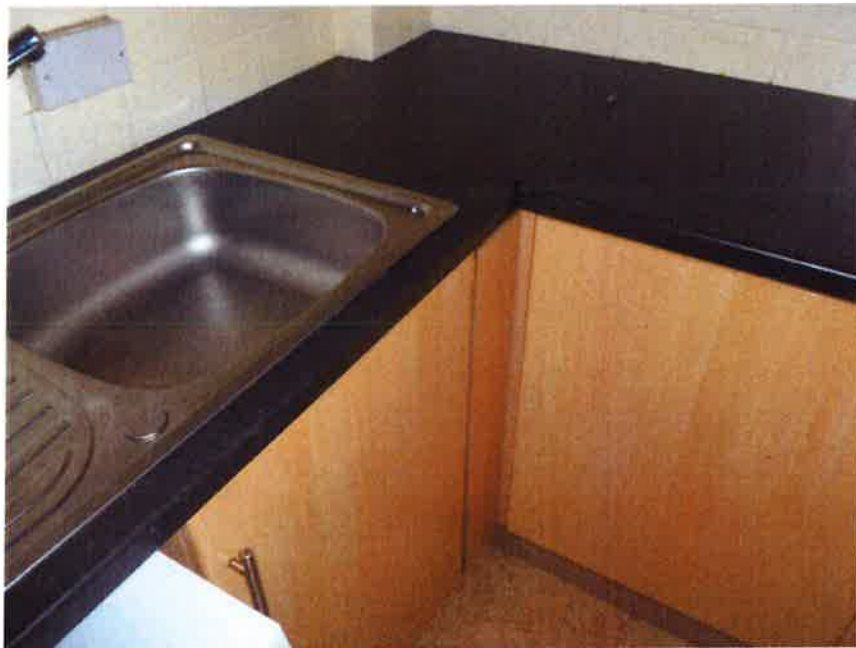
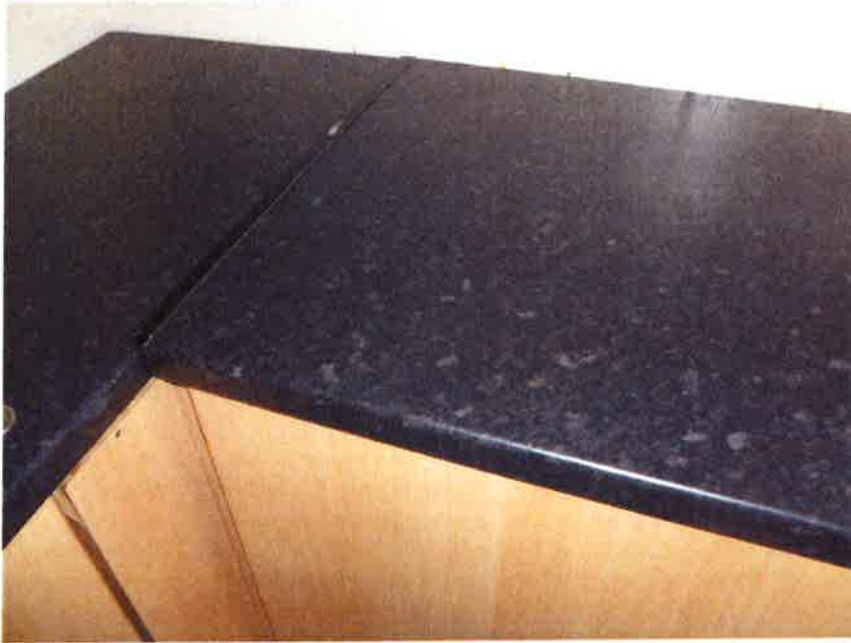
34.12.1. The Landlord's Representative advised that the kitchen worktop on the far left had been loose. It was fixed after the House was vacant. He has an invoice for the repair on file.

12. Kitchen worktops - now secured

13. Kitchen worktops now secured

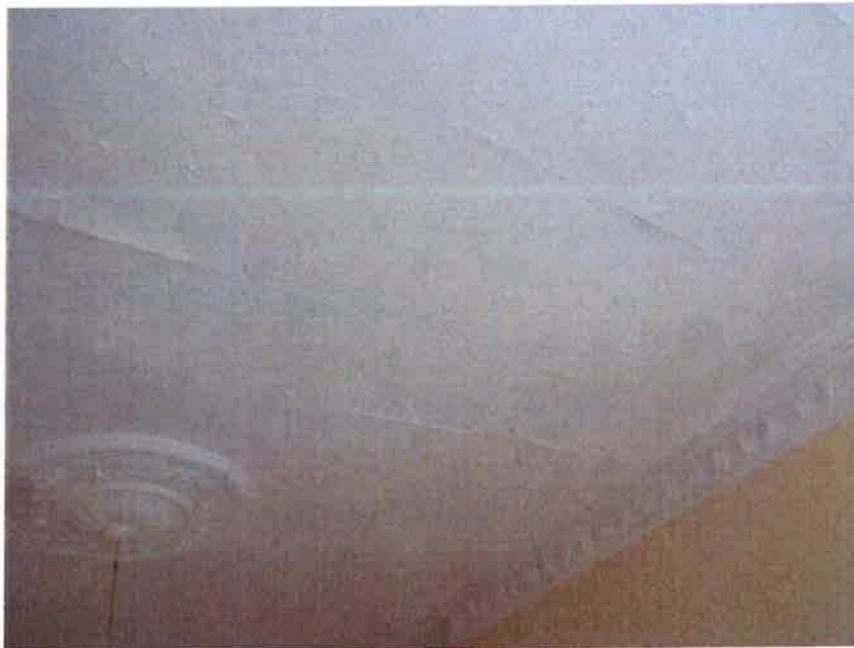
30.12.1. On inspection it was noted that there were cosmetic cracks on the lounge ceiling. See **Schedule of Photographs, number 14.**

37.1.9. The cracks in the living room ceiling are cosmetic and there is no evidence of asbestos in the House.

14. Cosmetic cracking to living room ceiling

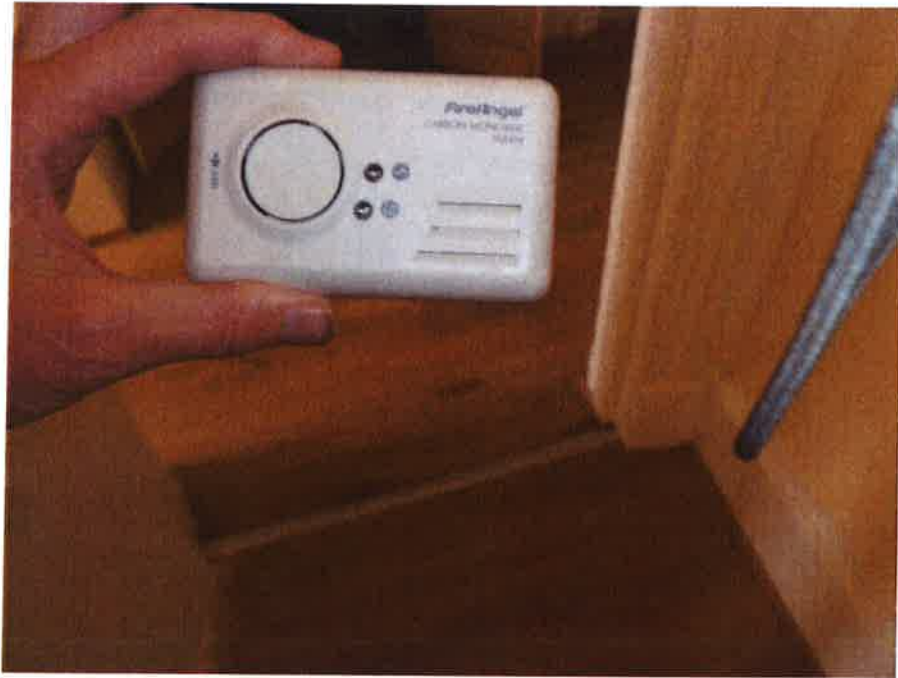
30.13.1. Although it did not form part of the Application, the tribunal also observed during the inspection that there was no carbon monoxide detector affixed to the wall or ceiling in the bedroom in which the boiler was situated, or indeed anywhere in the House. A non-functioning carbon monoxide detector was found by the Landlord's Representative in a kitchen drawer. See **Schedule of Photographs, number 15.**

- p. The House is in a satisfactory standard of cleanliness.
- q. There were no needles evident at the time of the inspection.
- r. There are cosmetic cracks on the living room ceiling.
- s. There is no evidence to suggest a problem with asbestos.
- t. There is no operational carbon monoxide detector in the House.

15. Carbon monoxide detector found  
in drawer

34.16.2. The tribunal made reference to the legal requirement to have satisfactory provision for giving warning if carbon monoxide is present in a concentration that is hazardous to health; and to Scottish Government guidance relative to the siting of carbon monoxide detectors.
