### **Repairing Standard Enforcement Order**

**Case Reference Number: FTS/HPC/RP/17/0070**

**Re: 20A Cowal Drive, Linwood, Paisley PA3 3JW ("the house")**

### Schedule of Photographs of 20A Cowal Drive, Linwood PA3 3JW

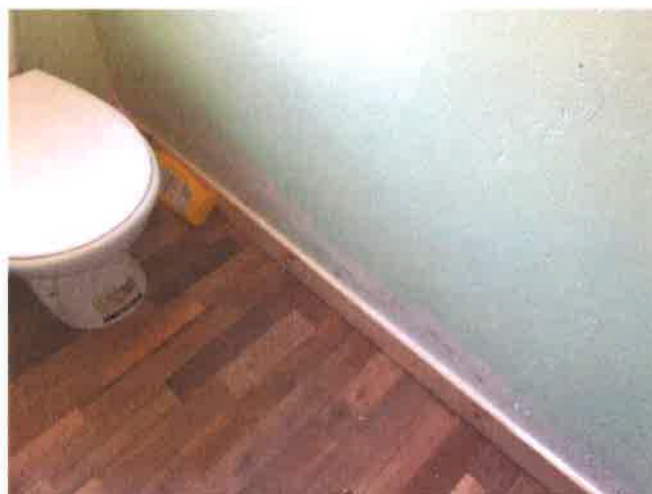
- iii. Damp readings were taken in the bathroom, and no signs of dampness were found.
  - iv. The skirtings in the bathroom had been replaced.
  - v. The bath tap had been repaired/replaced, and when tested, was found to be operating correctly.

22. The tribunal observed at its inspection that the skirtings in the bathroom had been replaced. Mr Brownhill told the tribunal at the hearing that these had been replaced at the same time as the bathroom ceiling.
23. The tribunal therefore determines that the bathroom skirtings are in a reasonable state of repair and in proper working order.

**Photograph 2:** Bathroom; skirting

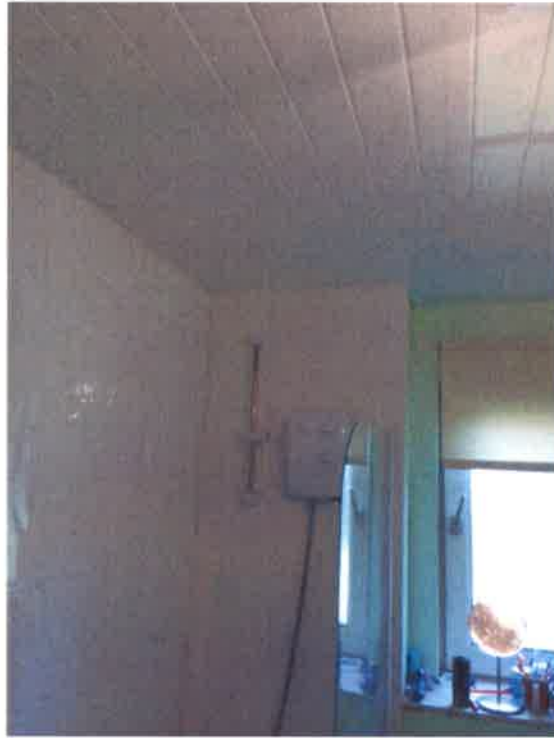
- i. The bathroom ceiling had recently been faced with plastic coated sheeting.
  - ii. There was no evidence of draughts coming through the bathroom wall or ceiling.

18. The bathroom ceiling had recently been faced with plastic coated sheeting. Mr Brownhill told the tribunal that there had been a leak coming through from the flat above, which had come through to the bathroom and had spread to the bedroom next door. He understood that the owner upstairs had now had the leak repaired, and he had instructed a joiner to replace the bathroom ceiling, which had been coming away, around 3 weeks previously. He therefore believed that the dampness problem had been resolved.

28. At its inspection, the tribunal observed no evidence of draughts coming through the bathroom wall or ceiling. Mr Brownhill told the tribunal at the hearing that the draughts had been due to a gap caused by the ceiling coming away as a result of the leak upstairs, which had now been fixed. He said that the issues had been addressed by the installation of the new bathroom ceiling, and the tenant indicated at the inspection that he agreed this was the case.
29. The tribunal therefore determines that the bathroom wall and ceiling are wind and watertight and in all other respects fit for human habitation.

**Photograph 3:** Bathroom ceiling

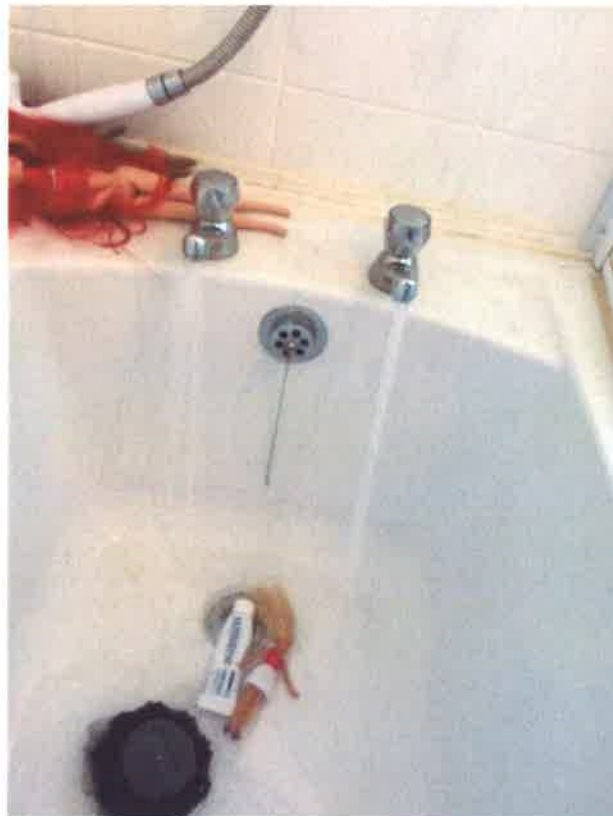
24. The tribunal observed at its inspection that the bath tap had been repaired or replaced, and when tested, was found to be operating correctly.
25. The tribunal therefore determines that the bath tap is in a reasonable state of repair and in proper working order.

**Photograph 4:** Bathroom: Bath taps

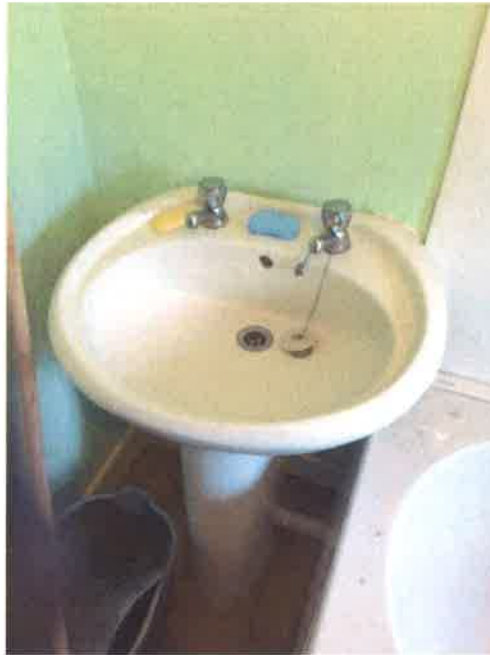
- vi. The bathroom sink was loose from the wall, and there was some movement when pressure was put on it.
  - vii. Damp readings were taken in the rear bedroom, and no signs of dampness were found. There were, however, signs of mould on the ceiling.

26. The tribunal observed at its inspection that the bathroom sink was loose from the wall, and that there was some movement when pressure was put on it. Mr Brownhill acknowledged that the sink required to be fixed. He said that the tenant had agreed to get it fixed himself, but had not done so.
27. The tribunal therefore determined that the bathroom sink is not in a reasonable state of repair and in proper working order.

**Photograph 5:** Bathroom: sink

1. Secure the bathroom sink to the wall so that it is in a reasonable state of repair and in proper working order.
2. Either a) install a gas central heating system throughout the house or b) reinstate the electrical panel heaters throughout the house, so that the installations in the house for space heating and heating water are in a reasonable state of repair and in proper working order.

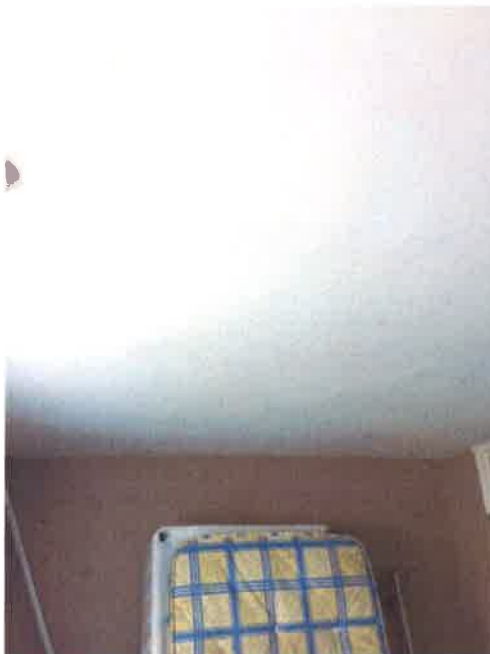
19. The tribunal observed some signs of mould on the rear bedroom ceiling, which the tenant told the tribunal he had cleaned off. No indication of dampness was found in that room.

**Photograph 6:** Rear bedroom: ceiling

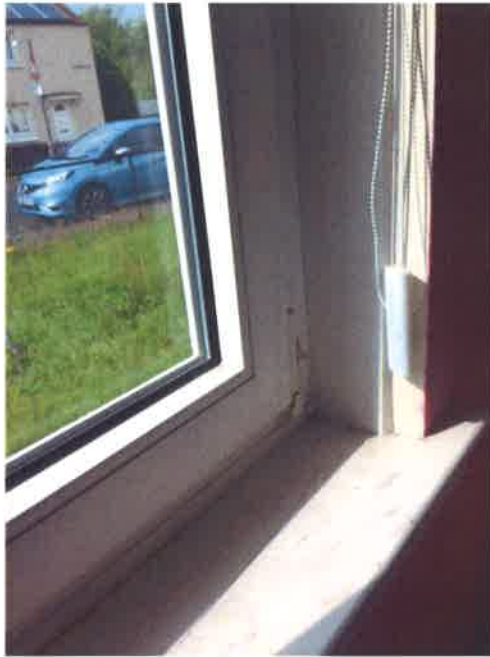
- x. While there was some evidence of damage to the UPVC window frame in the front bedroom, no evidence was found of any draughts coming through the bottom right hand corner, which the tenant told the tribunal was the subject of his complaint.

30. At its inspection, the tribunal observed that while there was some evidence of damage to the UPVC window frame in the front bedroom, no evidence was found of any draughts coming through the bottom right hand corner, which the tenant indicated was the subject of his complaint. The tenant said that there was a whistling sound from that part of the window. Mr Brownhill told the tribunal at the hearing that he believed there was an issue with the window frame and seal on the top left of the window, but this had not been checked by the tribunal as that was not the complaint indicated by the tenant. The tribunal checked the windows from both inside and outside, and found that the window was well sealed on both sides.
31. The tribunal therefore determines that the bedroom window is in a reasonable state of repair and in proper working order.

**Photograph 7:** Front bedroom: window - interior

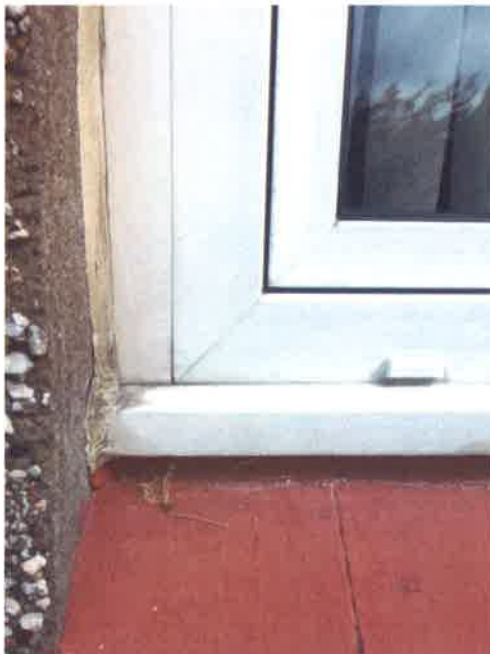
**Photograph 8:** Front bedroom: window - exterior

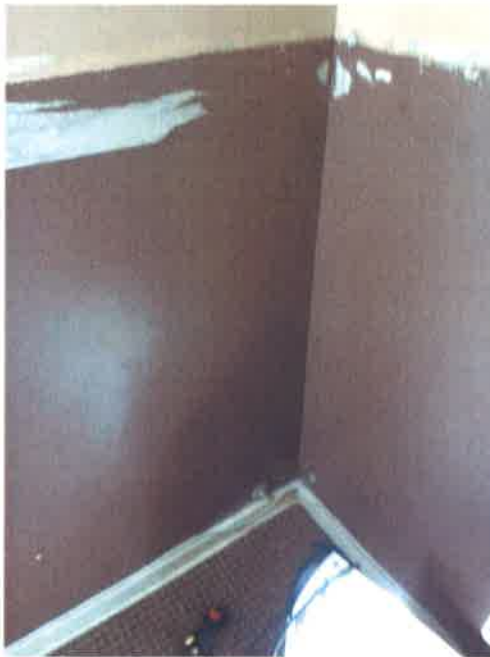
- viii. Damp readings were taken in the living room, but no dampness was found.
  - ix. There was evidence of a hole which had been sealed on the living room wall to the right of the window.

20. With regard to the living room, the tenant told the tribunal at the inspection that there had been some dampness in the corner of the room. He believed that this was due to a hole left in the wall following the removal of a television cable. At its inspection, the tribunal saw evidence of a hole which had been sealed on the living room wall to the right of the window. Both the tenant and Mr Brownhill told the tribunal that the issue had now been resolved, and the tribunal found no evidence of dampness in the living room.

**Photograph 9:** Living room: walls – hole filled - interior

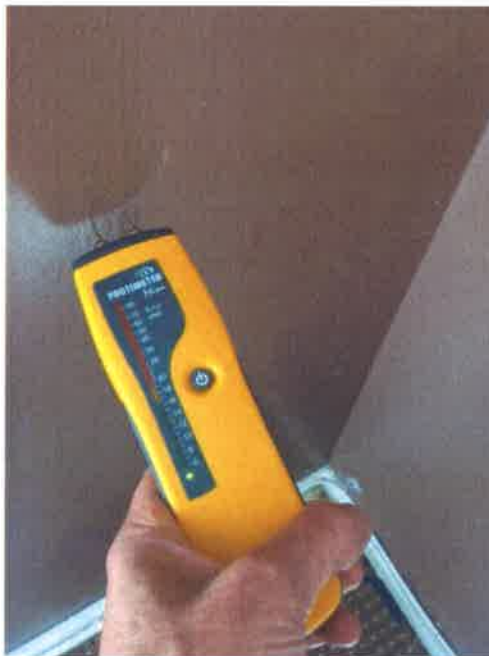
**Photograph 10:** Living room: wall - damp meter reading – interior

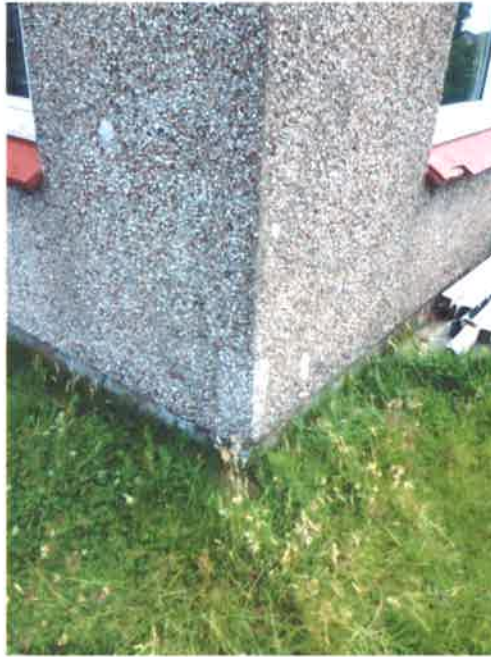
**Photograph 11:** Living room – wall - external

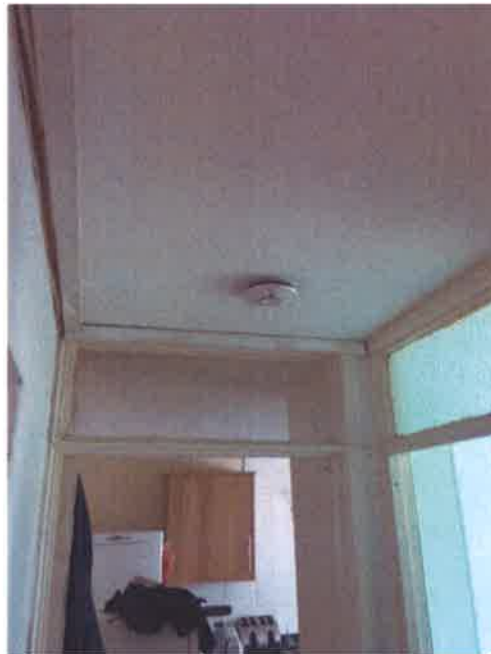
- xiii. There were two smoke alarms in the hallway, one of which was hard wired, which was tested and found to be working, and the other battery operated. There were no other smoke alarms in the house.

38. While the tenant did not make a complaint about this matter in his application, the tribunal also wishes to make an observation about the provision within the property for detecting fires and giving warning of fire or suspected fire. The tribunal noted at its inspection that there were two smoke alarms in the hallway, one of which was hard wired, which was tested and found to be working, and the other battery operated. There were no other smoke alarms in the house, and there was no heat alarm in the kitchen. The tribunal notes that this provision does not comply with the current statutory guidance for private rented properties.

**Photograph 12:** Hallway – smoke detector

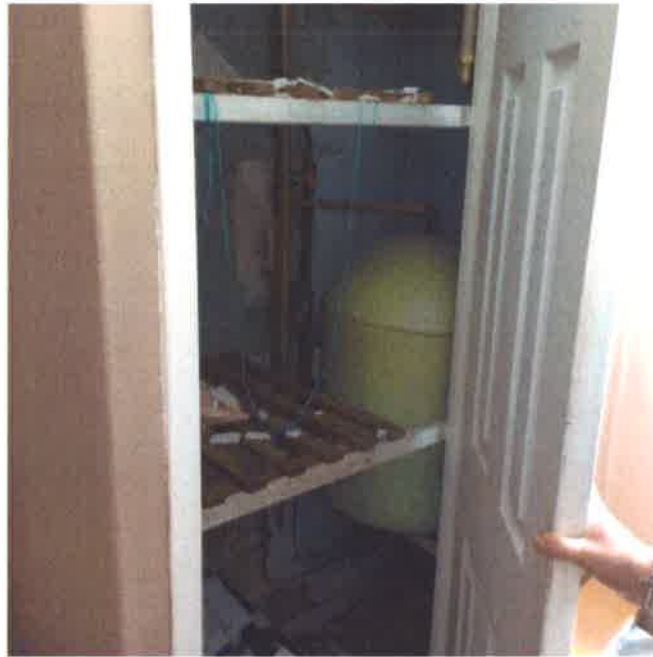
- xi. There were no storage heaters on the walls, but there were clear marks on the walls in some rooms where the heaters had been.
  - xii. There were no gas appliances in the house; the water is heated by an electrical immersion heater.

**Photograph 13:** Back bedroom - Hot water cylinder tank

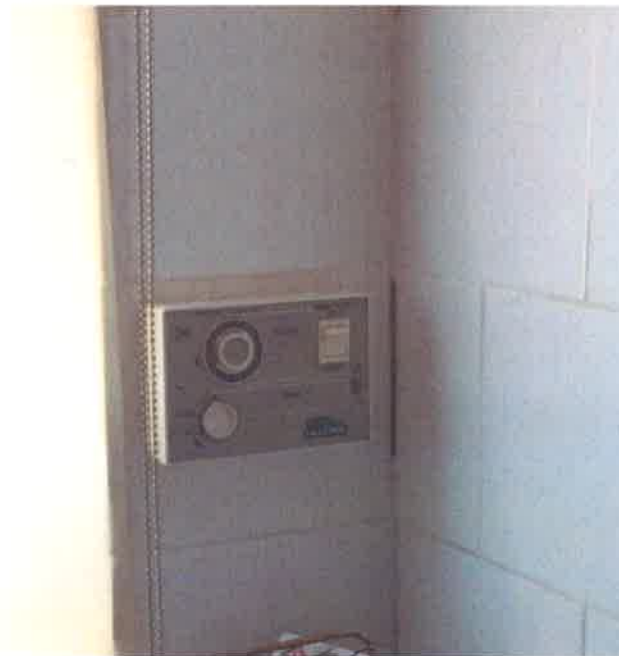
**Photograph 14:** Kitchen - Heating/hot water control

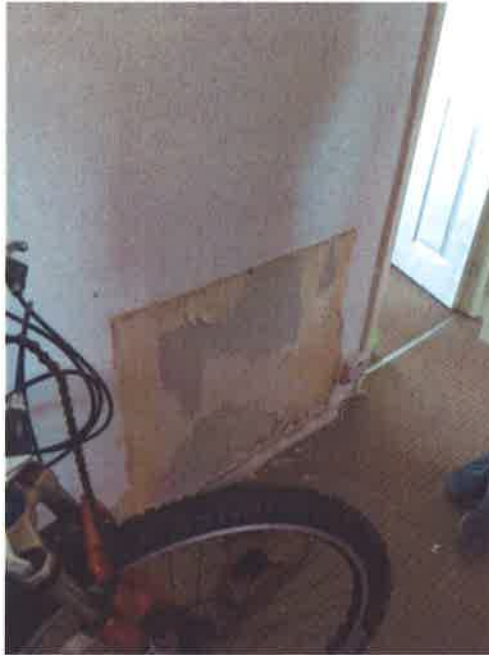
32. The tribunal observed at its inspection that there were no storage heaters on the walls, but there were clear marks on the walls in some rooms where the heaters had been. The landlords had provided electric and oil heaters in their

35. The tribunal notes that there was central heating in place at the time the tenant's current tenancy agreement with the landlords began. These were therefore installations provided by the landlord as part of the tenancy. The tribunal determines that the installations in the house for the supply of space heating are not in a reasonable state of repair and in proper working order.

**Photograph 15:** Hallway – wall where heater removed

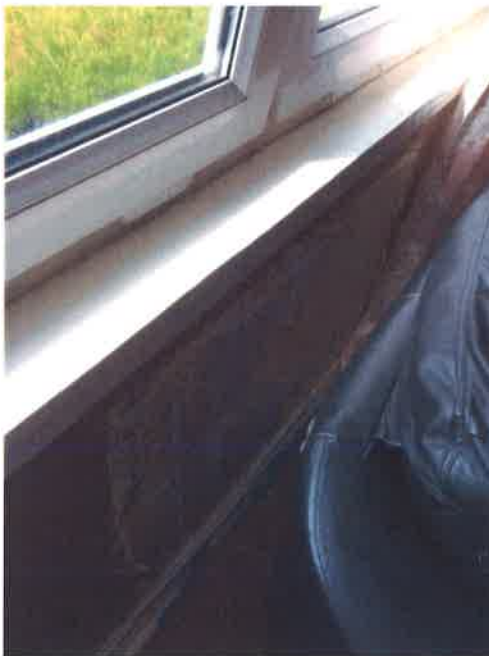
**Photograph 16:** Living room – wall under window where heater removed
