Repairing Standard Enforcement Order (RSEO): Housing (Scotland) Act 2006, Section 24

House at 46a Charlotte Street, Fraserburgh, Aberdeenshire, Ab43 9JE  
("The Property")

**STATEMENT OF DECISION: Housing (Scotland) Act, Section 24(1)**

Schedule of photographs of 46a Charlotte St., Fraserburgh, AB43 9JE/

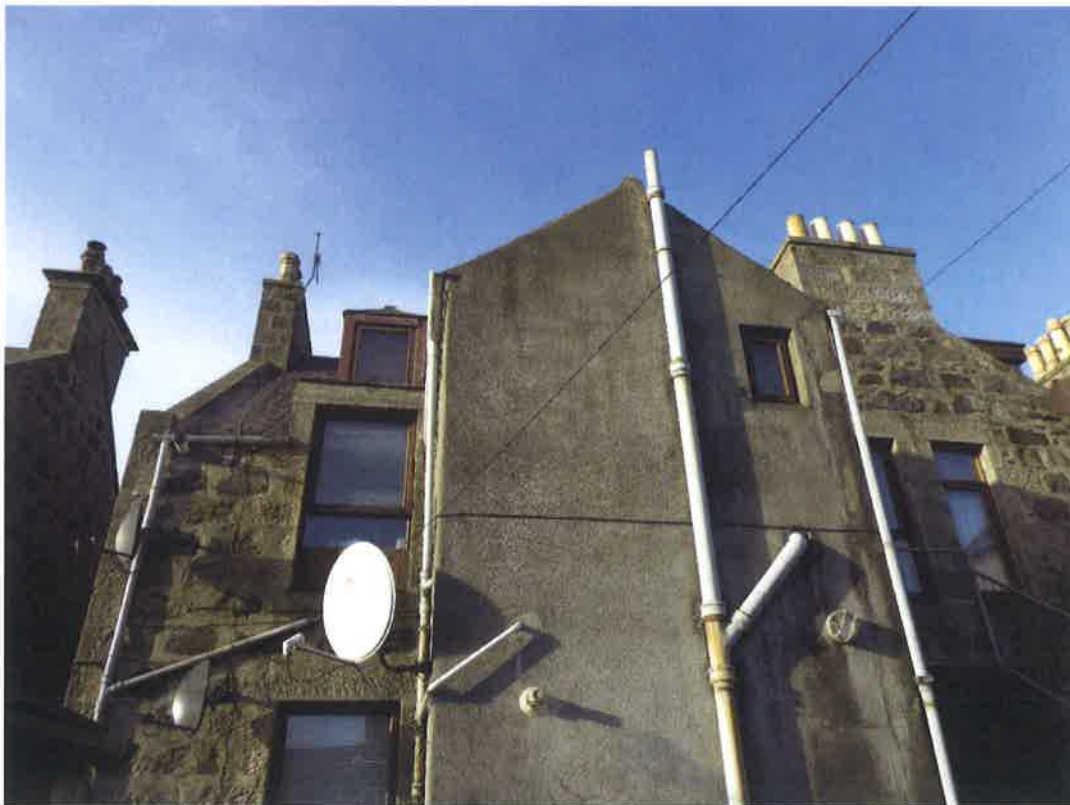
Rear elevation – 1<sup>st</sup> & 2<sup>nd</sup> floors. Left hand window to kitchen. Extension window to bathroom.

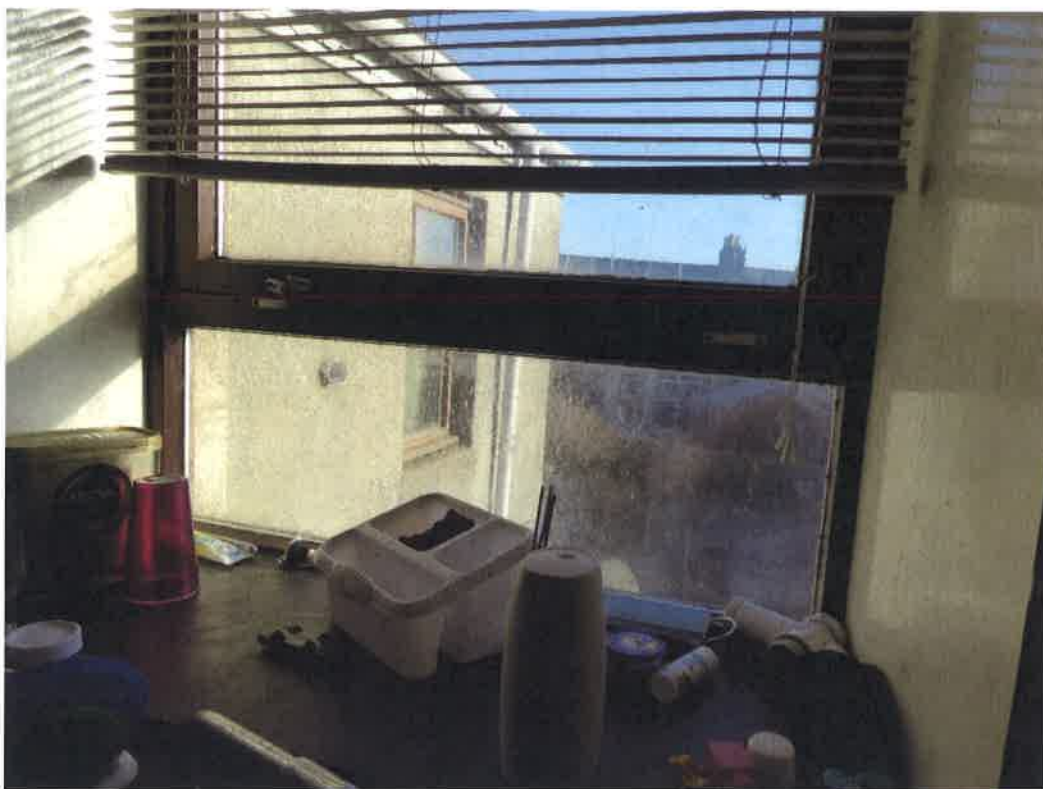
- (i) The kitchen window has no handles and is therefore not capable of opening and closing correctly. The kitchen window is therefore not in a reasonable state of repair and in proper working order.

Within the kitchen the window was found to have the handles missing. Accordingly, the window could not be opened or closed correctly and therefore failed to meet the Repairing Standard.

Kitchen windows. No handles to operate catches to window.

- (a) To repair or replace the kitchen window to ensure that the window opens, closes and locks correctly and is in a reasonable state of repair and in proper working order.

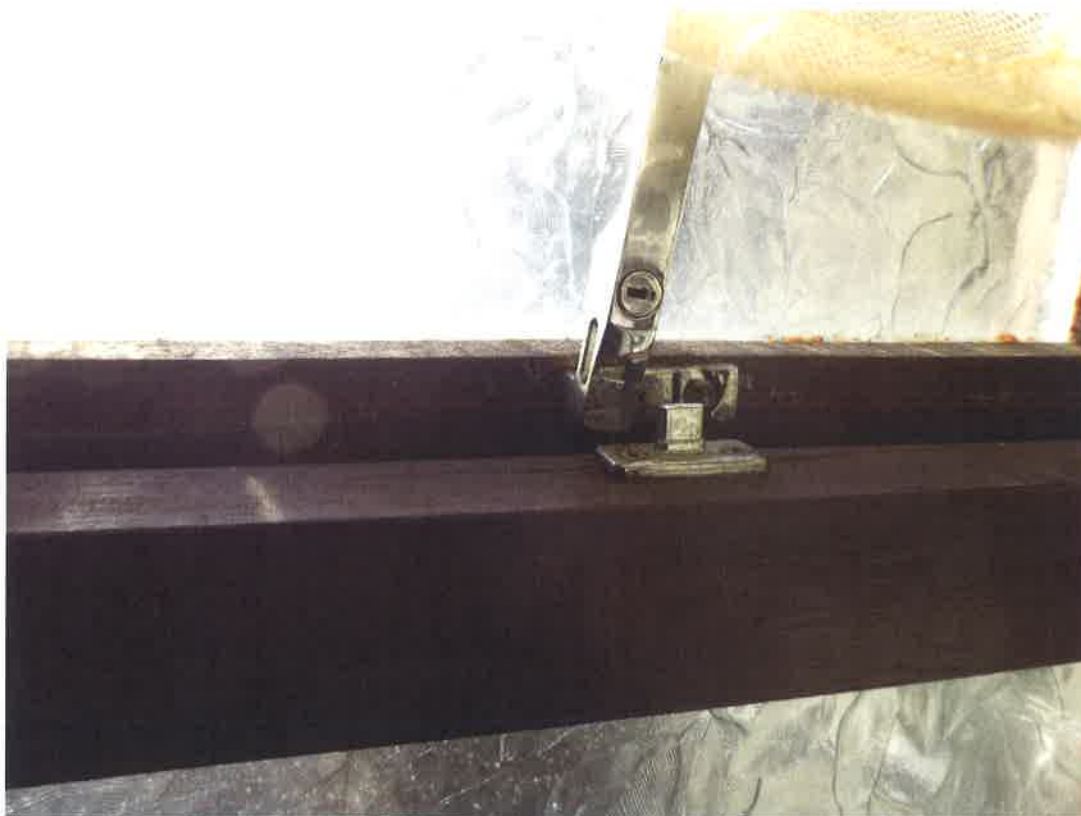
- (ii) In the bathroom, the window adjacent to the bath does not close properly and the window above the toilet does not open properly. The bathroom windows are therefore not in a reasonable state of repair and in proper working order.

In the bathroom, the window immediately adjacent to the bath opened but did not close properly whilst the window immediately above the toilet would not open. The bathroom windows are therefore not in a reasonable state of repair and in proper working order, and therefore breached the Repairing Standard.

Bathroom window does not close.

- (b) To repair or replace the two windows in the bathroom to ensure that the windows open, close and lock correctly and are in a reasonable state of repair and in proper working order.

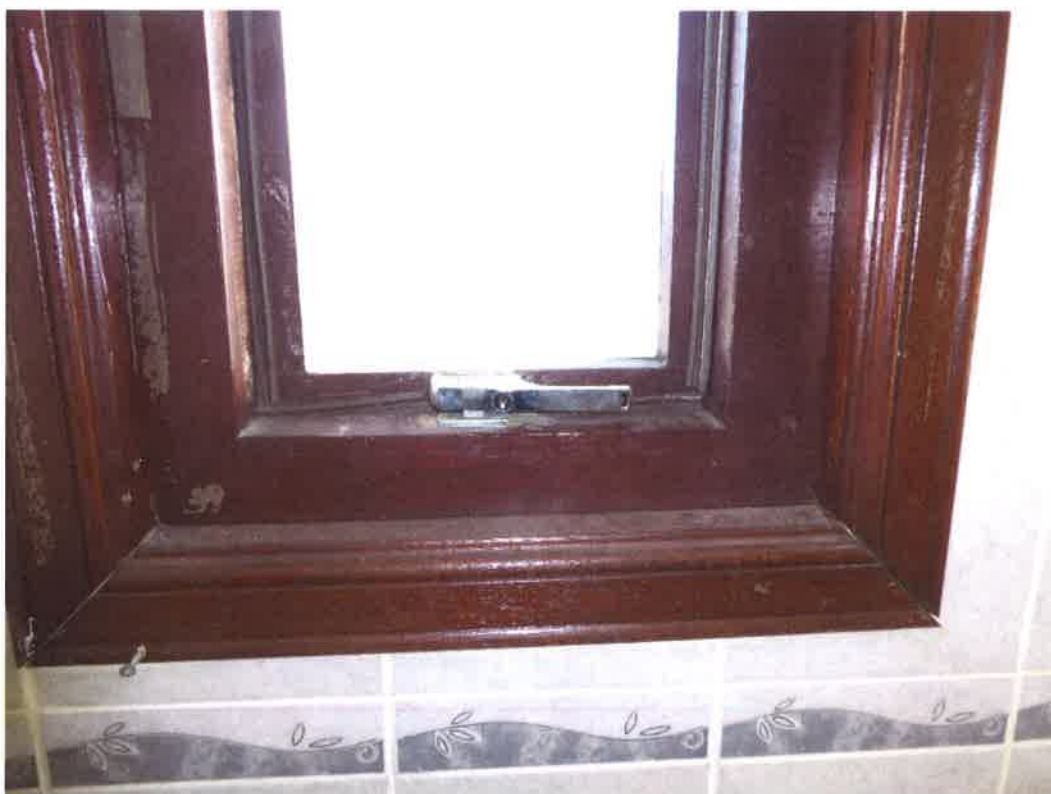
Bathroom window – locked shut

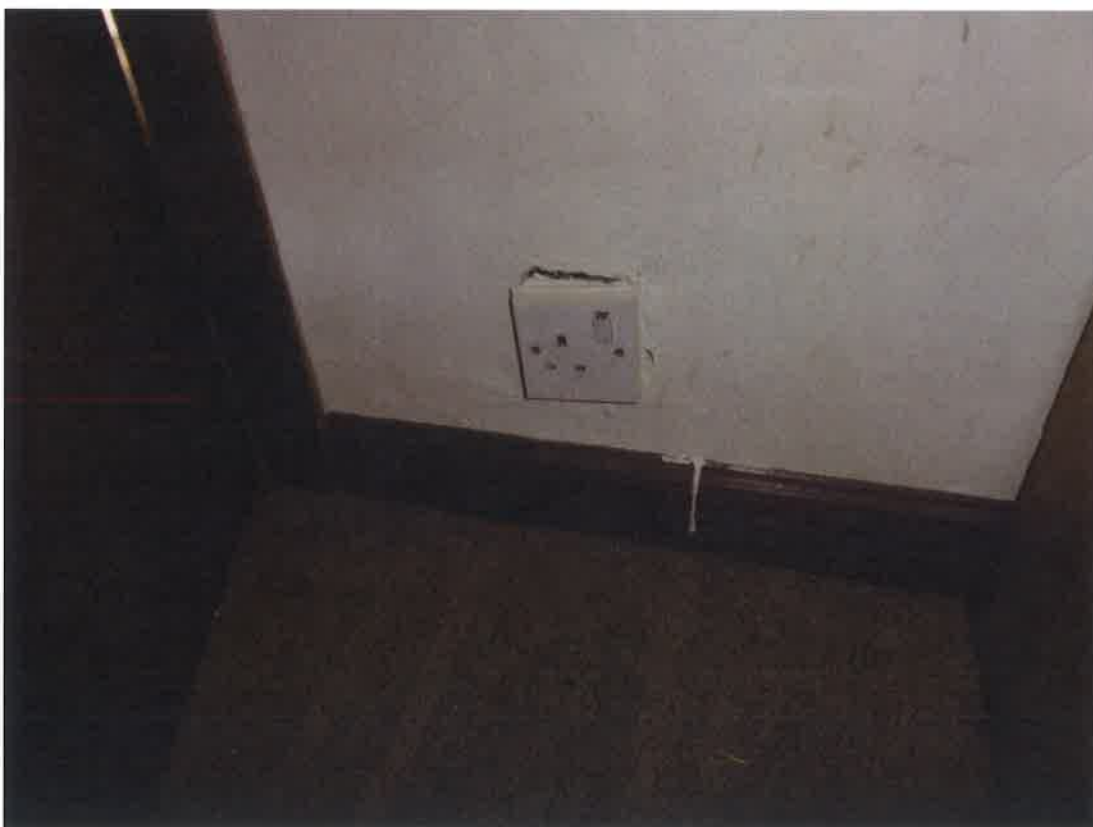
- (iii) That in the bedroom on the first floor the electrical socket situated behind the door and towards the floor is not properly affixed to the wall and is unsafe. The electrical socket is therefore not in a reasonable state of repair and in proper working order.

Within the bedroom on the first floor of the property the electrical socket situated immediately behind the door and towards the floor is not properly fixed to the wall and is unsafe. The socket is not therefore in compliance with the Repairing Standard.

Bedroom socket in disrepair.

- (c) To repair or replace the electrical socket in the first floor bedroom (being the socket situated behind the door and towards the floor) to ensure that it is in a reasonable state of repair and in proper working order.

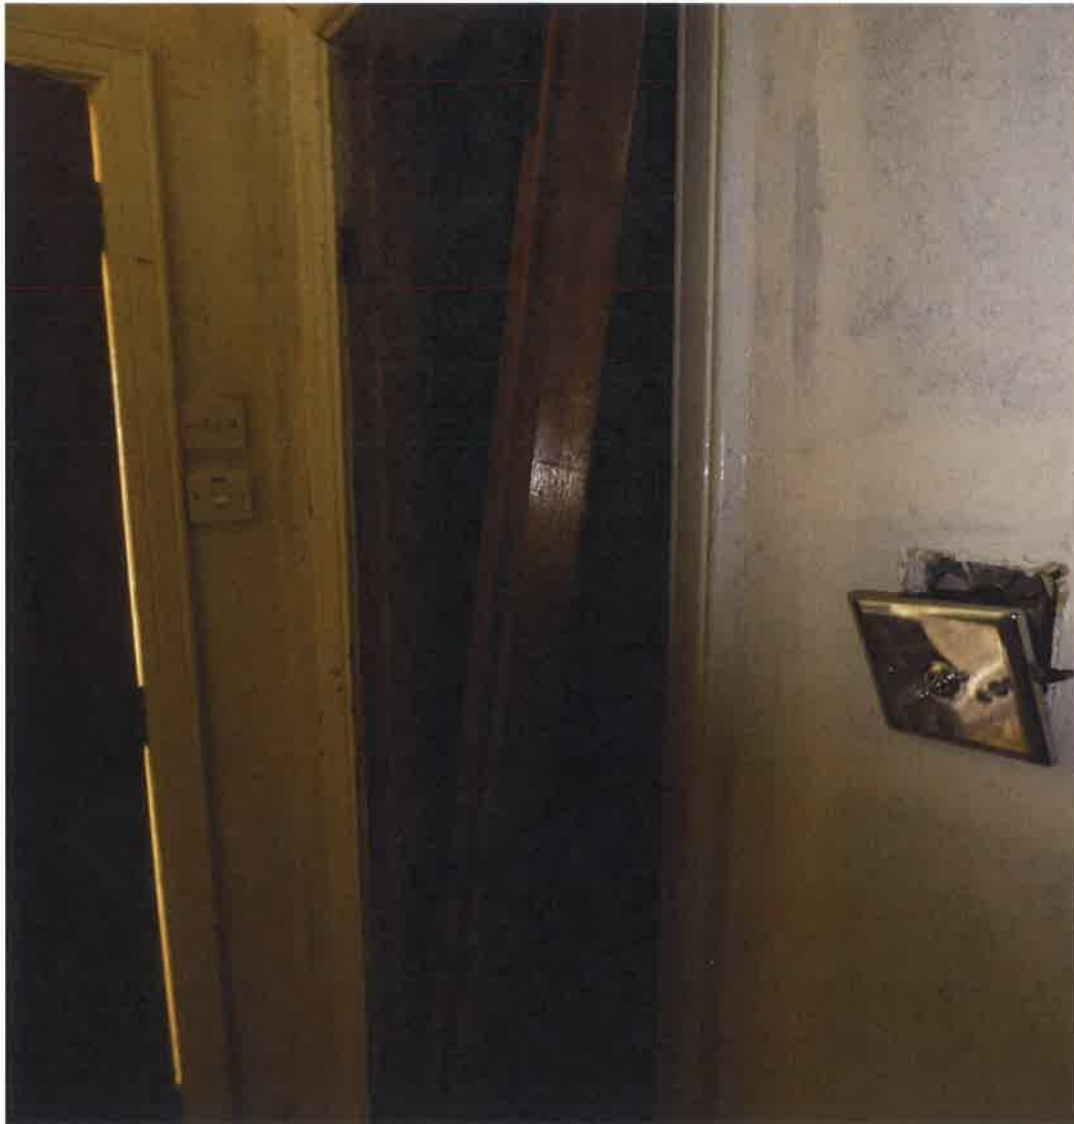
- (iv) The door to the cupboard immediately opposite the front entrance door is off its hinges. It does not therefore open and close correctly. It is therefore not in a reasonable state of repair and in proper working order.

Within the hallway, the door to the cupboard immediately opposite the front entrance door and within which the washing machine point is located was found to be off its hinges and therefore not capable of opening and closing correctly.

Corridor cupboard door (to washing machine point) off its hinges

- (d) To repair or replace the cupboard door in the hallway to ensure that it opens and closes correctly and is in a reasonable state of repair and in proper working order.

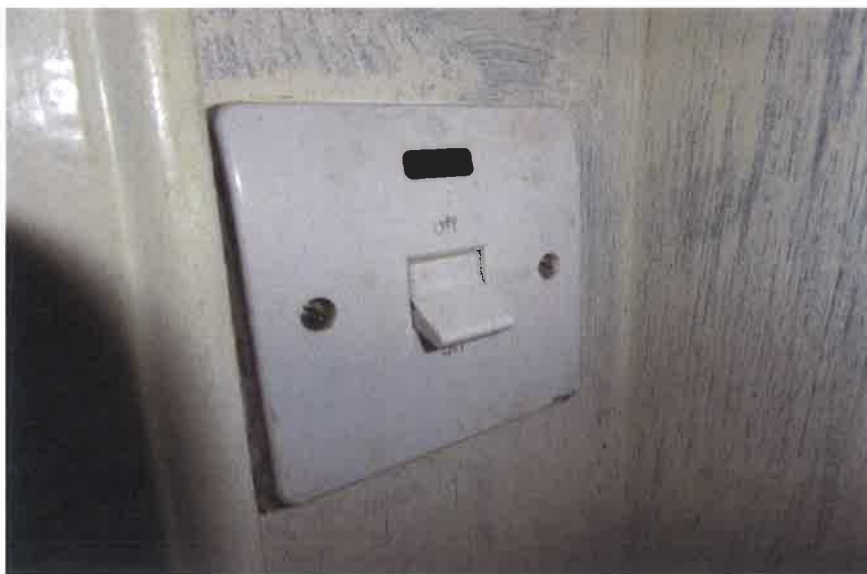
The Tenant reported that when trying to operate the shower the fuse in the fuse box repeatedly trips when the shower switch is turned on. The tribunal determined that either the wiring to the shower switch is faulty or the fuse in the consumer unit is the wrong size or the wiring to the shower is unable to take the number of kilowatts required to operate the shower. On any view, however, the electrical installations for the supply of electricity to the Property are not in a reasonable state of repair and are not in proper working order as a consequence of which the shower does not operate.

Shower switch fused

- (f) (i) To engage a suitably qualified and registered SELECT or NICEIC electrical contractor to carry out a certificated electrical condition check (EICR) on the electrical installations of the Property, and thereafter follow the recommendations of that report to ensure that the entire system is safe and in proper working order.

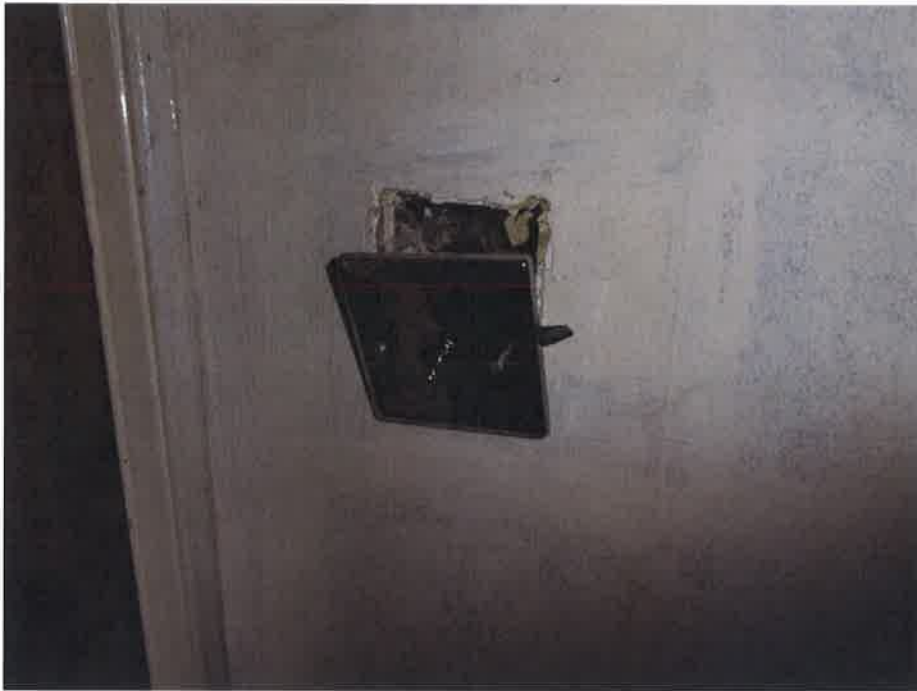
- (v) That in the hallway the "electrical socket" is a light switch situated to the right of the cupboard mentioned in paragraph 10(c)(iv) above which is loose from the wall and unsafe. The light switch is therefore not in a reasonable state of repair and in proper working order.

Also within the hallway the electrical socket about which the third party applicant complains was identified as being a light switch situated immediately to the right of the cupboard mentioned in the paragraph above. The light switch was found to be hanging loose from the wall and is therefore unsafe. The light switch is not in a reasonable state of repair and in proper working order.

Light switch in corridor unsafe.

- (e) To repair or replace the loose light switch in the main hallway (being the light switch situated to the right of the cupboard immediately opposite the main entrance to the Property) to ensure that it is in a reasonable state of repair and in proper working order.

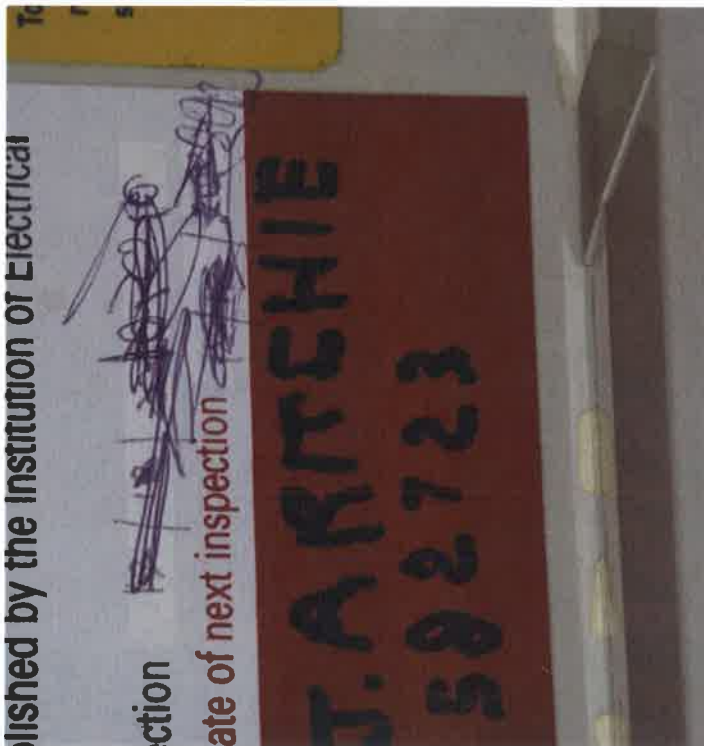
Close up of scored out inspection dates.

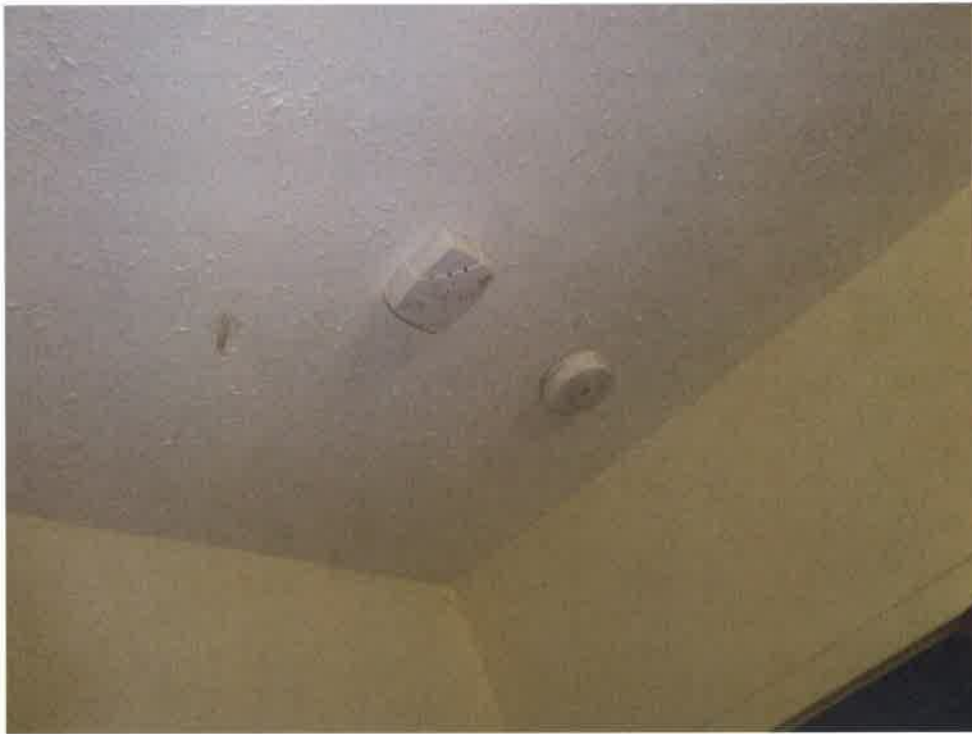
Within the Property the Tribunal identified satisfactory provision for detecting fires and for giving warning in the event of fire or suspected fire. In particular a heat and smoke detector were found affixed to the kitchen ceiling with additional smoke alarms in the livingroom, first floor hallway and on the landing on the second floor all of

Heat and CO detectors on kitchen ceiling

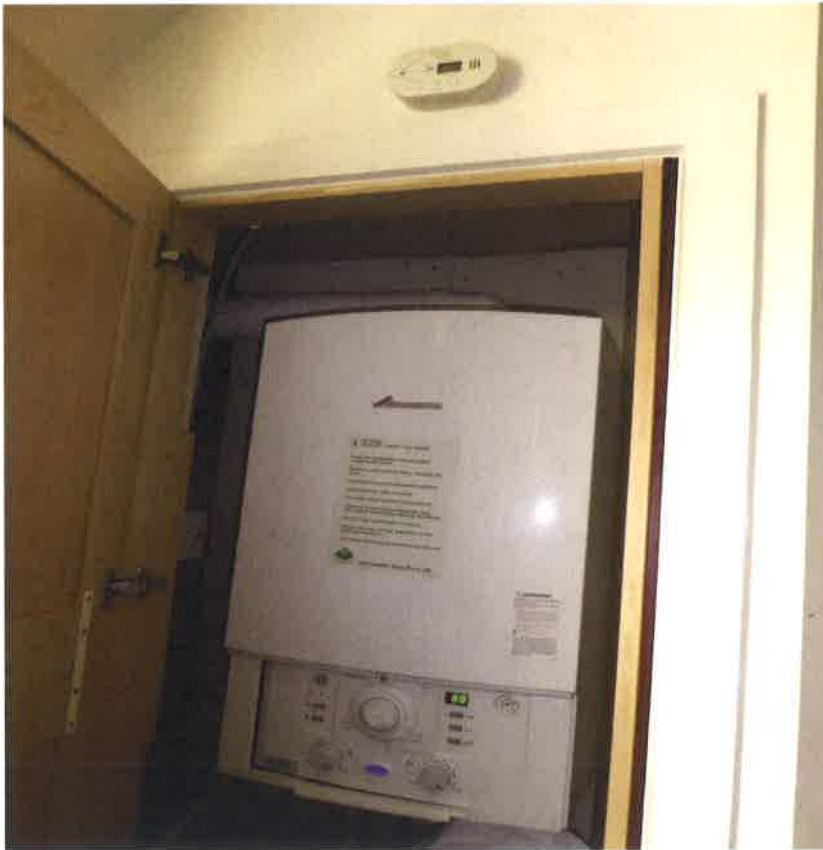
The boiler is located within a high level cupboard in the kitchen. The boiler appeared to be a relatively new Worcester boiler. A carbon monoxide detector was located above the cupboard housing the boiler. The radiators were warm. No Gas Safety Record had been produced.

CO alarm above boiler (too close – should be 1m + away)

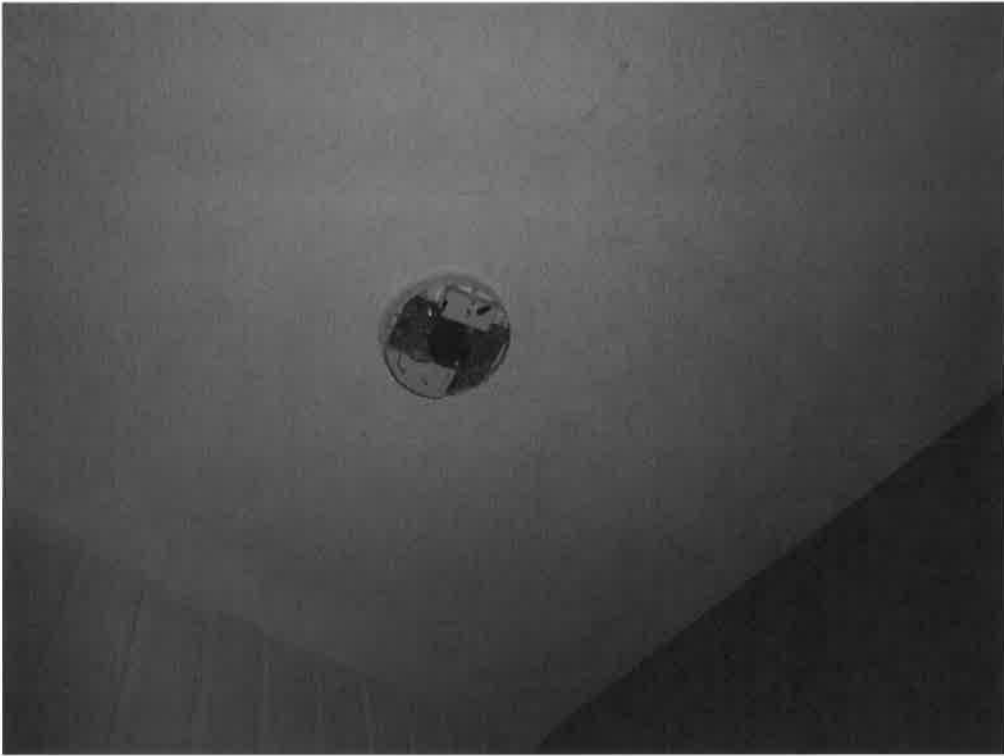
- (xi) That the whilst generally the Property has satisfactory provision for detecting fires and for giving warning in the event of fire or suspected fire, the smoke detector in the first floor hallway is damaged and is not therefore in a reasonable state of repair.

which are hard wired and interlinked. The smoke alarm in the first floor hallway was, however, found to be damaged and in need of repair.

Damaged smoke alarm on corridor ceiling

- (h) To repair or replace the smoke detector in the hallway on the first floor of the Property.
- (i) Repair or replace the exterior front door and frame to ensure that the door is wind and watertight, in a reasonable state of repair and in proper working order and to provide keys to the front door to the Tenant.

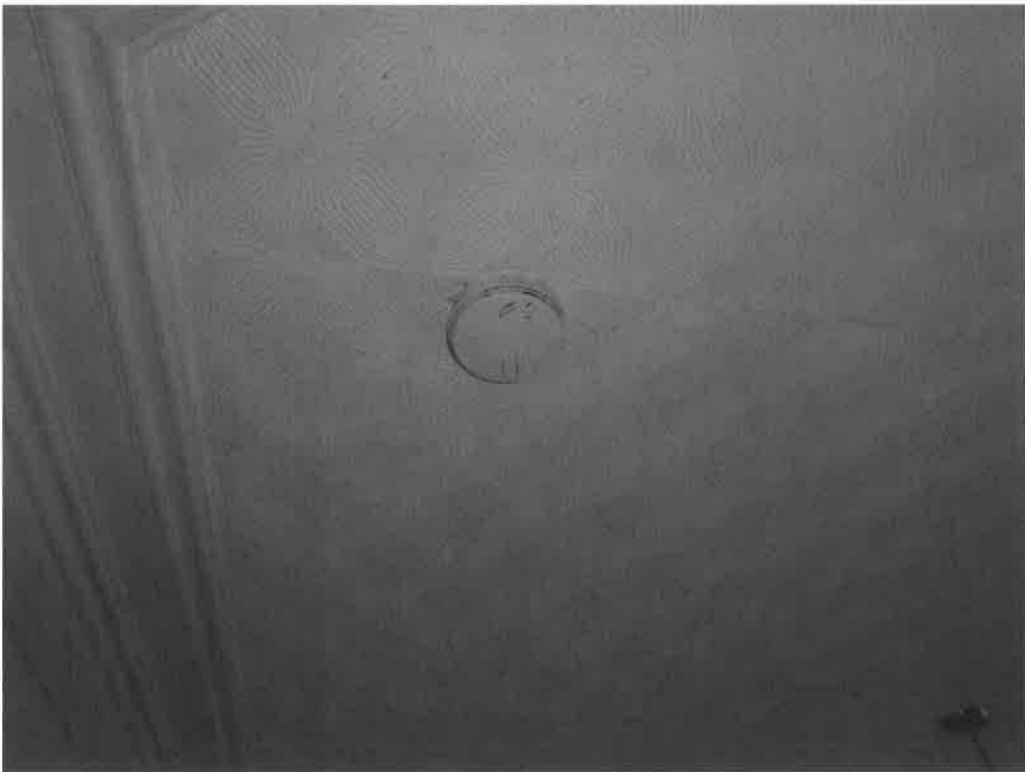
Smoke alarm on living room ceiling

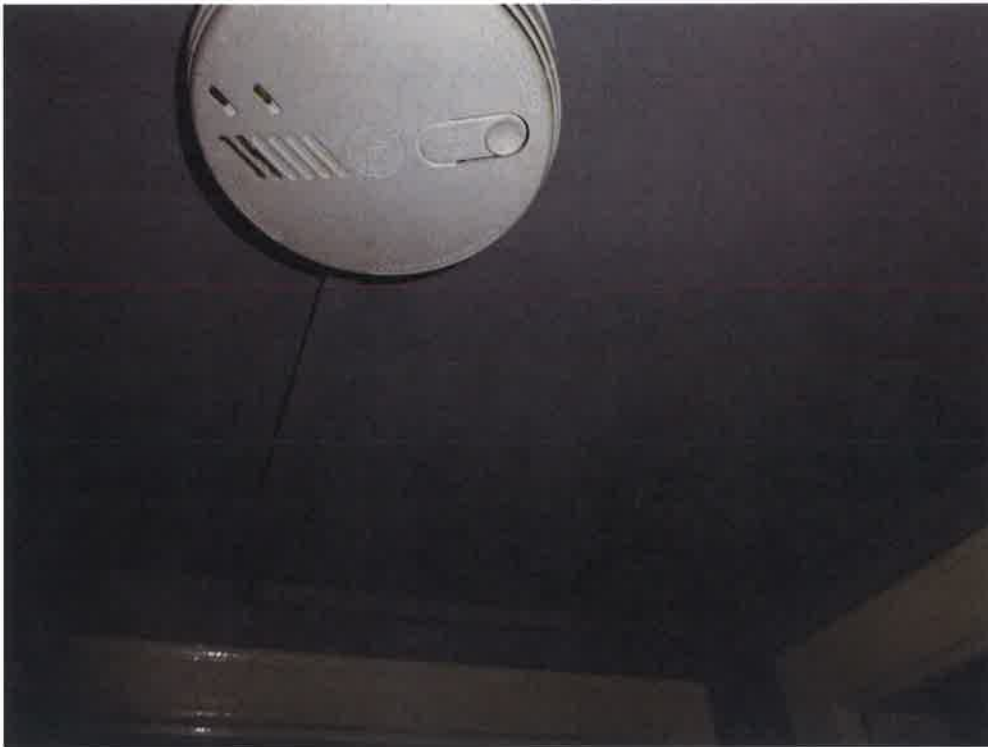
Smoke alarm on landing ceiling to 2nd floor.

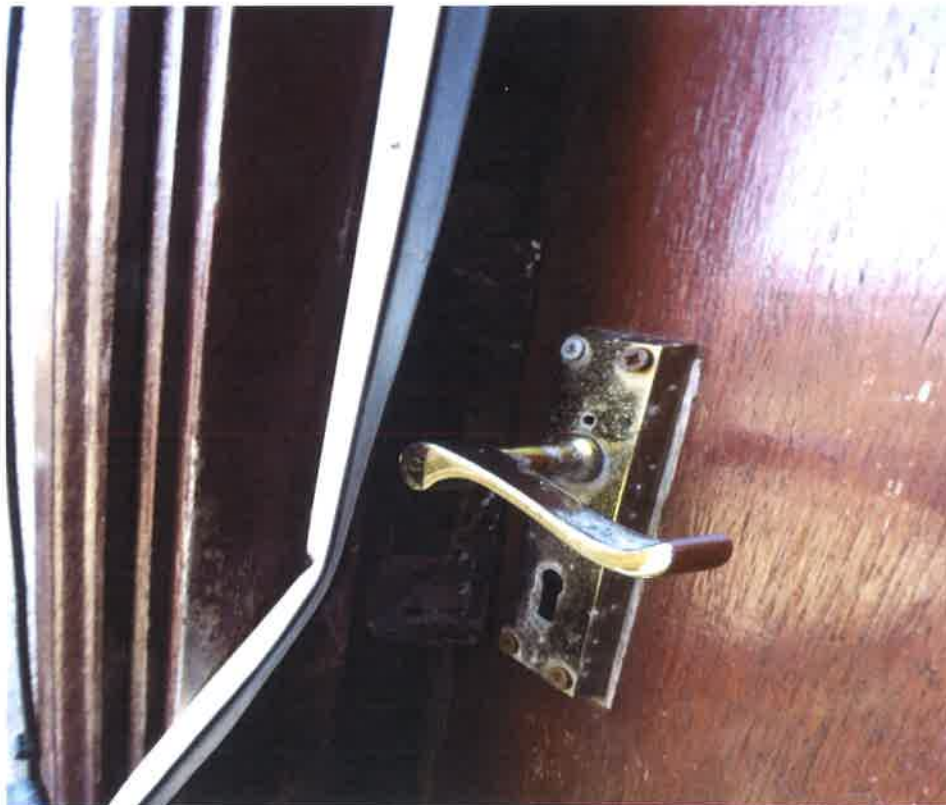
The front entrance door to the property does not open and close correctly and does not lock. In particular the door catch and the latch do not meet together as a consequence of the door frame being split. The draught proof strip on the external side of the door is partly unfixed and is bent out of shape. The front entrance door does not therefore open, close and lock correctly.

Door catch and latch do not meet because door frame split, lock loose and unsafe.

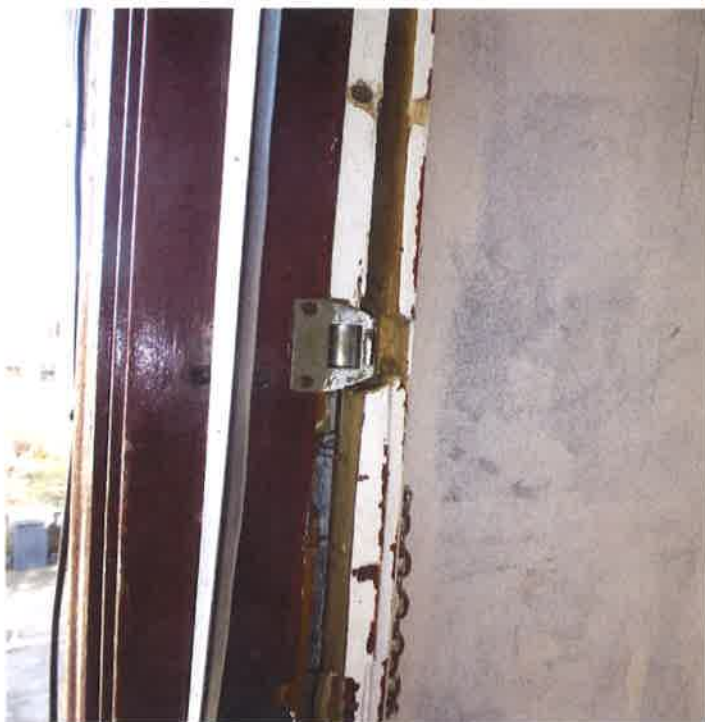
Internal view of split door frame above door catch.

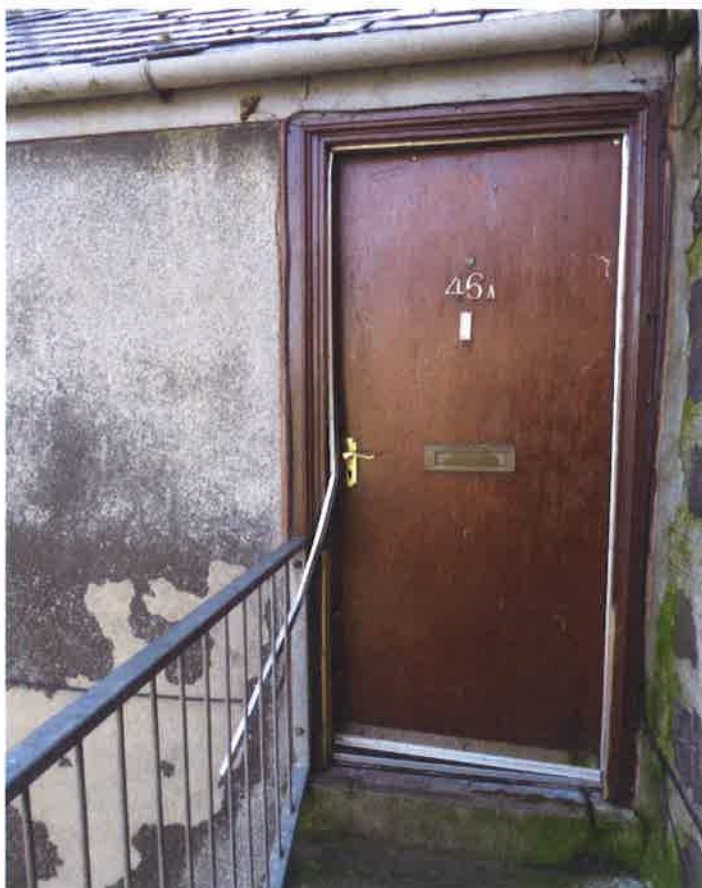
Door to flat does not open or close properly. Draught proof strip partly unfixed and bent out of shape.

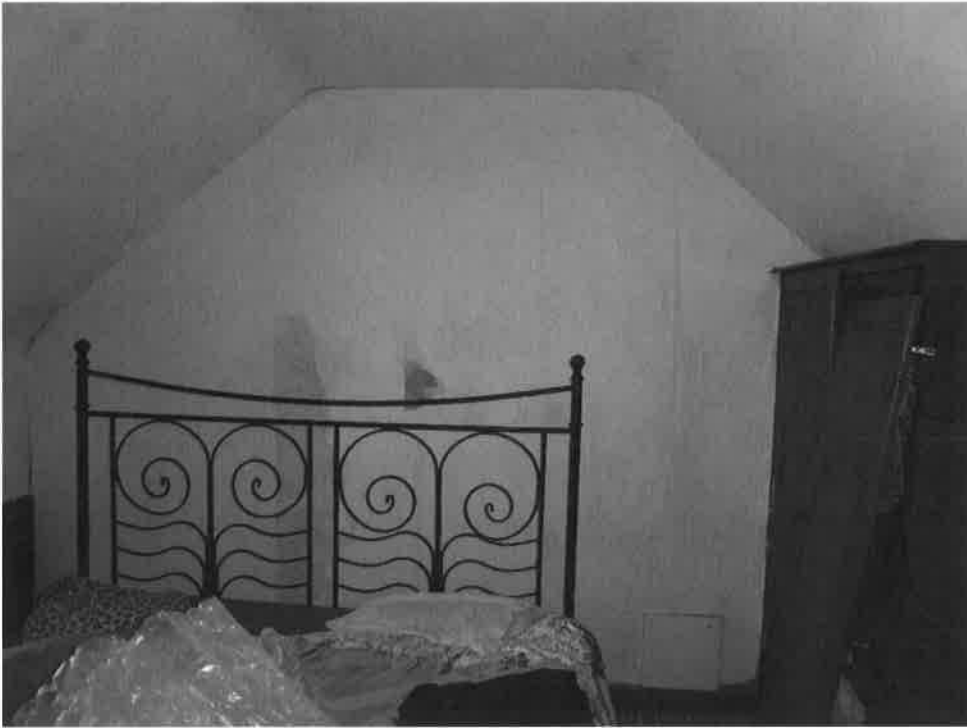
Observation – 2<sup>nd</sup> floor bedroom gable wall very damp.

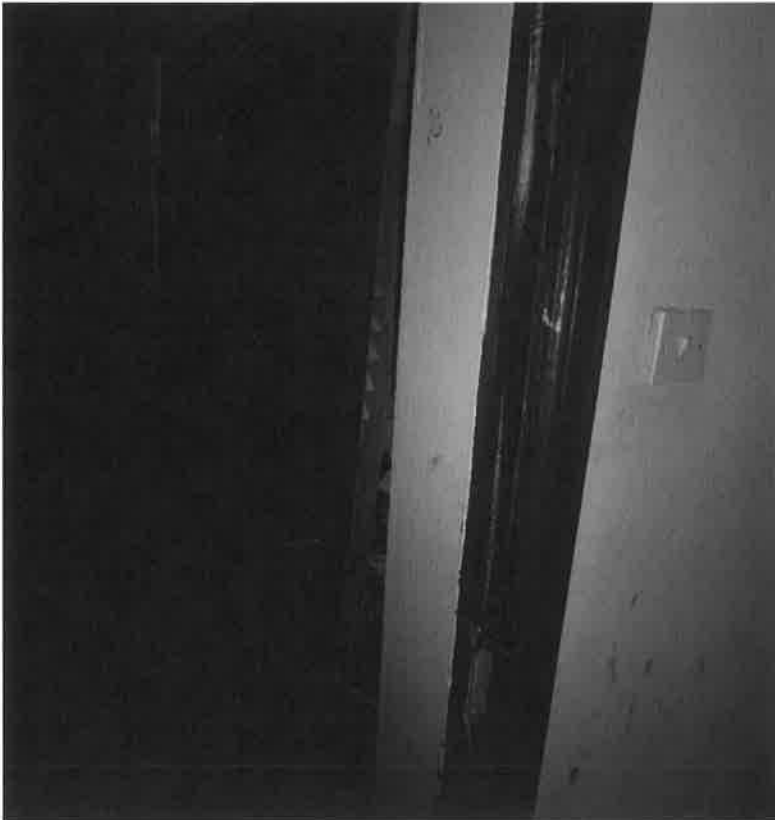
Observation – cupboard door on 2<sup>nd</sup> floor and cupboard door on 1<sup>st</sup> floor off their hinges
