**Statement of Decision of the First-tier Tribunal for Scotland (Housing and Property Chamber) (“the Tribunal”) under Section 24 (1) of the Housing (Scotland) Act 2006 (“the Act”)**

**Chamber reference number: FTS/HPC/RP/19/2641**

**Re: Property at 20 Burns Court, Kirkintilloch, Glasgow, G66 2NP (“the property”)**

**SCHEDULE OF PHOTOGRAPHS**

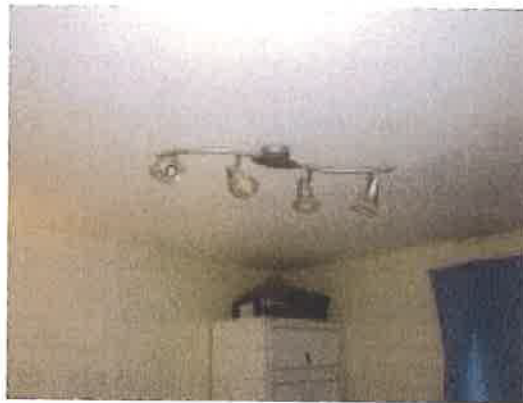
**BEDROOM LIGHT FITTING**

The tenant's representative, Mr Heath, drew to the attention of the Tribunal an electrical socket in the kitchen. The Tribunal observed that the socket was positioned on the wall dividing the kitchen from the living room. The Tribunal observed that the socket was flush with the wall and in a fixed position. The tenant advised the Tribunal that the socket had been hanging loose but had recently been secured. Similarly, Mr Heath directed the Tribunal to the light fitting attached to the bedroom ceiling. Mr Heath advised that previously the light fitting had been hanging loose from the ceiling but the landlord had arranged for this to be repaired. The Tribunal observed that the light was fitted securely to the bedroom ceiling.

30. That an inspection of the property took place on 1<sup>st</sup> November 2019 at which both parties were present.
31. That the light fitting in the bedroom was fitted securely to the ceiling and met the repairing standard as required by section 14 (1) (b) of the Act.

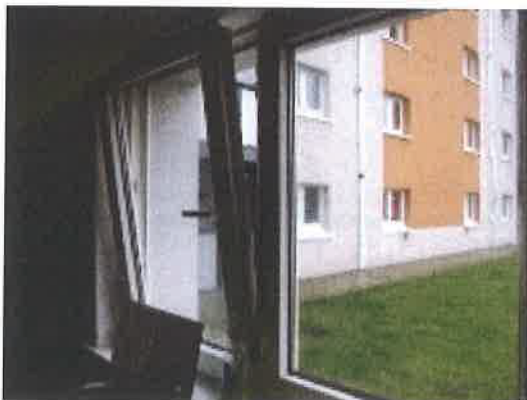
**KITCHEN WINDOW**

The tenant alleged that the kitchen window did not open. The window was positioned behind the sink. There were two windows within the frame. The window was double glazed. Each of the window panes were intended to open inwards. Only one of the panes (that to the left hand side of the window frame) was opening inwards. The pane on the right hand side did not open, at all.

46. That the window in the kitchen has two separate panes.
47. That only one of the panes of the window in the kitchen opens inwards and outwards.
48. That the other window pane cannot be opened and remains closed at all times.

49. That this window pane is not in proper working order.
50. That this window pane has not been in proper working order since the tenancy began in 2015.

51. That the landlord accepted that this window pane does not open and has never opened.
52. That the repairing standard of section 14 (1) (b) of the Act requires that the structure and exterior of the house (including drains, gutters and external pipes) are in a reasonable state of repair and in proper working order.

53. That the kitchen window is part of the structure of the house.
54. That the kitchen window does not meet the repairing standard as required by section 14 (1) (b) of the Act.

*1. Repair or replace, as necessary, the full window in the kitchen.*

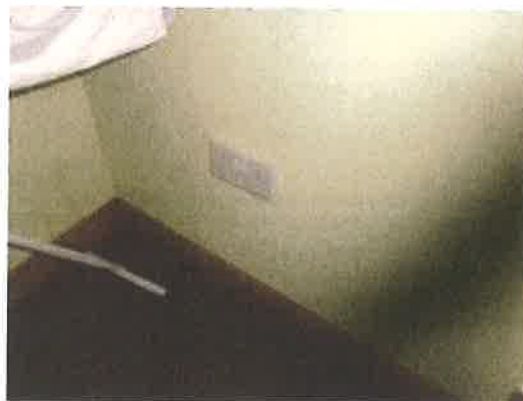
**POWER POINT – KITCHEN**

32. That the tenant was satisfied with the repair to the light fitting in the bedroom.
33. That the electrical socket in the kitchen was fitted securely to the wall and met the repairing standard as required by section 14 (1) (b) of the Act.

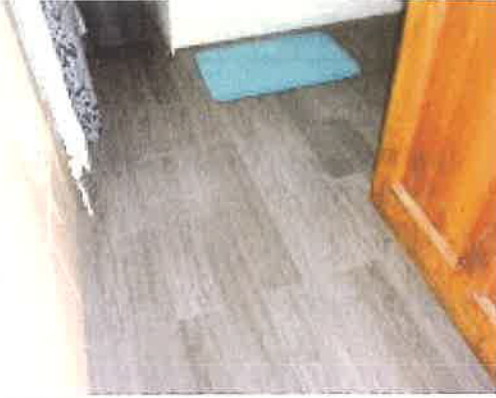
**BATHROOM FLOOR COVERING**

The Tribunal observed that a vinyl covering was applied to the bathroom floor. There was no evidence of any bathroom tiles. The tenant confirmed that the bathroom floor had been recently covered and that she was pleased with the new flooring.

34. That the tenant was satisfied with the repair to the electrical socket in the kitchen.
35. That the Tribunal found no evidence of any cracked tiles on bathroom floor at the time of the inspection.

36. That a new flooring had been fitted in the bathroom and met the repairing standard as required by section 14 (1) (b) of the Act.
37. That the tenant was satisfied with the new flooring fitted in the bathroom.

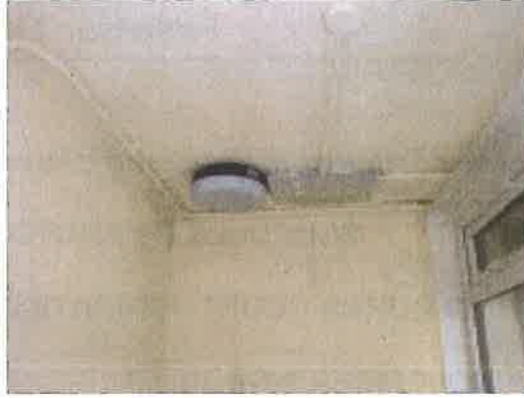
**PATIO LIGHT FITTING**

The entrance to the property was within a porch which was not part of the original building. The porch was made of double glazed fabric. The ceiling of the porch was the roof of the common close area. The Tribunal observed that, attached to the ceiling were two lights, one of which was noticeably older in presentation than the other. The older light appeared to be connected to the communal electrical supply. It was this light which the tenant alleged to not be in working order. The newer light also appeared to be connected to the communal electricity supply of the building. When the surveyor member attempted to switch on the light at the main switch, the light did not work. The Tribunal found no evidence of an additional switch having been fitted to operate the newer ceiling light. The tenant advised the Tribunal that this light had been fitted by the local authority on Tuesday 29<sup>th</sup> October 2019. The tenant advised that the new light was not on a timer and did not switch on automatically in darkness.

40. That there are two light fittings attached to the ceiling of the common area in the patio at the entrance to the property.
41. That these light fittings are not in proper working order.

42. That the landlord accepted that the light fittings in the patio area are not in proper working order.

44. That the lights at the patio are "*fixtures*."
45. That the lights at the patio do not meet the repairing standard as required by section 14 (1) (b) of the Act.

*2. Repair or replace, as necessary, the light fitting at the entrance to the property.*
