### Statement of Decision; Housing (Scotland) Act 2006

Chamber Ref: FTS/HPC/RP/18/2531

Flat 2/2, 11 Craigie Street, Glasgow, G42 8NG ("the Property")

**3rd Re-inspection Report**

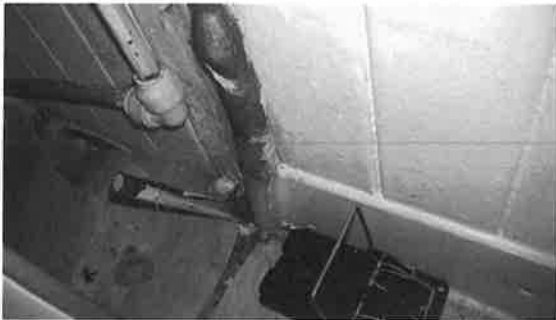
However there were three areas that still required attention. Behind the basin in the bathroom there was still a hole in the floor where rodent infestation could occur. In addition there was a hole in the cupboard underneath the sink, around the pipework where rodent infestation could again occur. The Tribunal noted that most of the skirtings had been repaired to an acceptable standard, however at the protruding corner in the kitchen there had been a large hole in the skirting where rodents had been getting access to the Property. The Landlord appeared to have had this filled with sealant. The Tribunal was able to push the sealant and it was apparent this was a very flimsy repair and that rodents could very easily gnaw their way back through this. This would require to be properly repaired.

Photo 2 – Rodent access point in bathroom

16. The Tribunal was pleased to note that progress had been made. However, as noted above there were a number of items that still required to be dealt with in order to allow compliance and the Discharge of the RSEO and the Rent Relief Order.
17. In summary the Landlord and his agents require to:-
  - Infill the hole behind the bathroom sink to ensure no rodent infestation.
  - To infill the holes around the pipework in the cupboard under the kitchen sink to ensure no rodent infestation.
  - Properly repair the hole that has been filled with sealant in the kitchen.

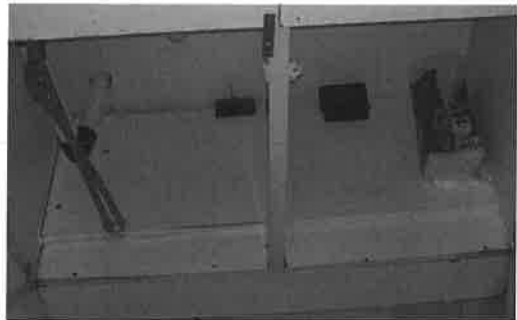
Photo 3 – Kitchen sink cupboard

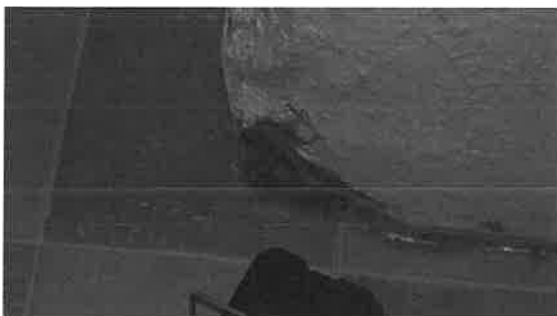
Photo 4 – Silicon filled hole in kitchen

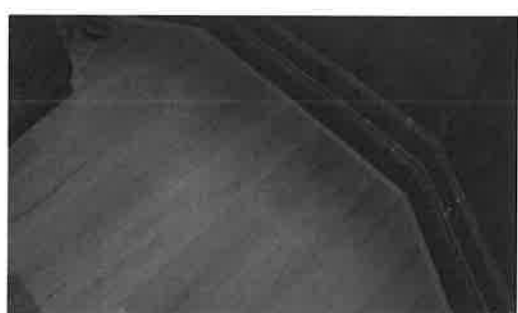
10. The next item in the RSEO had been for the repair of the floorboards in the kitchen and a new floor to be properly fitted. As noted above new flooring of a good standard had been laid throughout the Property and accordingly compliance had been achieved in this regard.

Photo 7 – New floor covering in L/Room

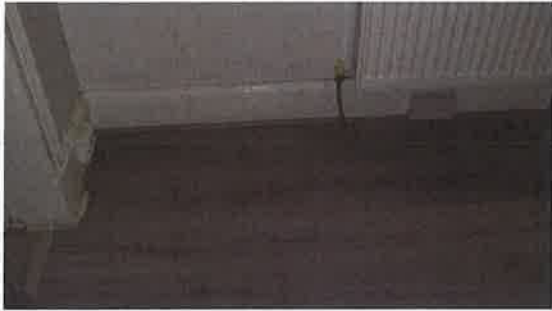
Photo 8 – New flooring in Hallway

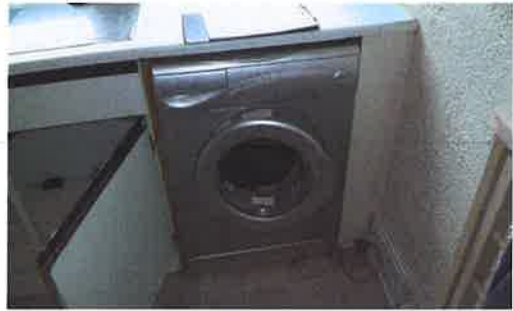
11. The next item in the RSEO was for the repair or replacement of the washing machine. The Tribunal noted that at the earlier inspection in July 2019 it had been stated that this was working properly and the Tribunal had therefore removed this from the ambit of this matter. However, the Tenant complained that the washing machine was again not working and had not been for some time. The Tribunal noted that whilst the door didn't shut readily it did indeed shut. However, the washing machine itself did not appear to be working. The Tribunal had noticed in the correspondence that the Tenant had notified the Landlord of this. Accordingly the Tribunal would, whilst not making any order in relation to the washing machine, recommend that the Landlord repair or replace this as otherwise the Tenant could simply lodge another application with the Tribunal in relation to the washing machine. This would benefit neither party.

Photo 9 – Defunct washing machine
