**Housing and Property Chamber**  
First-tier Tribunal for Scotland

**First-tier Tribunal for Scotland (Housing and Property Chamber)**

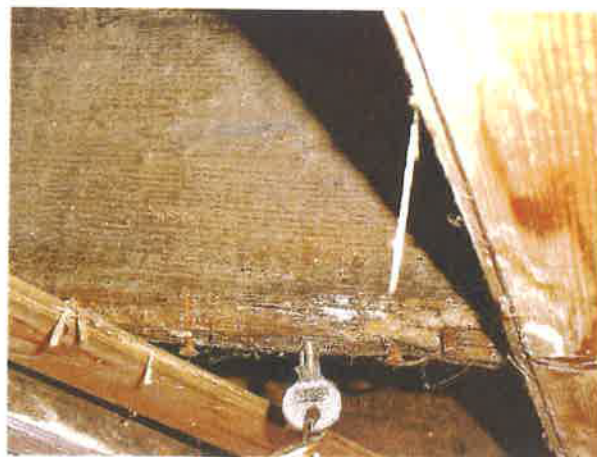
(5) Rot in joist below bath

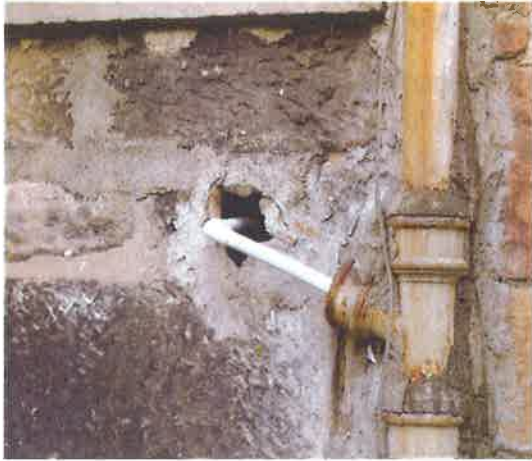
**(6) Hole in wall at condensate pipe**

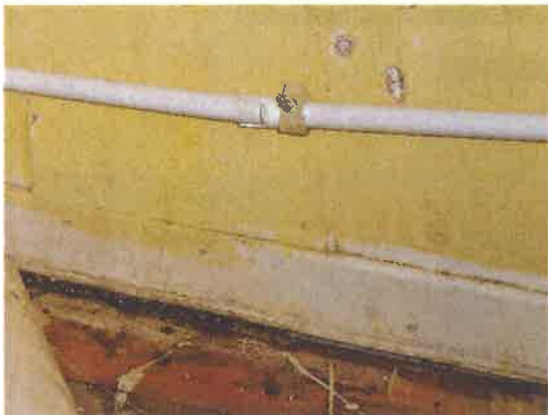
**(8) Broken joint in condensate pipe**

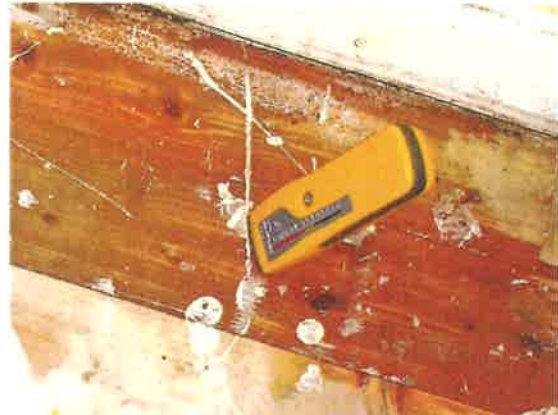
**(9) Saturated floor below condensate pipe**

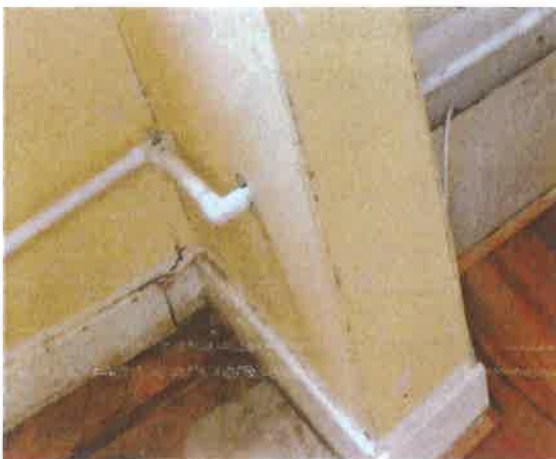
**(10) Damaged floor covering rear bedroom**

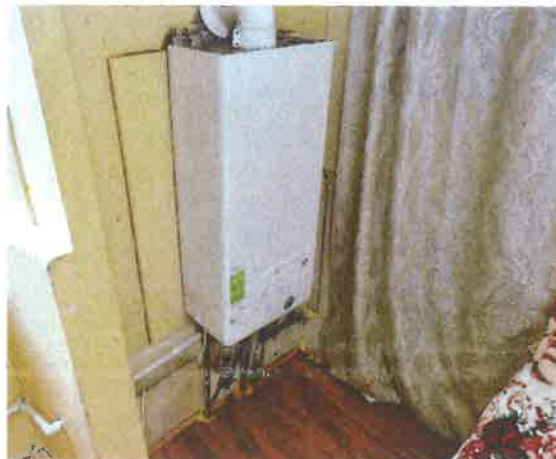
**(11) Replacement boiler**

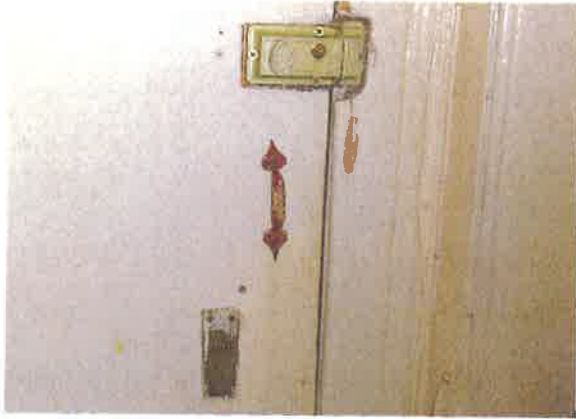
**(12) Replacement "Yale" lock**

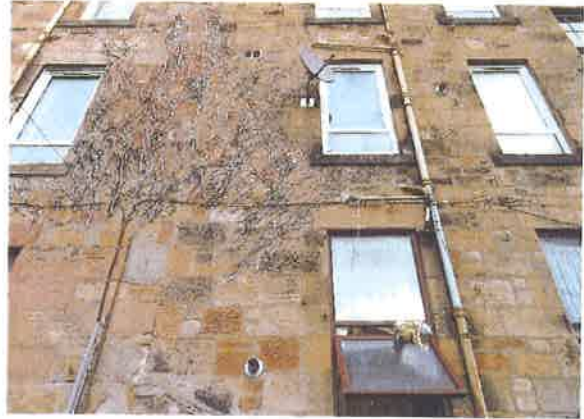
**(13) No visible external vent from kitchen**

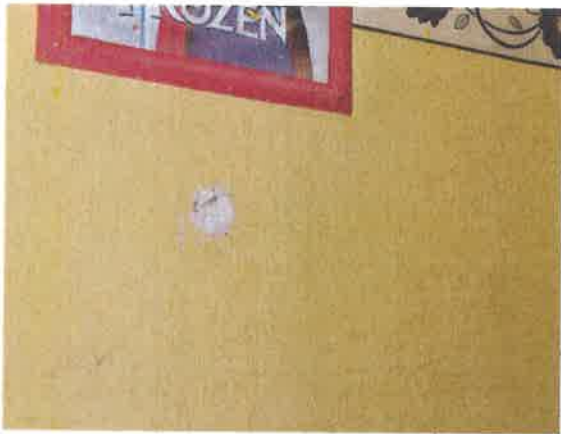
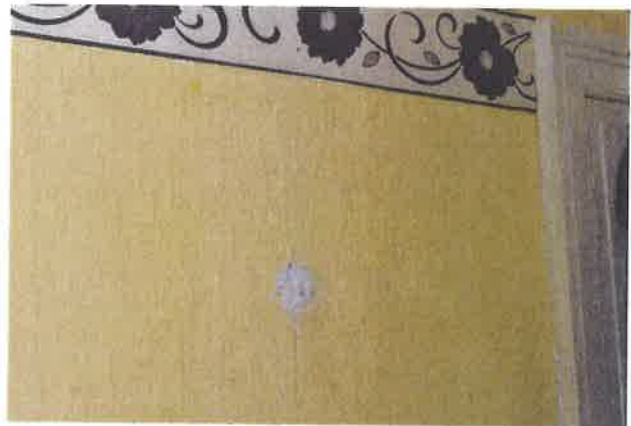
**(14) & (15) Residual damage after removal of "loose hanging wall light fittings"**

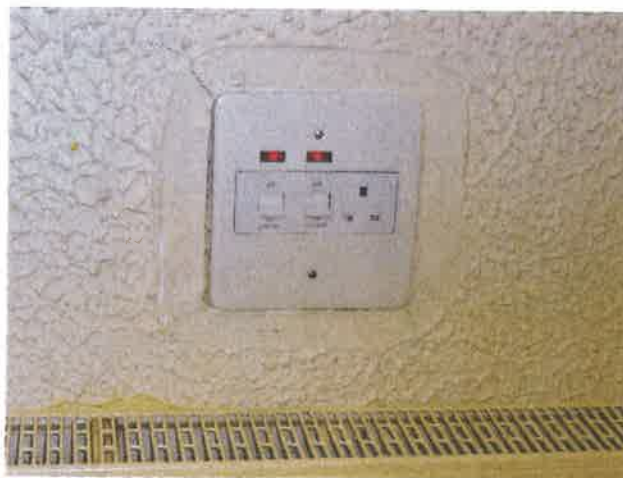
**(16) Replacement cooker control unit**
