Repairing Standard Enforcement Order

Reference PRHP/RP/15/0147

RE: Property at 5 Burnfoot Avenue, Barrassie, Troon KA10 6RF being the subjects more particularly described in Land Certificate Title Number AYR84275 (hereinafter referred to as "the house")

Schedule of photographs taken at the inspection on 1st July 2015

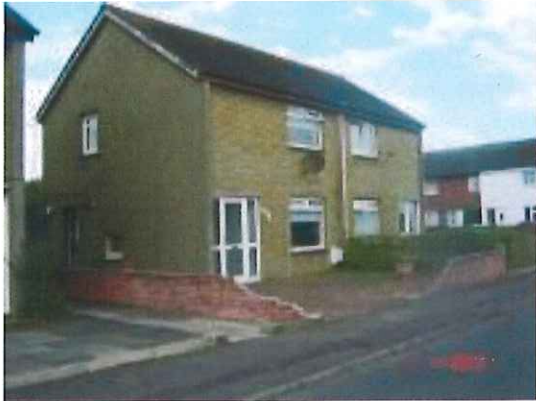
PHOTO 1.

- (a) The boundary wall to the front of the house bounding the pavement and the dividing wall at the front between the house and next door property are in disrepair. The walls are constructed of single brick with a coping at the top. Sections of both walls have collapsed. The brickwork from the section of collapsed walls has been removed but rubble and mortar remains (photo 1).

Front elevation and boundary walls

- (g) *To employ a plumber to sink the rodding eye into the ground so that it is flush with the garden ground level.*
- (h) *To reinstate the front and side boundary walls.*

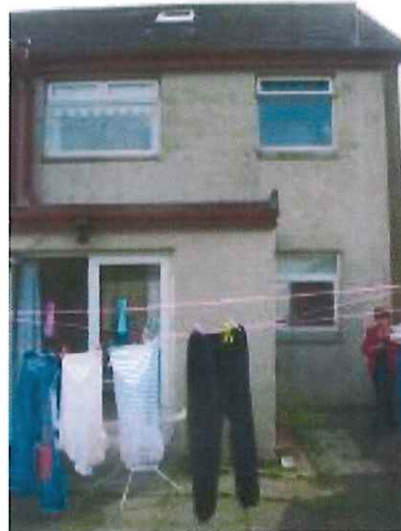
PHOTO 3

- (b) The external wall light next to the front door is damaged. It is sitting at an angle and is held in place by exposed wires (photo 2).
- (c) There is an extension to the rear of the house (photo 3).

Rear elevation

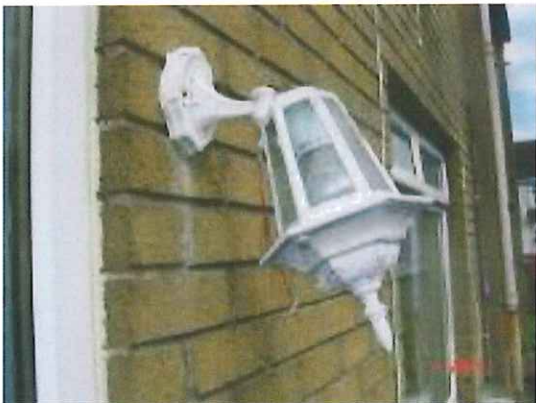
PHOTO 2

Wall light on front wall

- (a) *To arrange for an inspection of all aspects of the electrical wiring at the house including an inspection of the fittings and appliances provided by the Landlord, said inspection is to be carried out by a SELECT or NICEIC Registered Electrical Engineer; and following that inspection, an electrical inspection report requires to be prepared and submitted to the private Rented Housing Committee; If works are identified as required in terms of that report, then these works require to be undertaken and certified as satisfactorily completed by the Registered Engineer and the Landlord is required to provide certification to confirm this from a SELECT or NICEIC Registered Engineer acceptable to the Committee.*

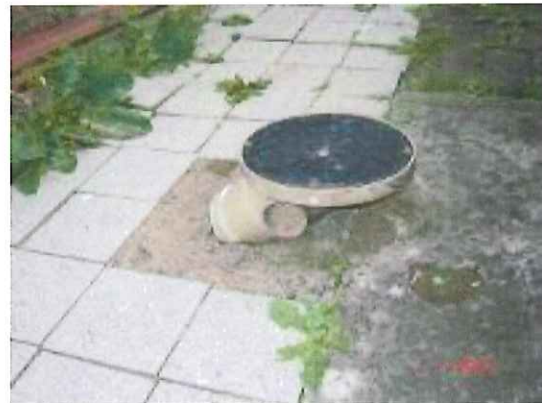
PHOTO 4

- (d) Adjacent to the rear extension, a rodding eye located in the garden area is sitting proud by about five inches from ground level and is a trip hazard (photo 4).

Rodding eye

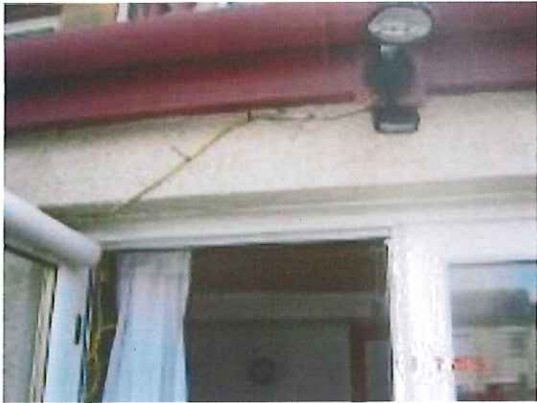
PHOTO 5

- (e) The external light on the rear extension above the patio doors has exposed wires (photo 5).
- (f) The guttering and downpipe at the rear extension is not connected (photo 6). From paperwork submitted to the Committee it appears that this item has not been notified to the Landlord.

Light and wiring at extension

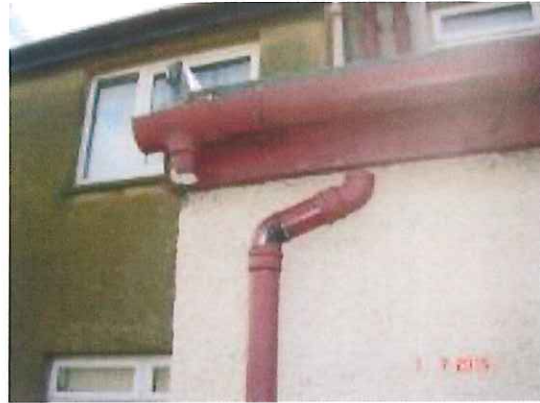
PHOTO 6

Gutter/downpipe at ext.

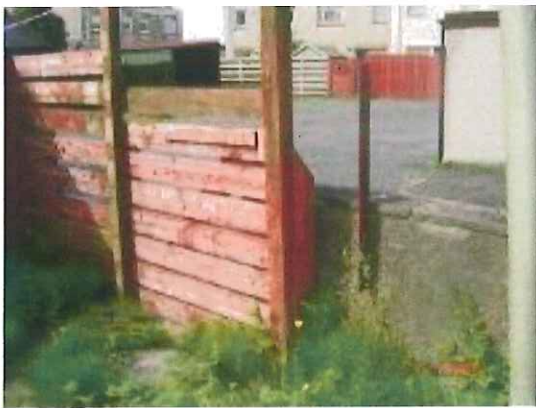
- (g) The rear garden fence has a slat missing, a metal strut is in place but there is no fence and there is no access through the gate (photo 7).
- (h) The timber garage wall is bulging and sections of the wood are rotten (photo 8). The garage door is constructed of grey asbestos and is crumbling (photo 9). The timber around the perspex window is rotten and the structure and roof of the garage is in poor condition (photo 10).

Rear garden fence - PHOTO 7

- (f) *To repair the fencing and the gate opening to ensure that it is constructed to a uniform style of uniform materials and finish and to ensure that it is in a reasonable state of repair and proper working order.*

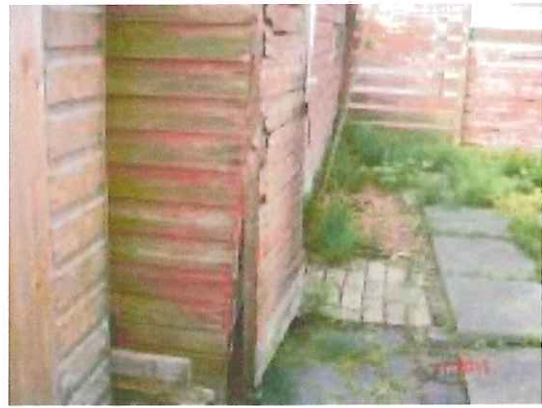
Garage wall - PHOTO - 8

- (e) *To remove and replace the garage which is at risk of collapse and is beyond economic repair. The replacement structure should be capable of housing a car. To remove the asbestos door of the garage using the services of a competent contractor who is licensed under the Waste Management Regulations who will dispose of the door and a receipt to confirm this is to be submitted to the Committee.*

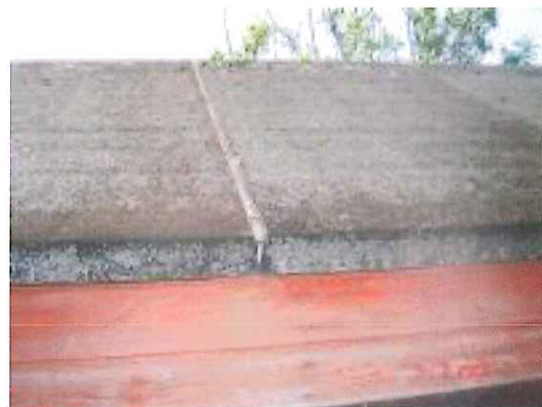
PHOTO 10

Garage roof

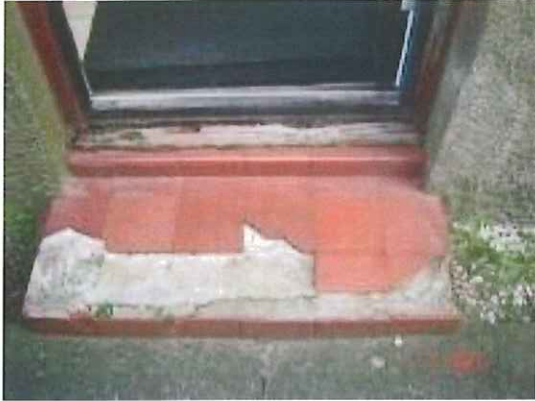
PHOTO 11

- (j) The external step at the kitchen door is in poor condition with broken quarry tiles. The wooden door sill is rotten (photo 11).
- (k) The rendering is cracked at the base of the rear gable wall (photos 12 and 13). This may be the cause of water penetration and dampness.

Ext step at kitchen door

- (c) *To replace the sill at the kitchen door with treated timber or a suitably weatherproofed material.*
- (d) *To repair and, as required replace, the quarry tiling at the kitchen exit step.*

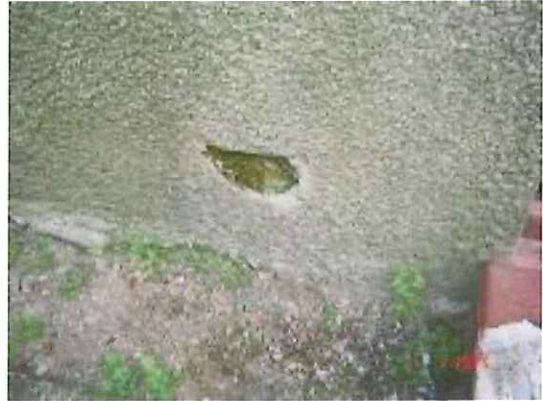
PHOTO 12.

Defective render at gable

- (b) *To identify the source of dampness and to rectify the cause to ensure that the house is wind and watertight; and to redecorate the affected area.*

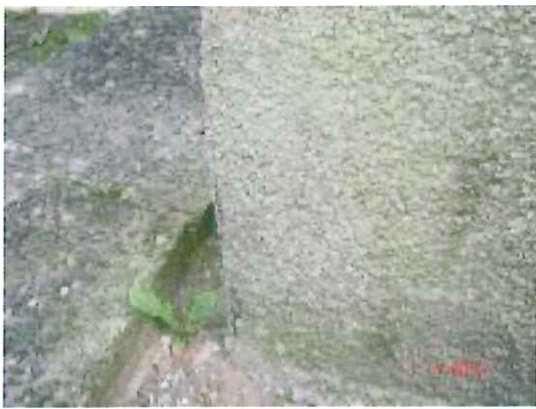
Render crack-gable/rear - PHOTO 13

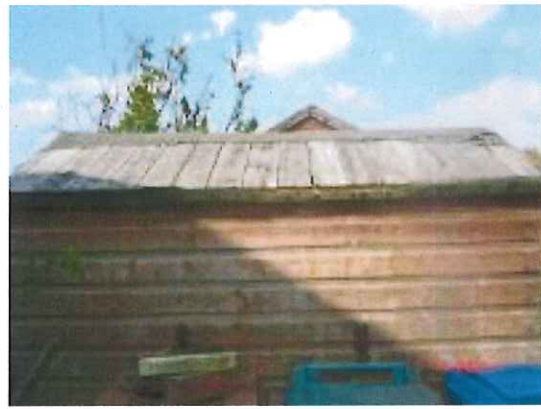
- (i) Felt is missing to the garden shed roof and parts of the timber are rotten (photo 14). From paperwork submitted to the Committee it appears that this item has not been notified to the Landlord.

Shed - PHOTO 14

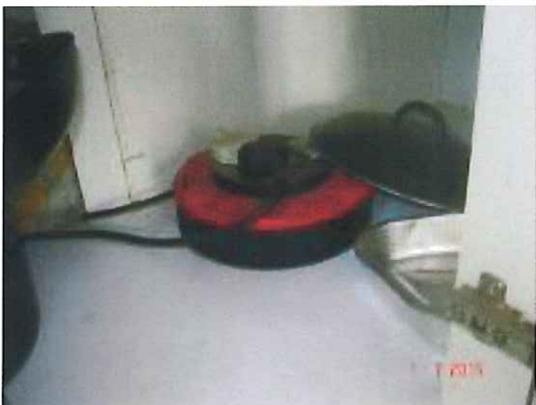
PHOTO 15

- (l) The dishwasher and washing machine are powered from an extension cable in the kitchen (photo 15). The fluorescent strip light in the kitchen does not work and the sole lighting in the kitchen is provided from a table light sitting on top of the fridge/freezer (photo 17). The fuse box in the hall cupboard requires to be checked

Cable extension in kitchen

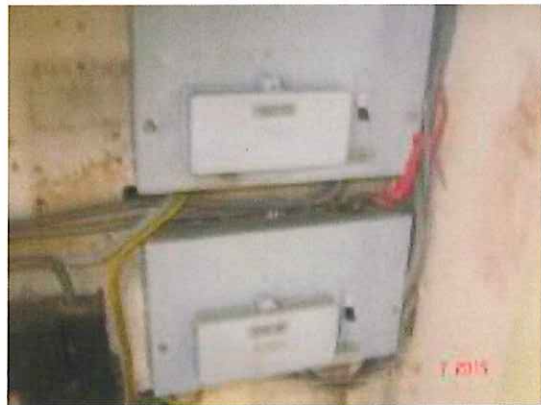
PHOTO 16.

by a qualified electrician given that it is located within a damp cupboard (photo 16).

Fuse boxes

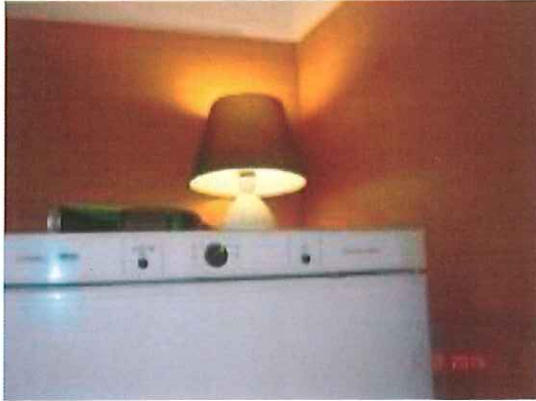
PHOTO 17

Light in kitchen

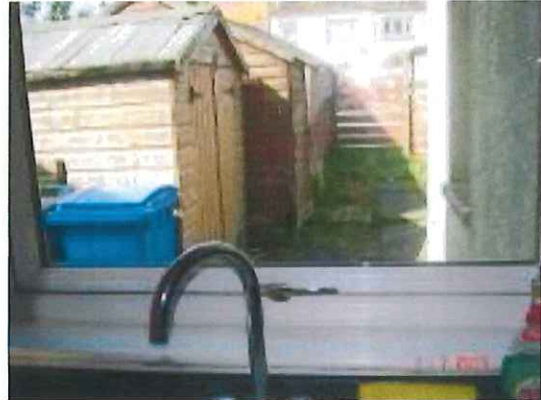
PHOTO 18

- (m) The kitchen window does not lock. The allegation is that the window is insecure and would fall out if opened. For safety reasons this was difficult to check given the associated risks to the Committee members and the possibility of damage to the window if an attempt had been made to open the window (photo 18). The Tenant confirmed there were no window keys. The upstairs hall window, which is the only window which has the means of exit in the event of fire, is locked (photo 32). This creates a risk that the upstairs occupants could not evacuate the house in the event of fire. Some other windows are unlocked and this causes the house to be insecure. Some windows are alleged to be draughty, which was difficult to ascertain at the inspection because of the calm weather conditions. It is possible that the rubber seals are not catching. The bathroom window does not shut and the window handle in the front bedroom is loose (photos 31 and 27).

Kitchen window

- (i) *To repair the windows as required to ensure that the windows are in a reasonable state of repair and in proper working order and draught free and that keys are provided to all windows with a locking mechanism. The hall window upstairs being used as a fire exit must be capable of being safely opened and closed.*

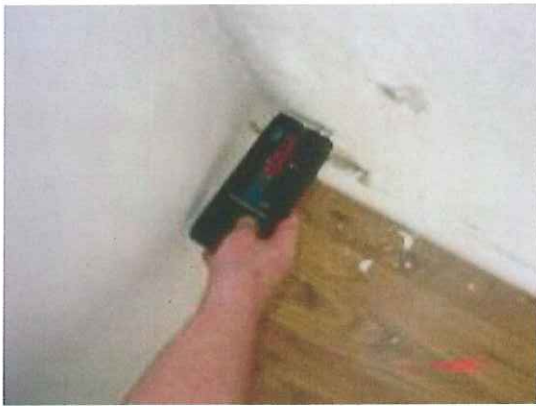
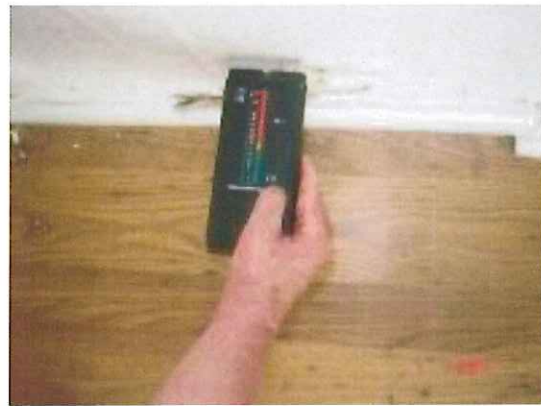
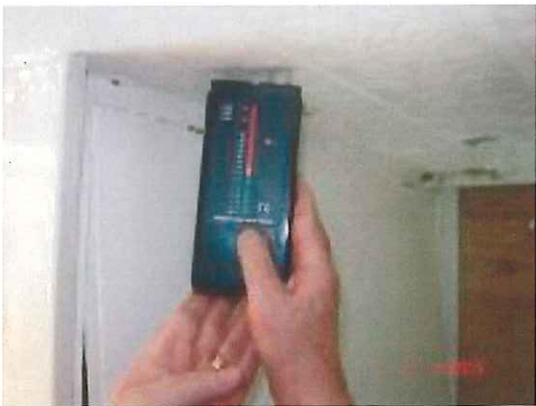
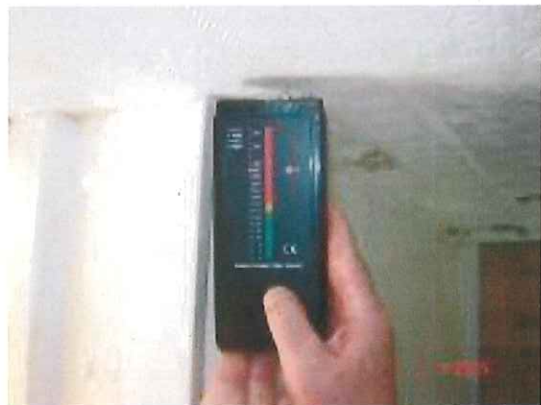
- (n) The damp meter displayed high moisture readings indicative of the presence of dampness in the vicinity of the downstairs hall window (photos 19-23) and in the electrical cupboard housing the fuse box (photos 24 and 25).

Damp reading-hall wall - PHOTO 19

Damp reading-hall wall - PHOTO 20

Damp reading-hall wall
PHOTO 21

Damp reading-hall wall
PHOTO 22

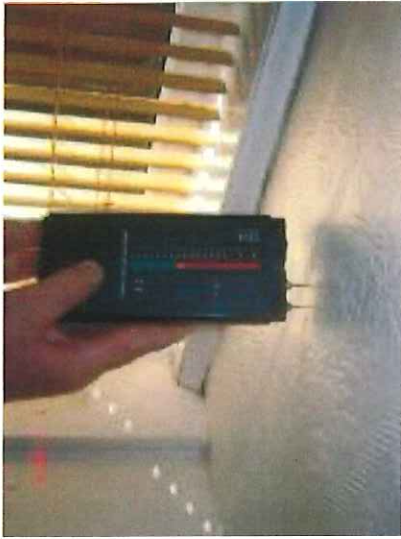
PHOTO 23.

Damp reading

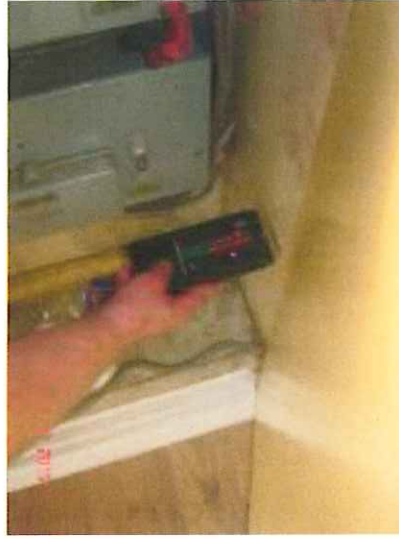
PHOTO 24

Damp reading in meter cpd

Damp reading - PHOTO 25

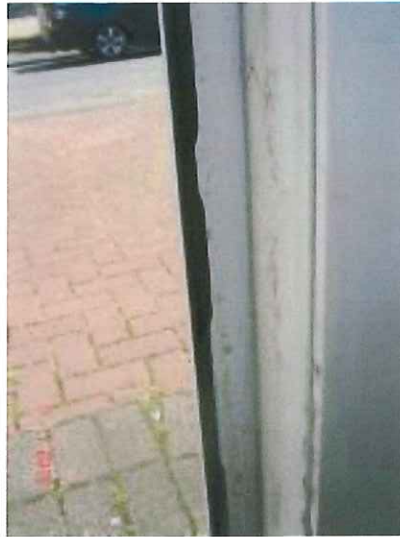
- (o) The rubber seal on the front door frame is twisted and is not performing its function as a draught excluder (photo 26).
- (p) The stairs to the first floor are open and there is no banister to prevent a fall onto the lower level (photo 29). This would be a particular danger to young children and anyone who has an unsteady gait. From paperwork submitted to the Committee it appears that this item has not been notified to the Landlord.

Front doorframe seal - PHOTO 26

- (j) *To repair the skylight velux window so that it is in a reasonable state of repair and in proper working order.*
- (k) *To repair the front door to ensure it is wind and watertight and draught free.*

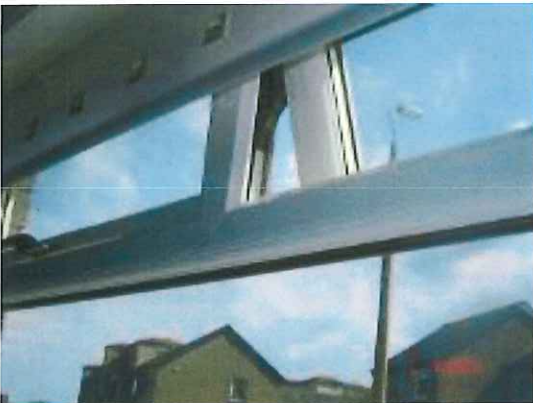
PHOTO 27

Living Room window

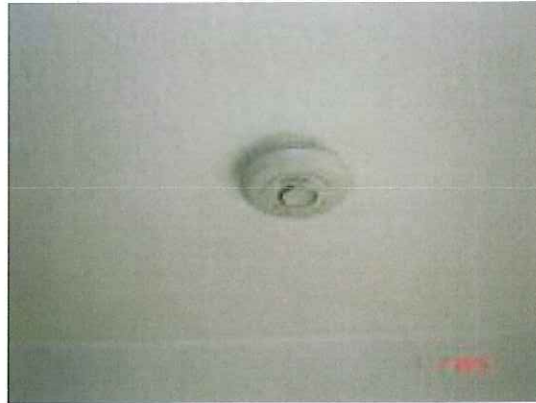
PHOTO 28

- (q) There are battery smoke detectors on the ceiling of the ground floor hall (photo 28), on the upper floor landing (photo 30) and on the attic ceiling (photo 35). The devices were checked by the Committee and the ground floor and attic devices do not work.

Ground floor hall - smoke alarm

(m) To install fire detection devices in the house which comply with the current guidance issued by Scottish Ministers for the provision for such devices. A copy of the Statutory Guidance referred to is attached to this Order.

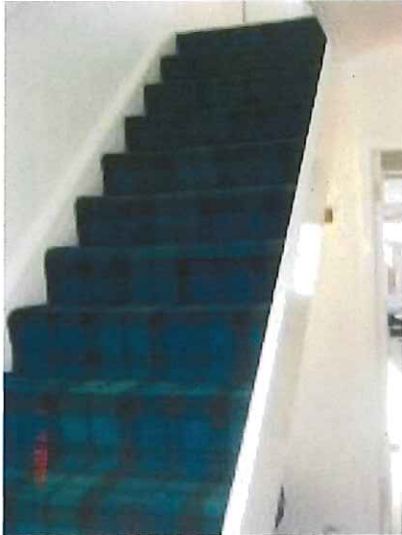
PHOTO 29

Main staircase

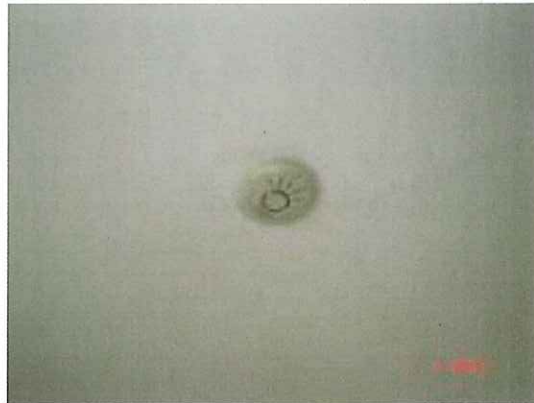
PHOTO 30

Upper floor landing – smoke alarm

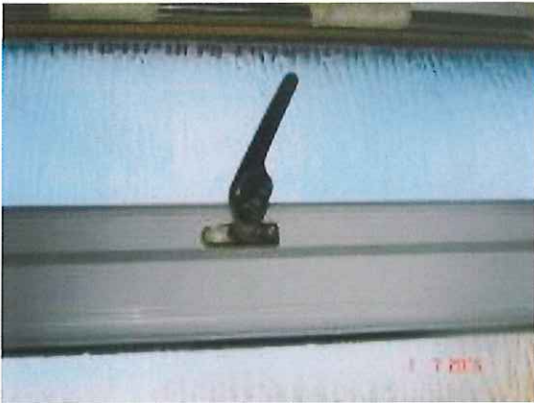
Bathroom window - PHOTO 31

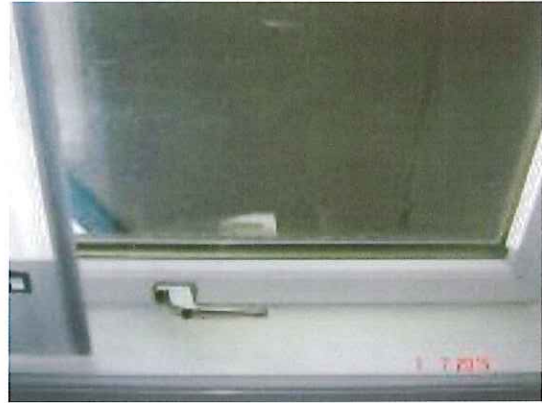
Upper Landing window - PHOTO 32

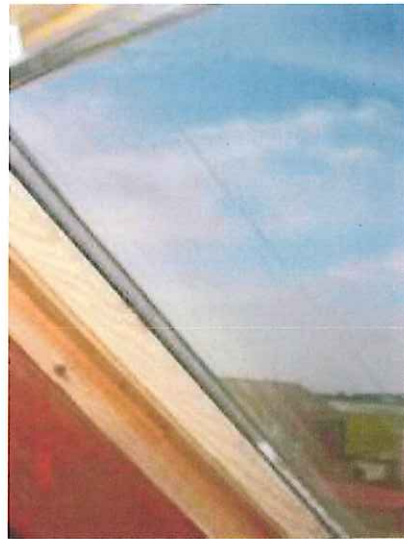
- (s) The glazing is cracked in the attic velux window (photo 34).
- (t) There are exposed bare wires in the attic (photo 36).
- (u) The access to the attic is by means of timber open stairs which are not fixed. The attic conversion does not appear to conform to building regulations.

Velux window
PHOTO 34

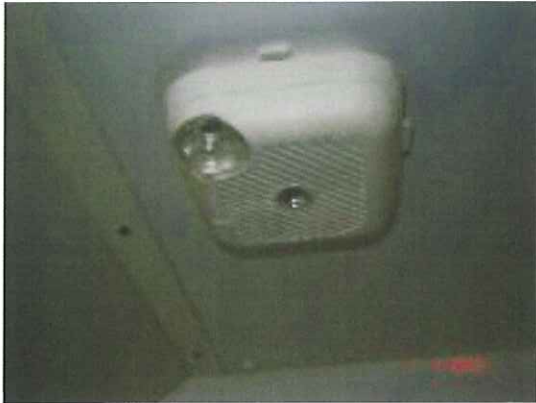
PHOTO 35

Attic smoke alarm

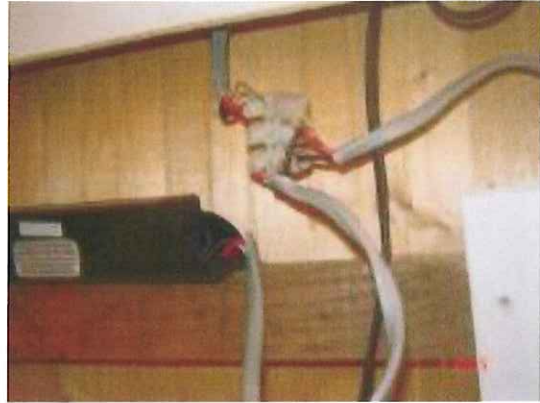
PHOTO 36

Attic-electric wiring

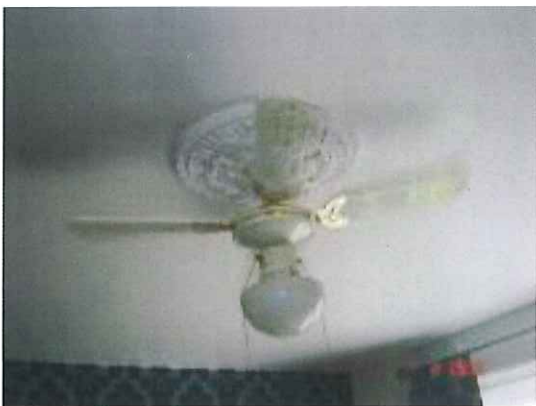
- (w) The ceiling light in the living room with fan attachment is unsafe and when it is switched on the fan rotates with such vigour that the glass bowl swings unsafely (photo 37).

Living room-fan light - PHOTO 37

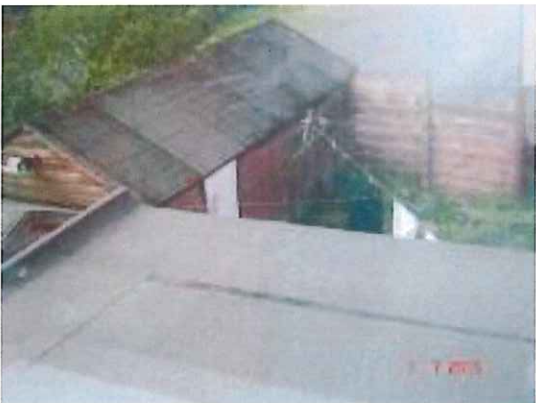
PHOTO 39

- (x) The felt on the flat roof extension does not overlap at one section (photo 39). This is likely to be a future weakness and may result in water penetration but is not the subject of complaint in the application. From paperwork submitted to the Committee it appears that this item has not been notified to the Landlord.

Rear ext roof/garage

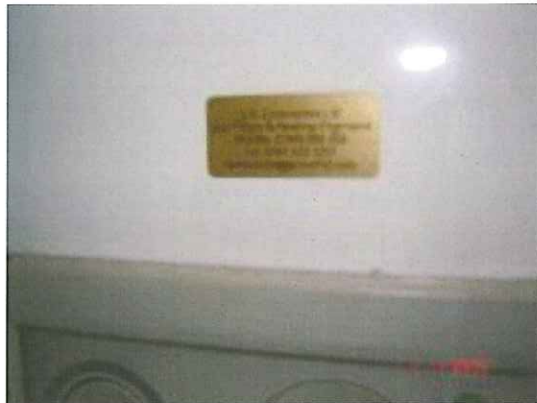
PHOTO 40

- (y) The sticker on the boiler provides the name of the installer (photo 40). It is SR Contractors Ltd. Enquiries by the Committee reveal this company is registered in the Gas Safe register (registration number 132449).

Gas boiler installer

- (l) *To produce an up to date and satisfactory Gas Safe certificate for the gas*
